# **Southern Great Barrier Reef Coastal Habitat Archive and Monitoring Program: Mangrove Management Plan Volume 2**

## **Volume 2**

Norman C Duke<sup>1</sup>, Jock Mackenzie<sup>1</sup>, Ric Fennessy<sup>2</sup>, Riley Cormier<sup>3</sup> & John Kovacs<sup>3</sup>

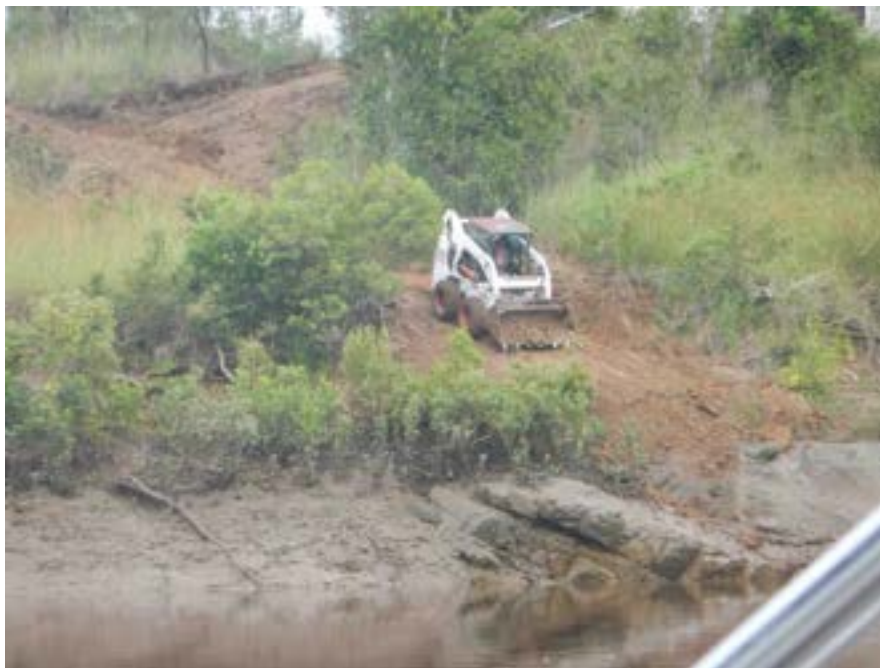
**Figure 13: Cutting a new track through to the river bank in a particularly vulnerable area. Is this permitted?**

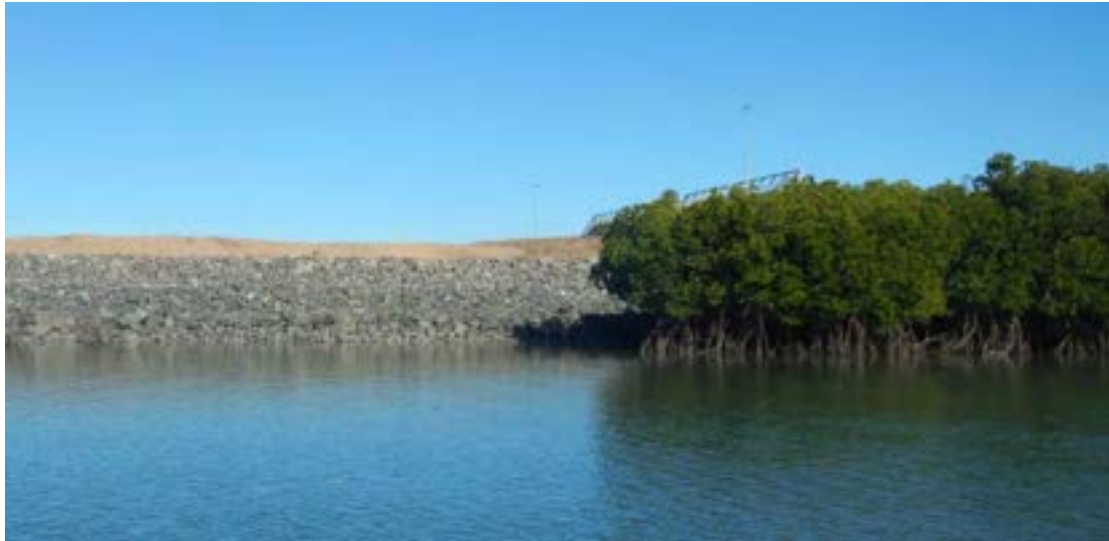
**Figure 16: Reclamation areas appear as sterile places with low biological diversity compared to the adjacent mangrove systems.**

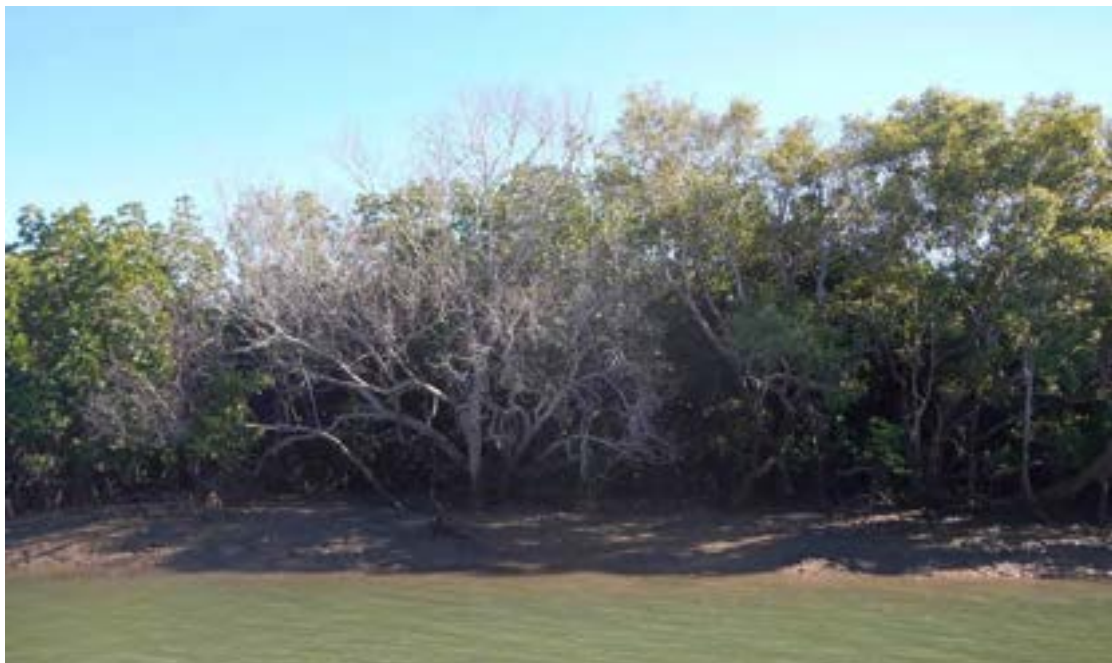
Figure 18: Species specific death of *Avicennia* trees is indicative of herbicides in runoff waters.

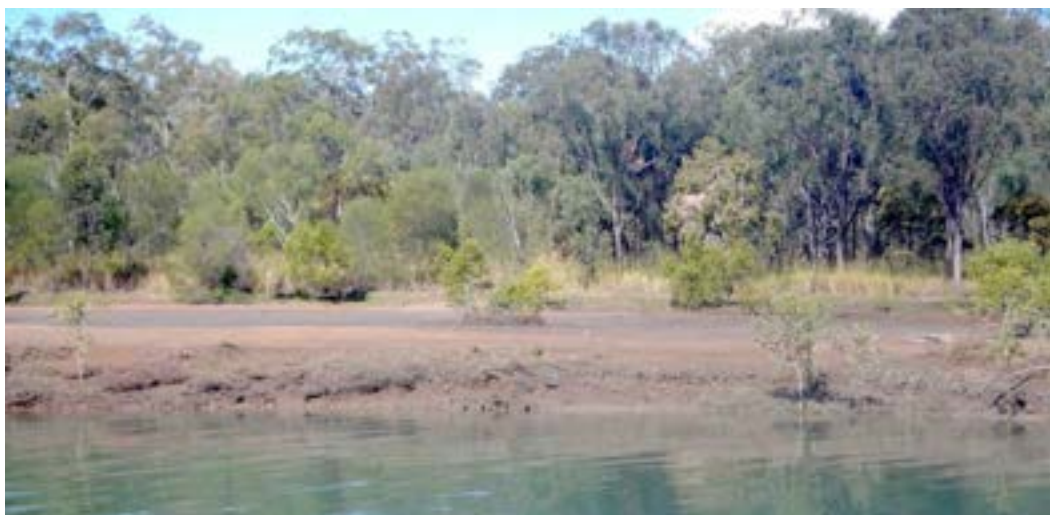
**Figure 20: Scouring of saltmarsh-saltpan areas.**

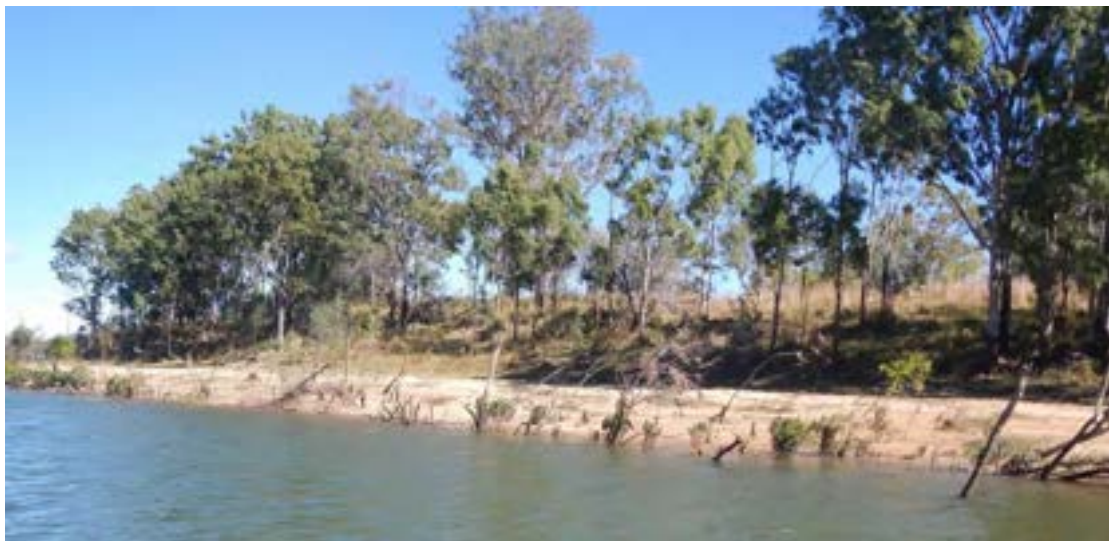
Figure 22: Flood damaged mangrove verge in the Calliope upstream estuary.

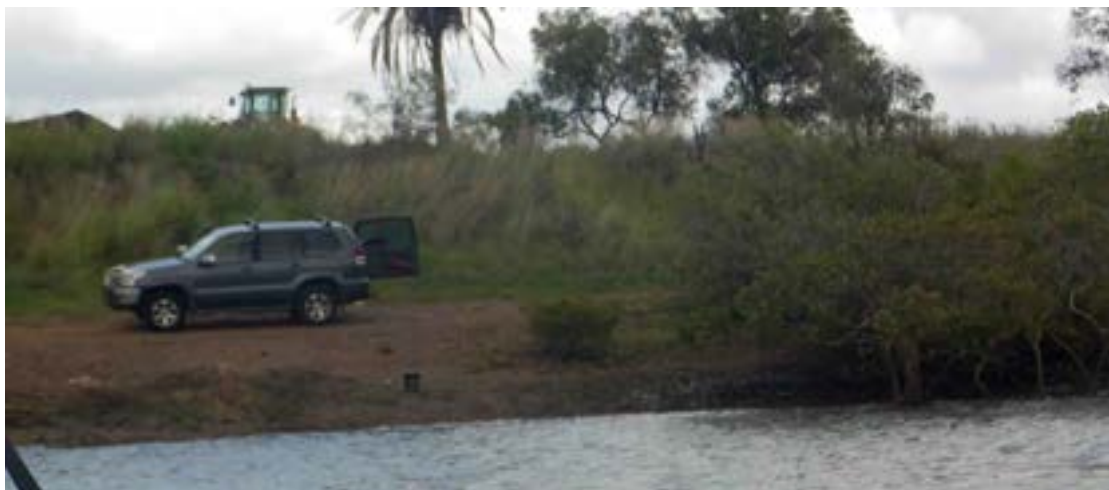
**Figure 32: Vehicle access onto delicate and vulnerable shoreline verges seems quite normal.**

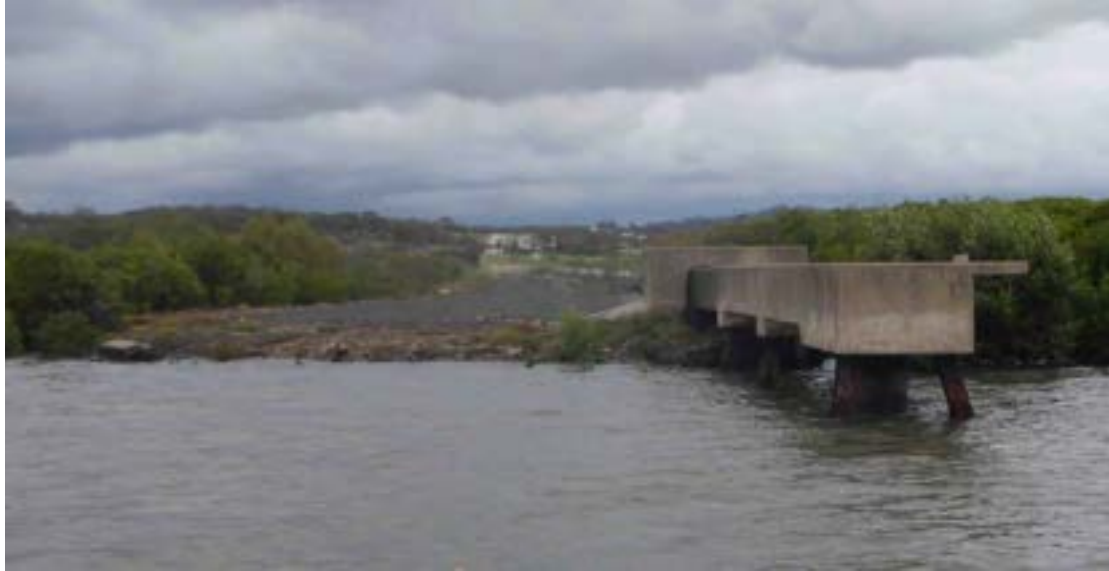
**Figure 33: Damaged tidal wetland habitats are common adjacent to constructed structures needed for industry operations.**

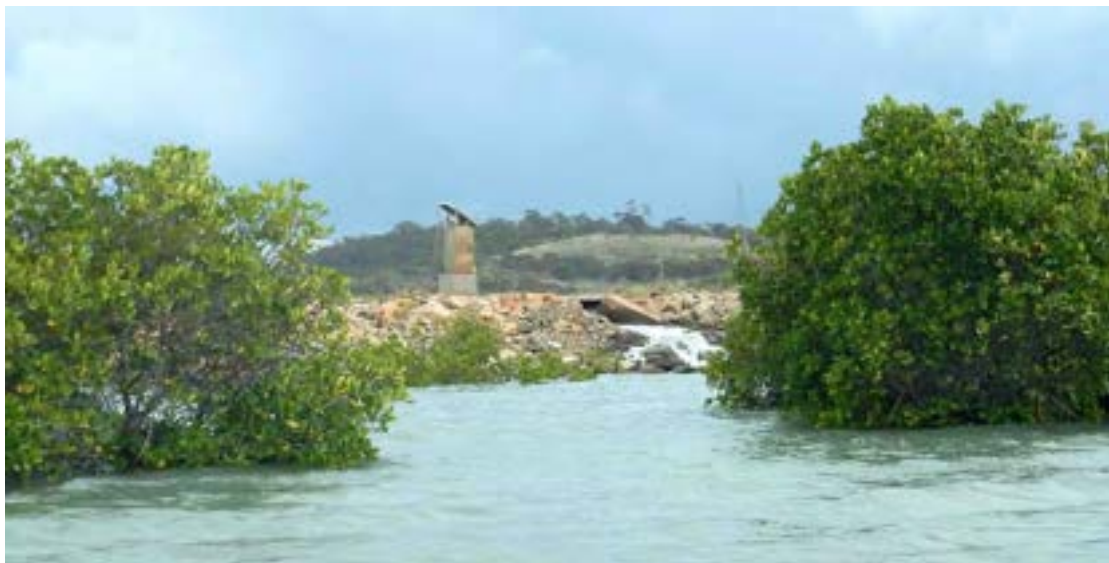
**Figure 34: Constructed walls mark the perimeter of landfill areas with added drains from which flows unknown waste waters.**

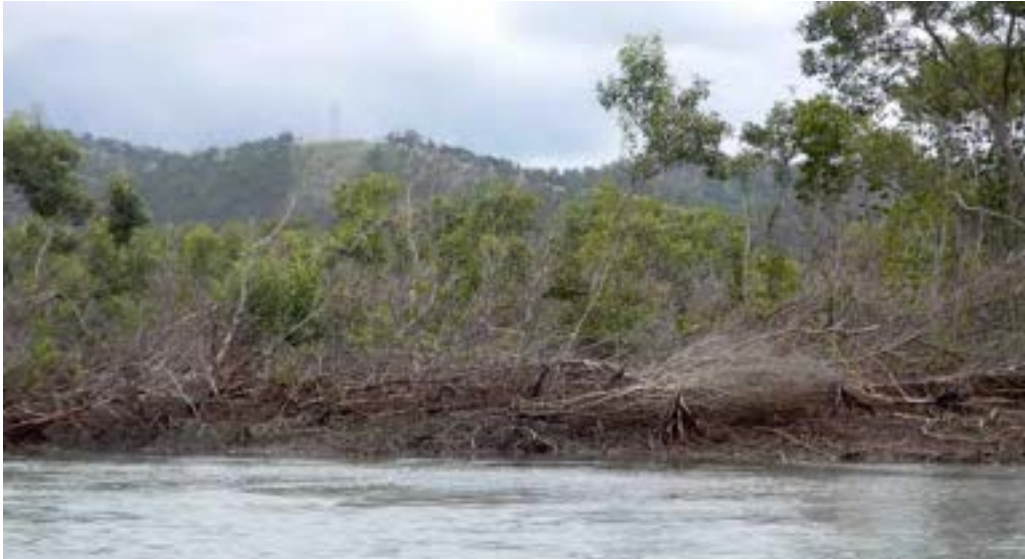
**Figure 39: Stand damage attributed to flood damage.**

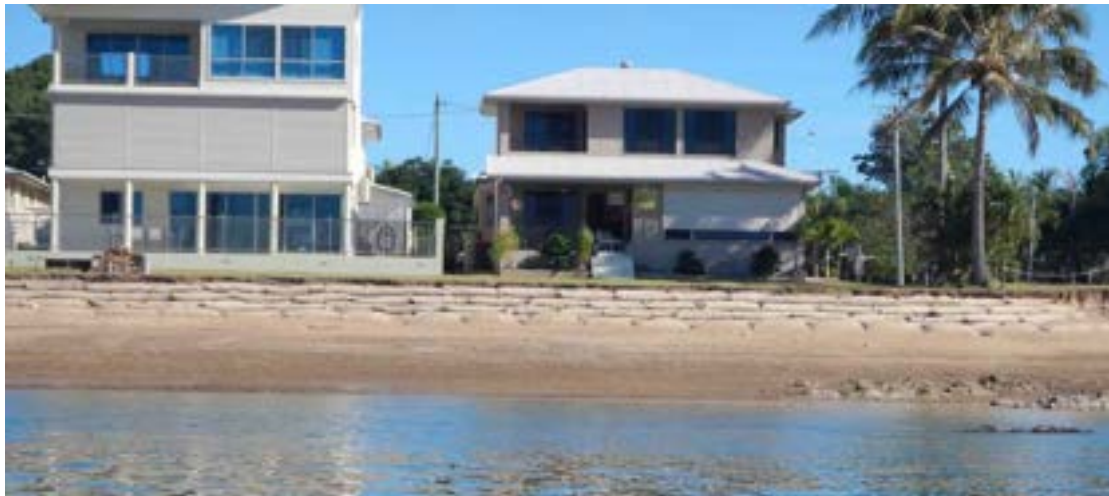
**Figure 47: Where urban meets estuary, there appears the estuary often losses.**

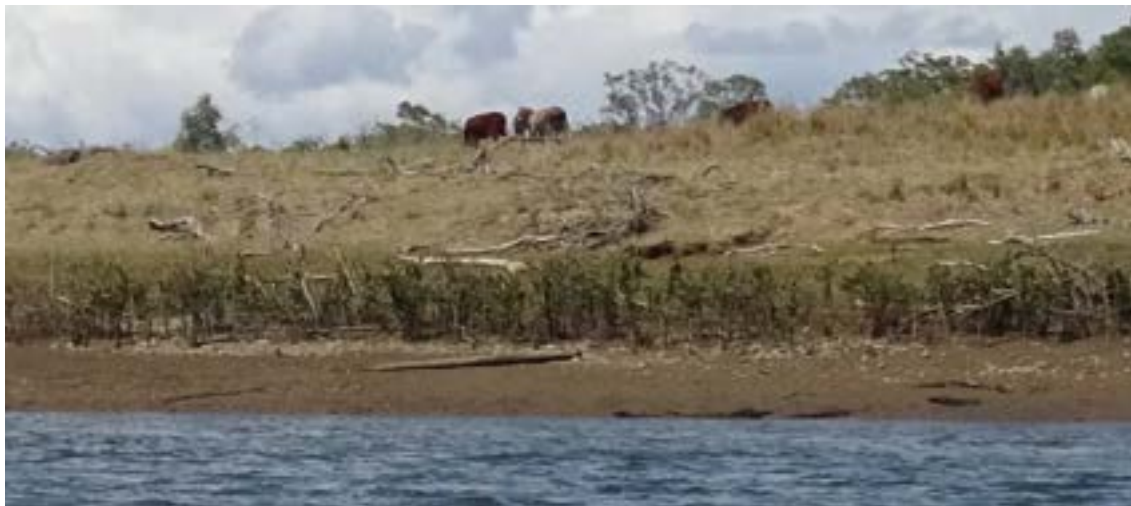
**Figure 48: Young mangrove seedlings after the flood event have a hard time when they can be easily grazed upon by hungry cattle.**

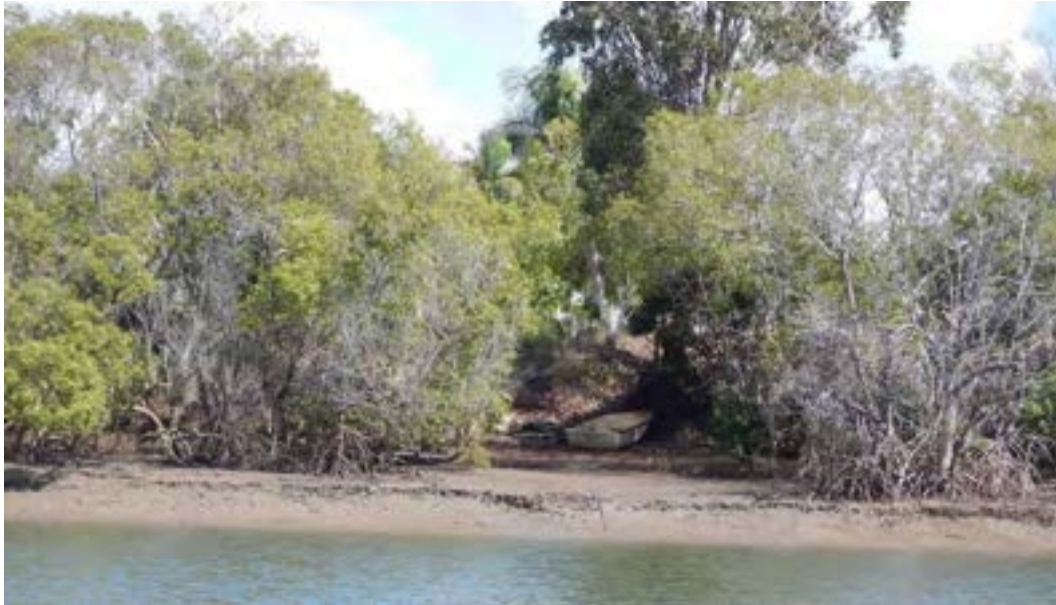
**Figure 49: Access paths cut through the mangrove verge offer little protection for surrounding plants during the flood event.**

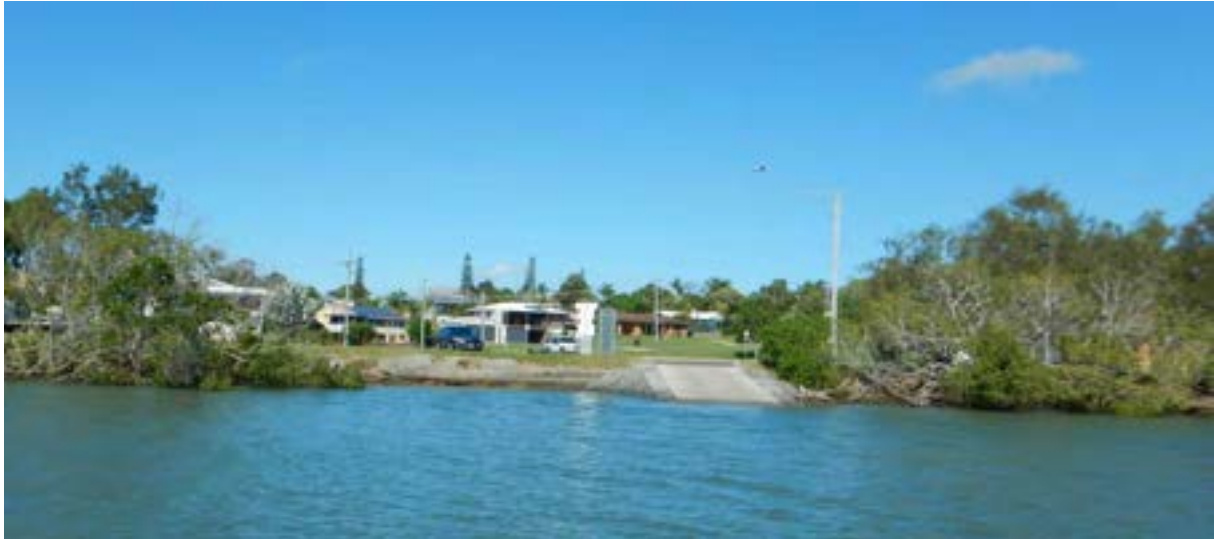
Figure 50: Boat ramps are common – so is the damage to connectivity and stability of estuary shorelines.

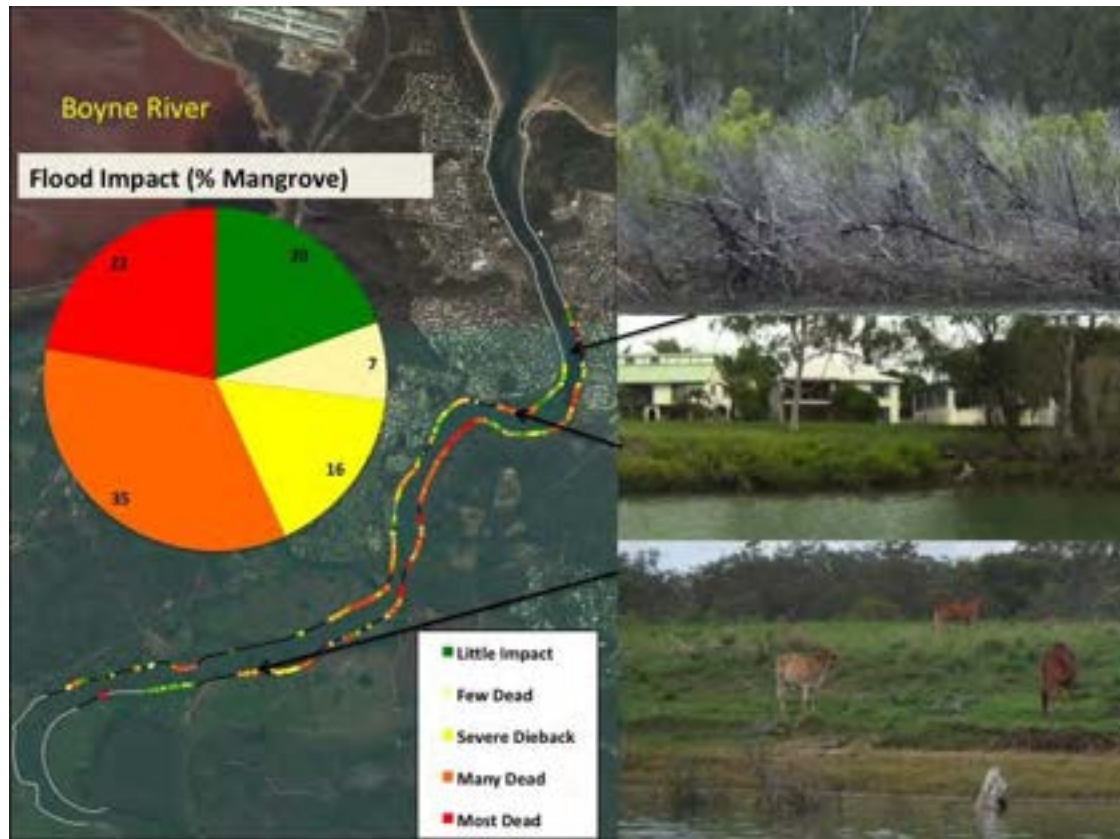
Figure 54: Flood damage was notable in the Boyne estuary. Shoreline video assessment method (S-VAM) surveys quantify mid-estuary sections with severe damage and loss of mangroves.

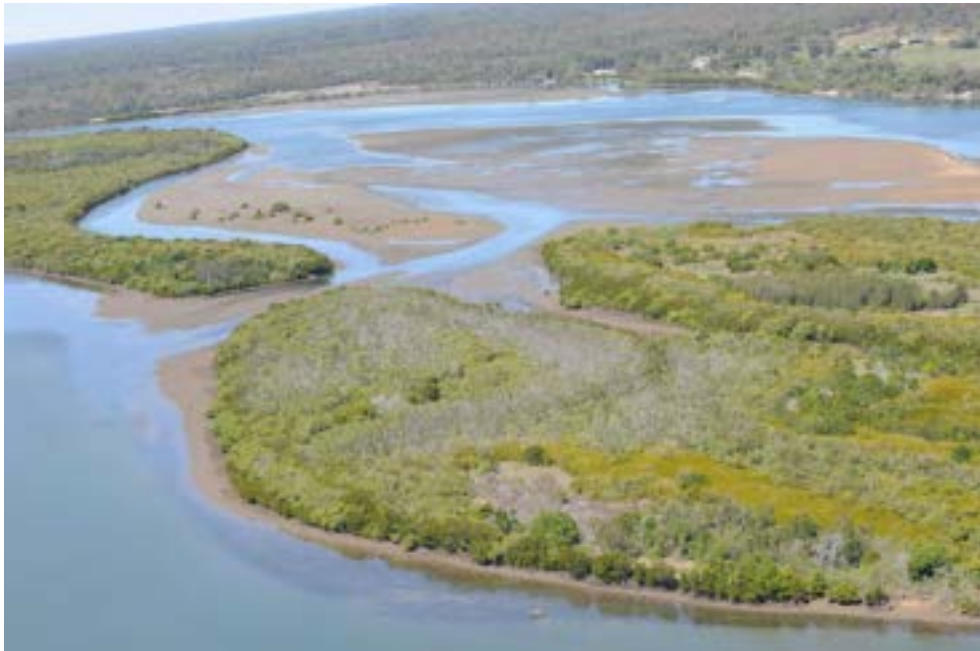
**Figure 62: Large depositional banks are common throughout Baffle Creek estuary. Note the dieback (grey tinge) of fringing *Casuarina* as a result of drought.**

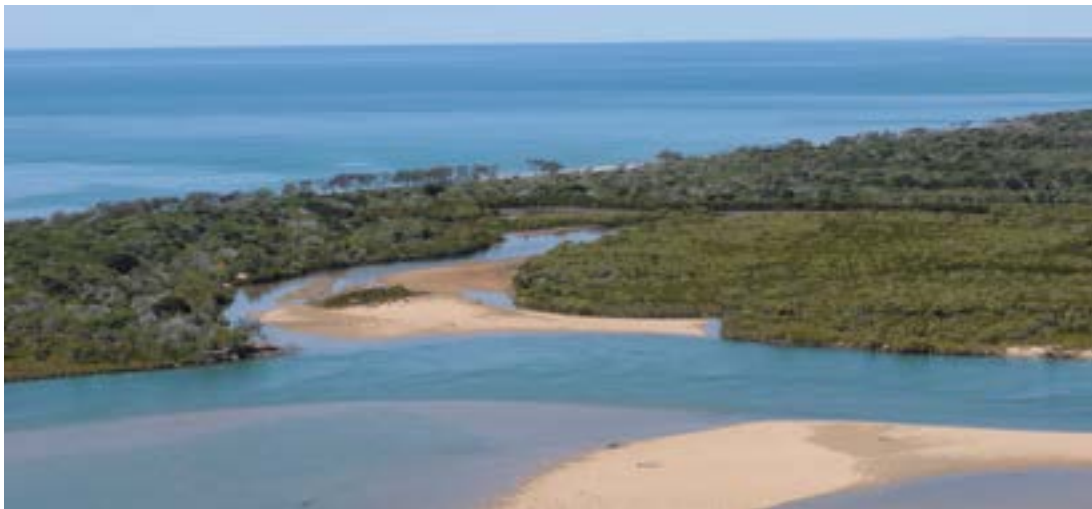
Figure 72: Natural sand deposition at the entrance of a creek running through the southern Mouth of Baffle Creek Conservation Park is affecting tidal flows to tidal wetland areas in the park area.

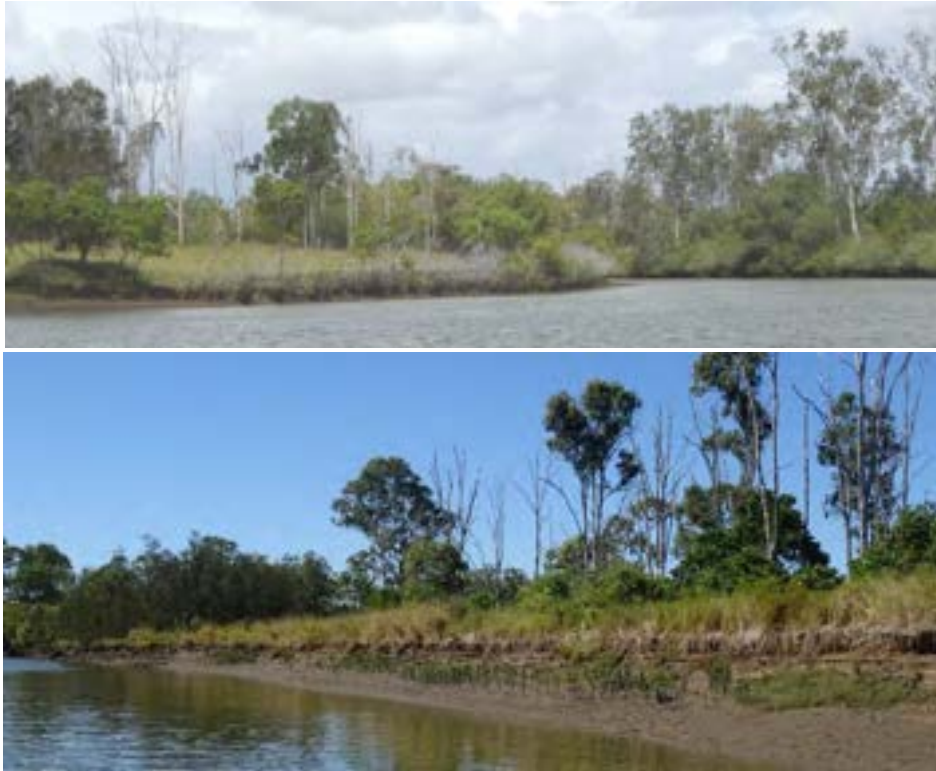
**Figure 88: Fringing *Aegiceras* suffering severe drought stress 2008 and the same area in 2018 showing complete loss of habitat following flooding with evidence of habitat recovery.**

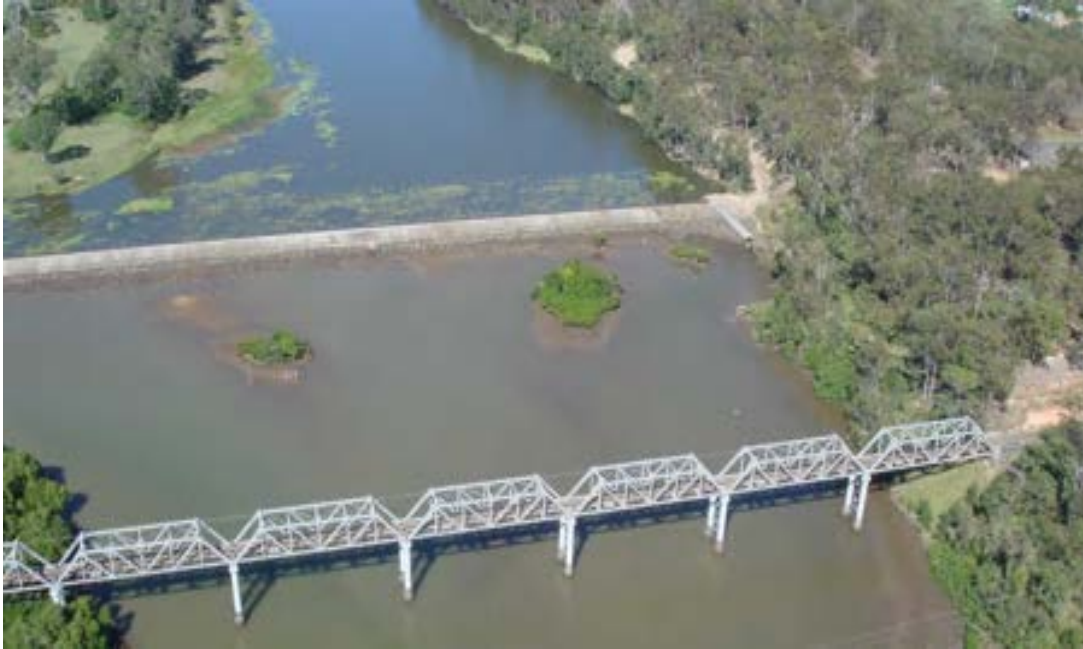
Figure 94: The barrage is likely to exacerbate estuarine shift in the Kolan River.

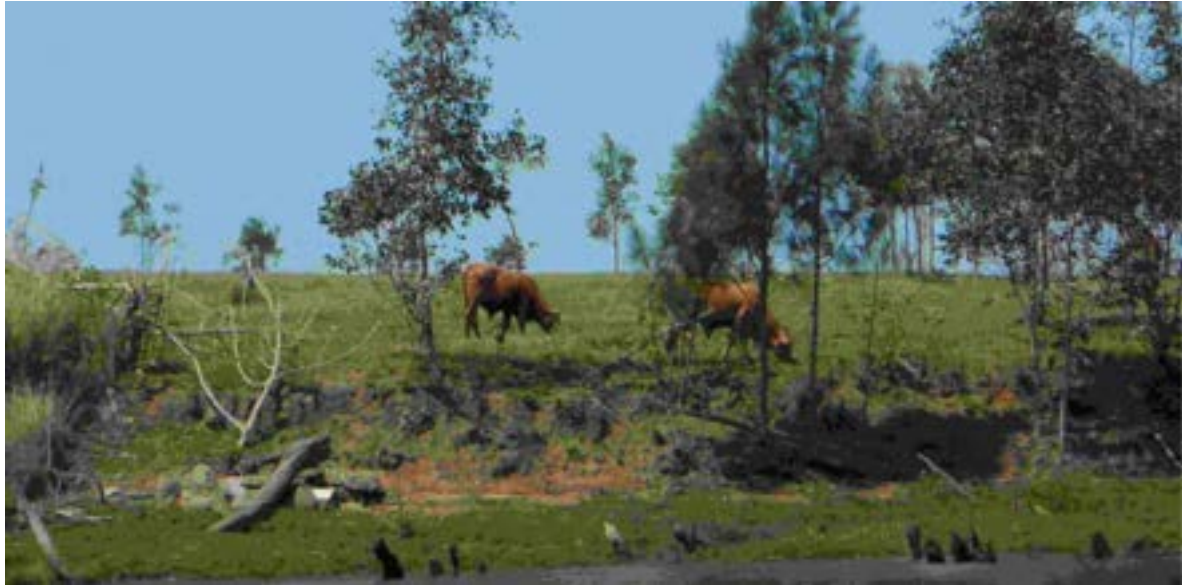
Figure 106: Cattle grazing was recorded close to and including intertidal vegetation.

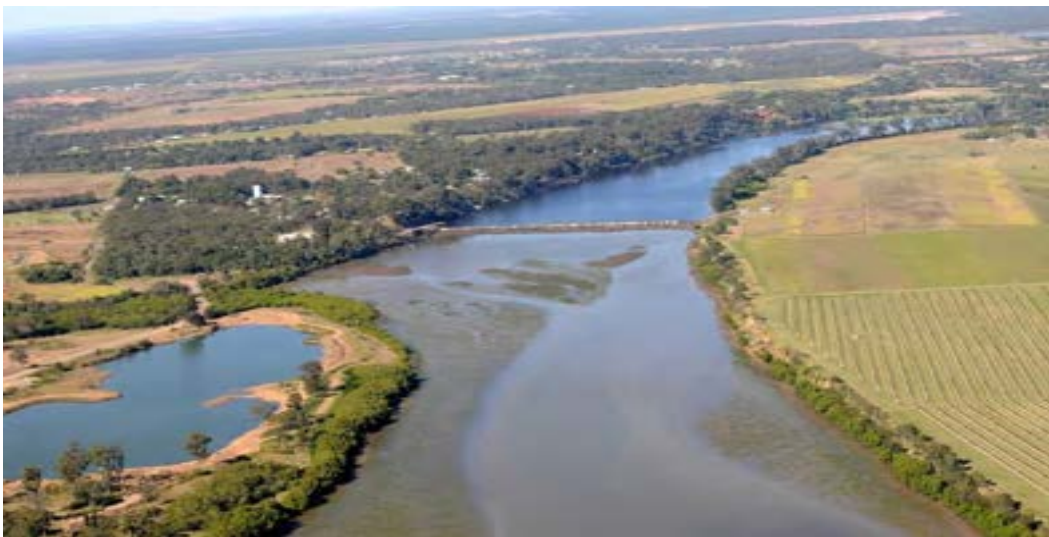
**Figure 108: Mud banks created after the installation of the weir restricting flows have become sites of depositional gain as young mangrove plants spread across them.**

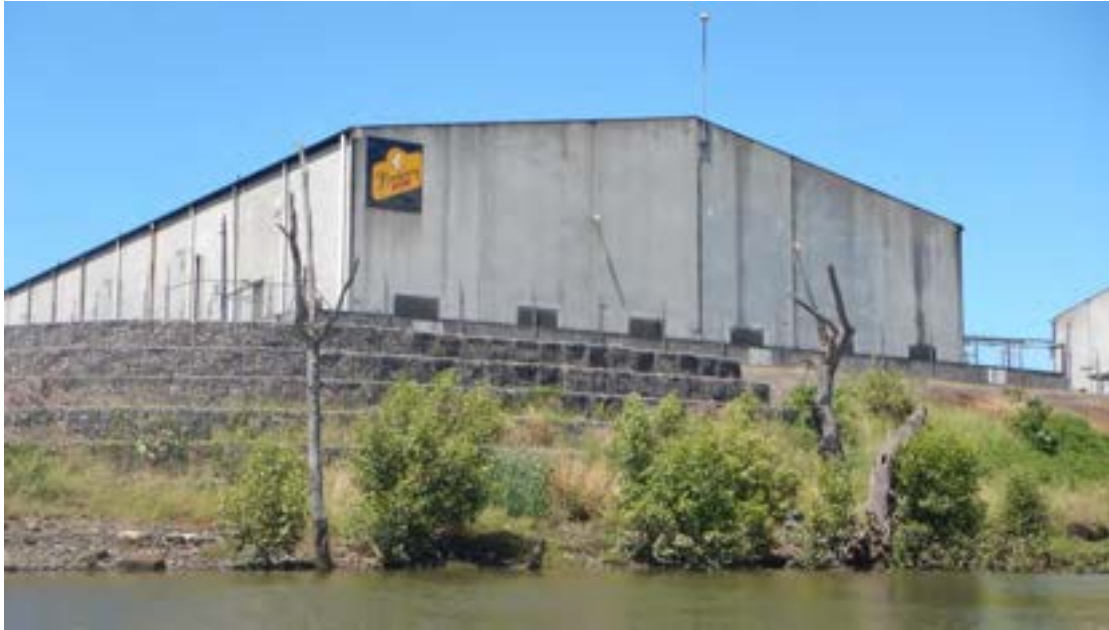
**Figure 110: Bank hardening has been undertaken without regard for tidal wetlands or riparian margins in many areas bordering the Burnett estuary.**

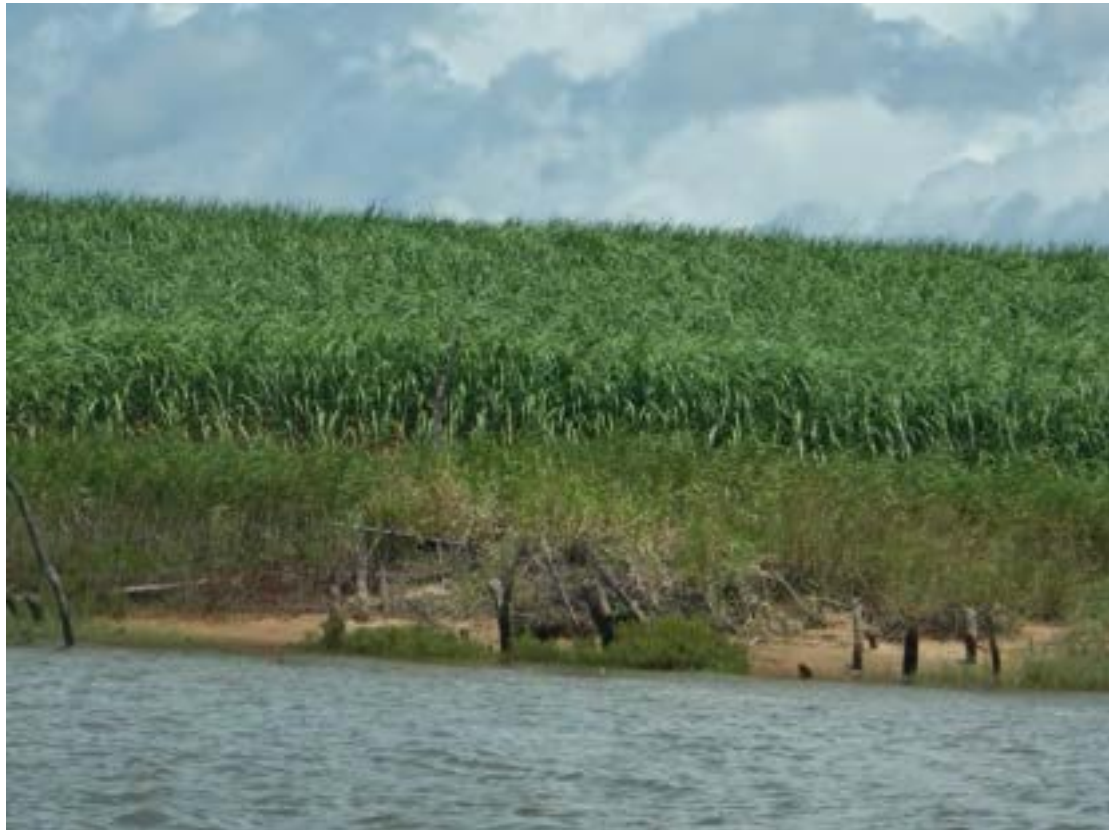
**Figure 112:** There is limited natural buffer between agricultural and urban land use along the estuary.

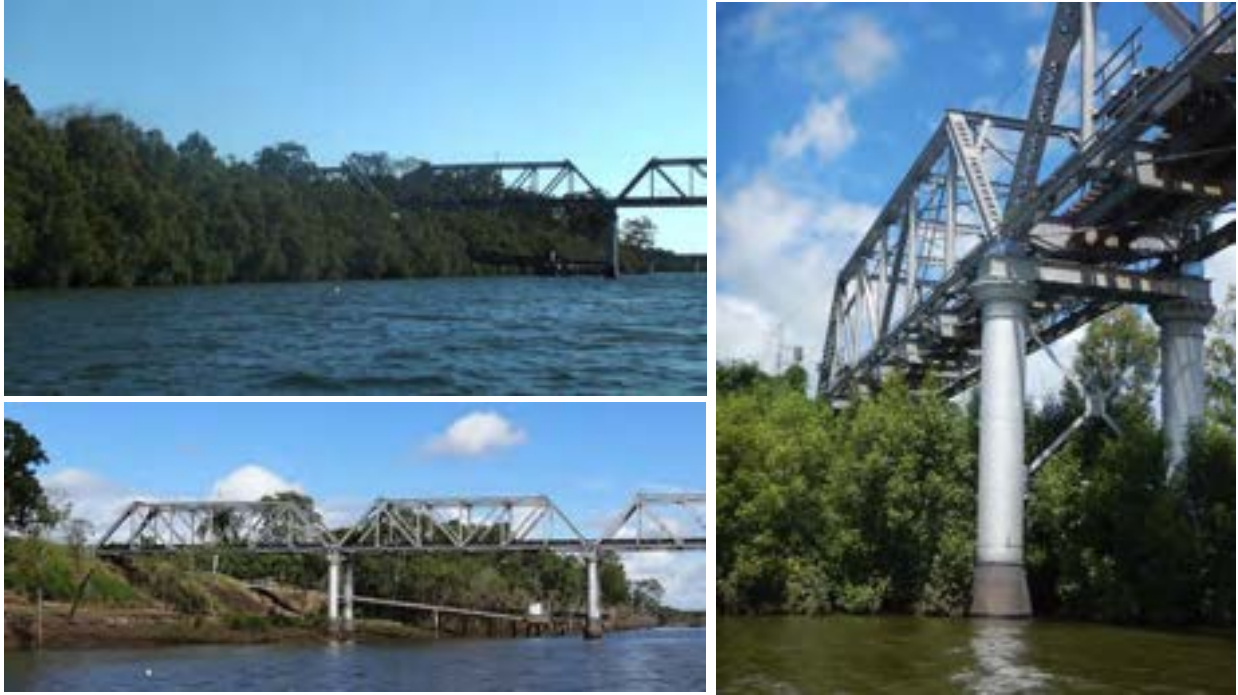
**Figure 113: Mangroves prior to flooding in 2009 (top left), immediately after flooding in 2013 (bottom left) and showing signs of recovery in 2018 (right).**

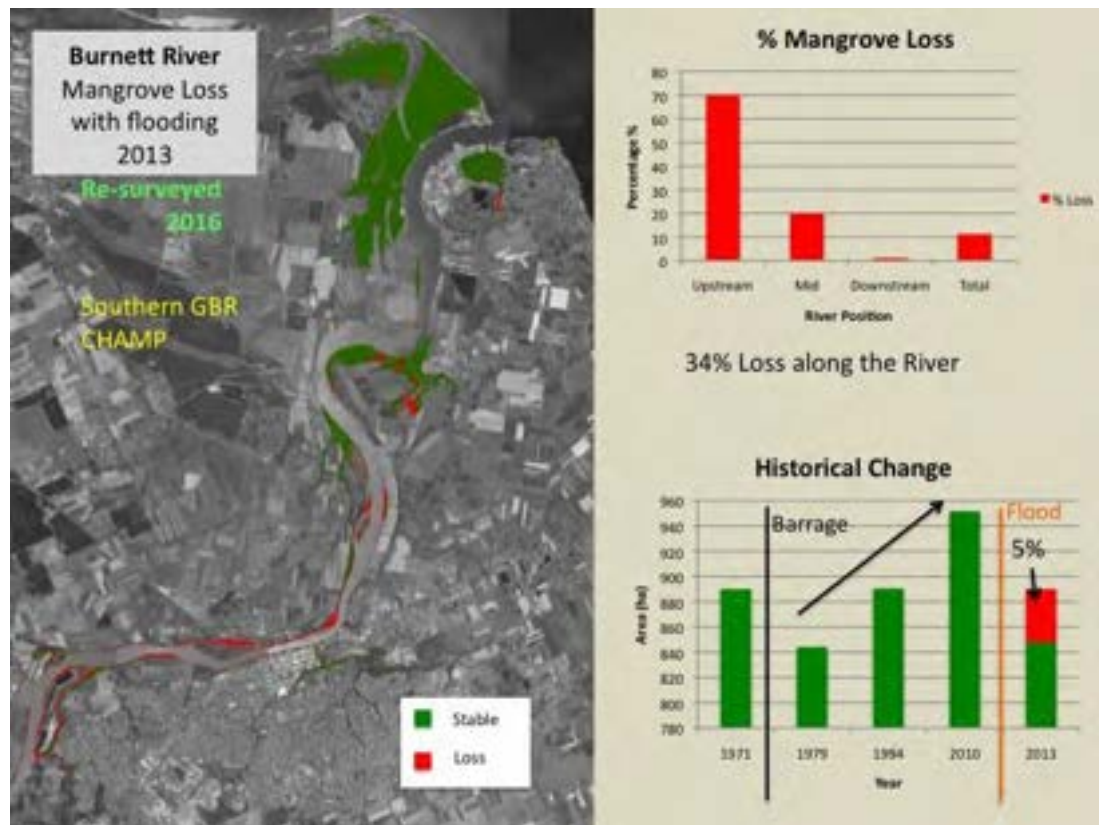
Figure 114: An image of the Burnett River estuary showing the severe impact of the 2013 floods on mangroves upstream. While there was little change at the mouth, it is clear that upstream stands fluctuate widely in response to flooding events and alterations to hydrology like the installation of the barrage upstream. More recent surveys with the NESP TWQ Hub S-GBR project show the longer term status of this event.

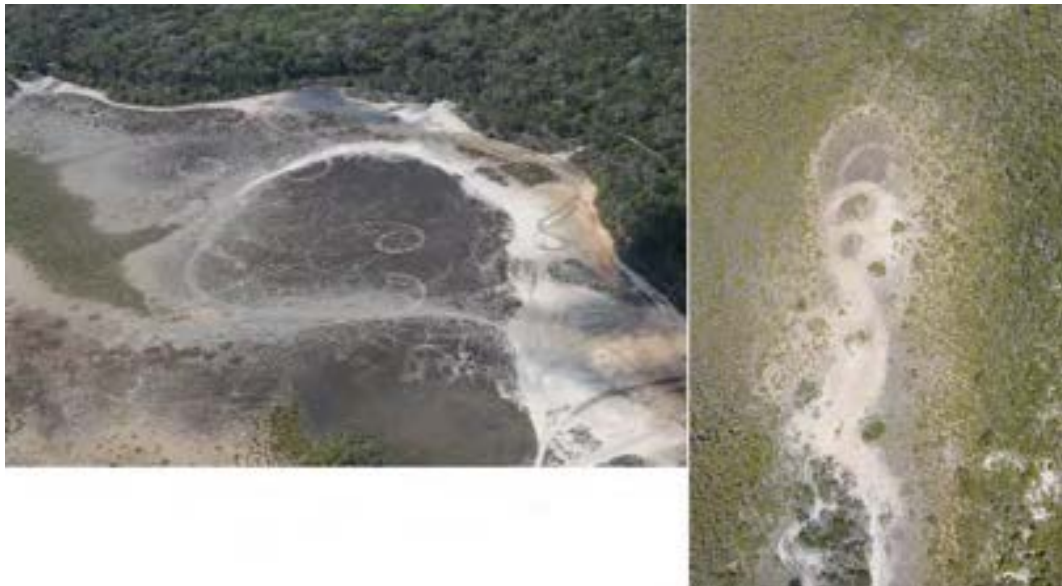
**Figure 123: Left and right images show extensive damage to tidal wetlands on the southern bank.**

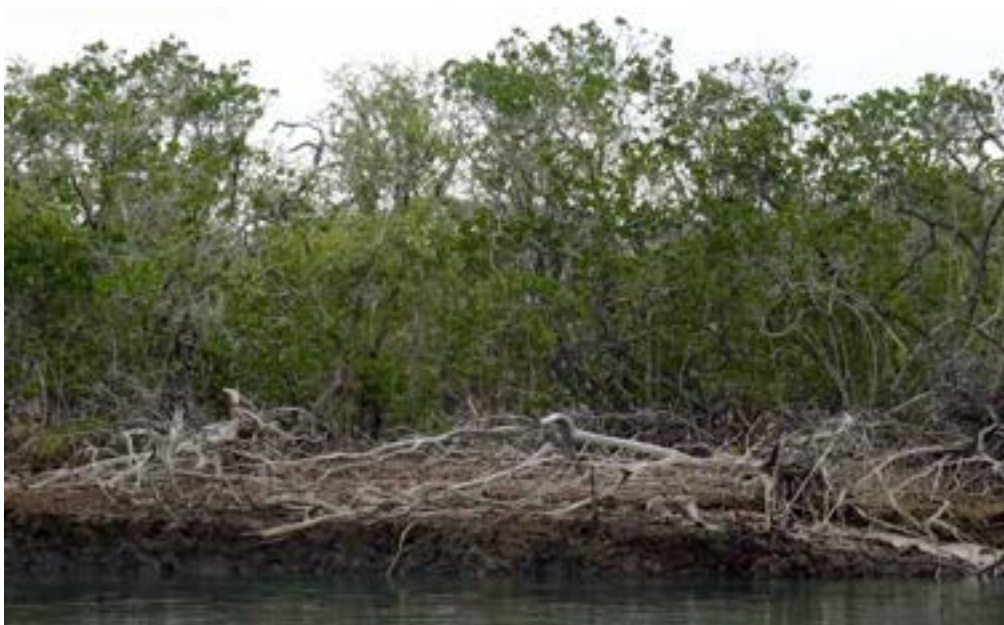
Figure 128: Recent flooding has damaged and killed mangrove vegetation in several places along the estuary.

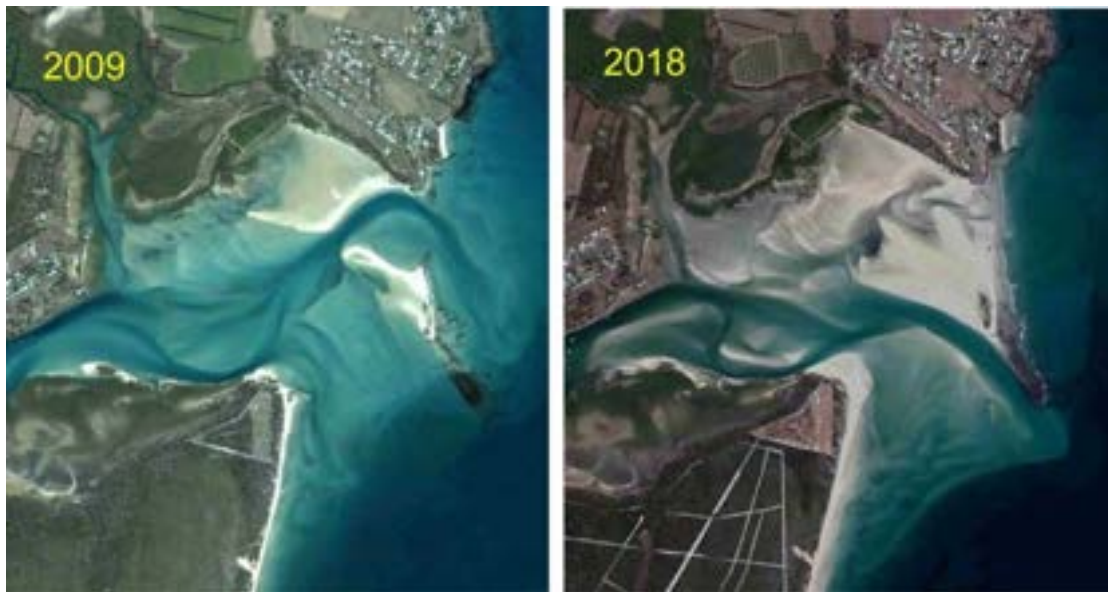
**Figure 129:** Significant changes have occurred at the mouth of the estuary. Note the closure of the northern main channel and the opening of a southern channel south of the small islet.

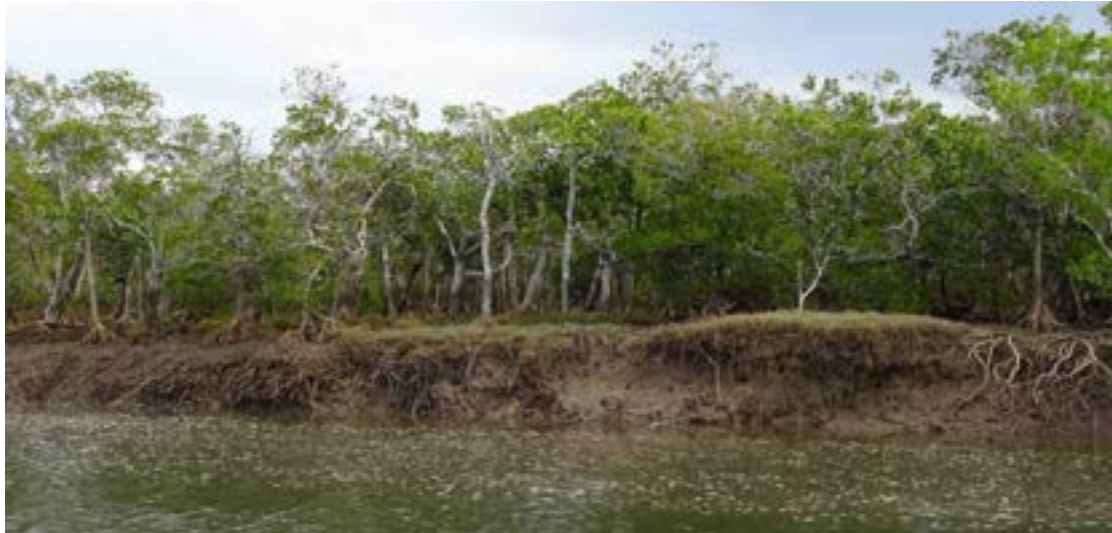
Figure 130: Bank erosion in the lower estuary with channel migration into upper-intertidal mangrove forest.

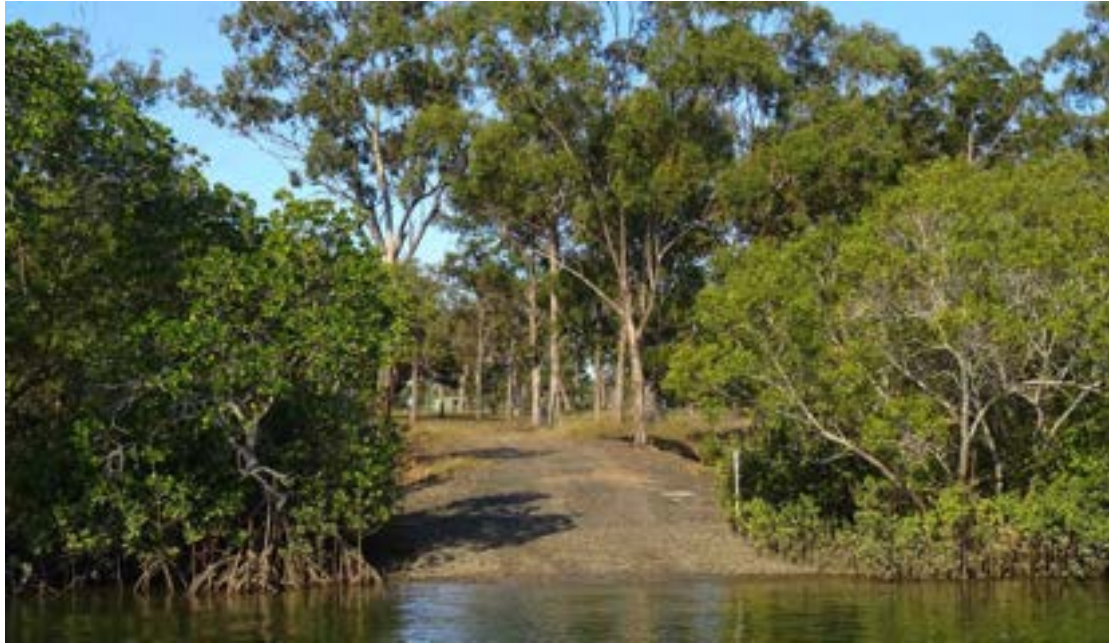
**Figure 140: Boat ramp cutting through the mangrove fringe, Burrum River.**

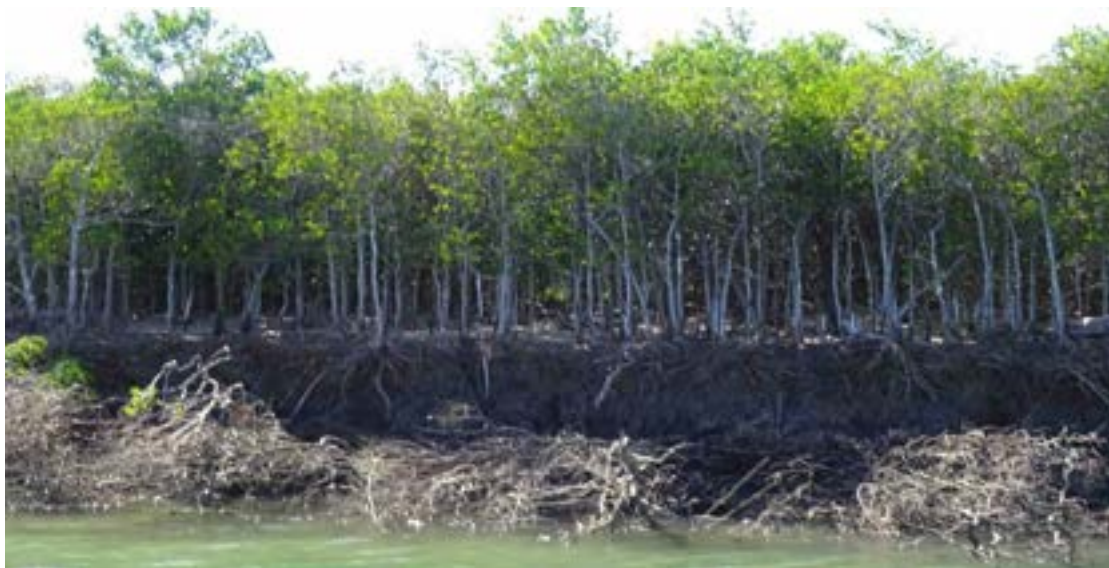
Figure 148: Eroding bank, exposing upper intertidal closed *Ceriops* forest, Burrum River mouth.
