# **Quantifying the effectiveness of gully remediation on off-site water quality: preliminary results from demonstration sites in the Burdekin catchment**

Supported by the Australian Government's  
National Environmental Science Programme  
Project 2.1.4 Demonstration and evaluation of gully remediation on downstream water quality  
and agricultural production in GBR rangelands

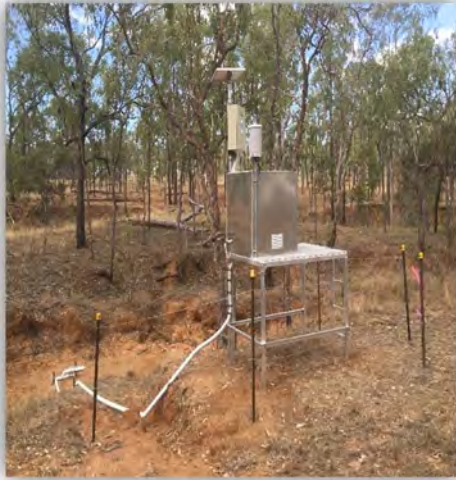
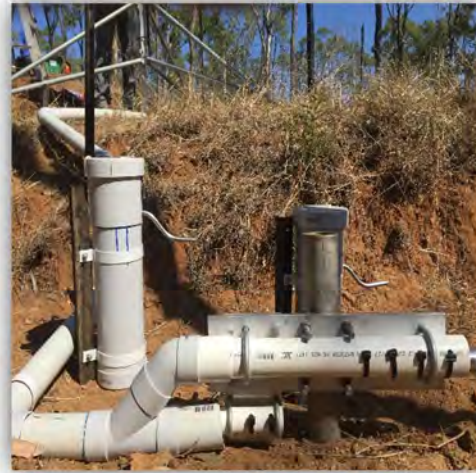
**Figure 7: (A) Example of a treatment gully set up and (B) and example of a control gully set up including two rising stage samplers**

using poly-pipe rocket structures (Figure 7B). Data from both the treatment and control sites had telemetered communications to allow remote access of data.

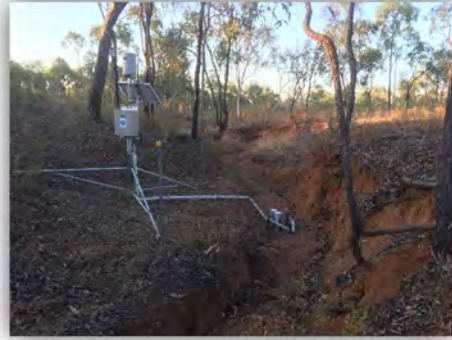
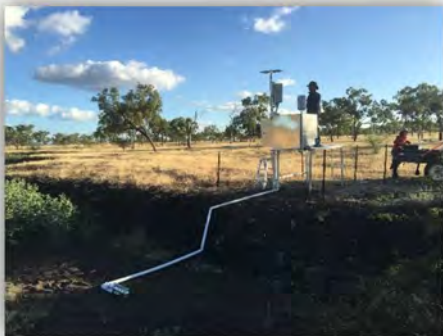
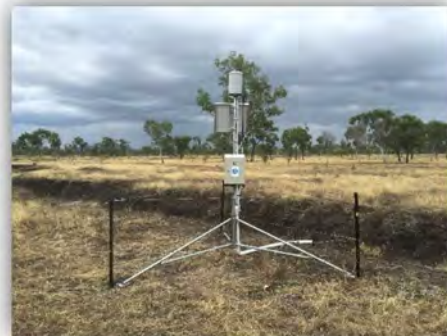
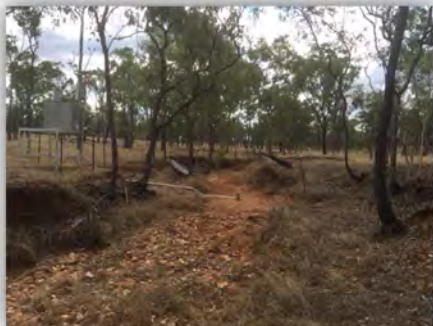
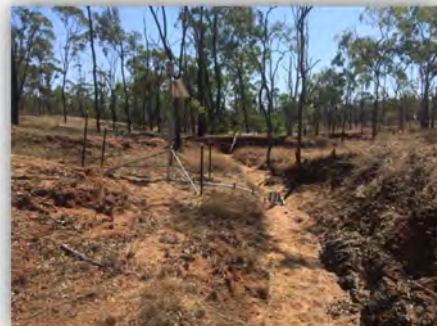
**Figure 8: The treatment (left) and control (right) instrumented gullies at each property. (A) Virginia Park (B) Meadowvale (C) Strathbogie and (D) Minnie Vale**

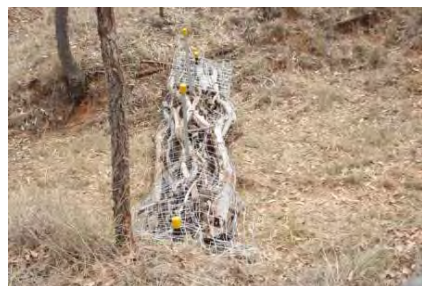
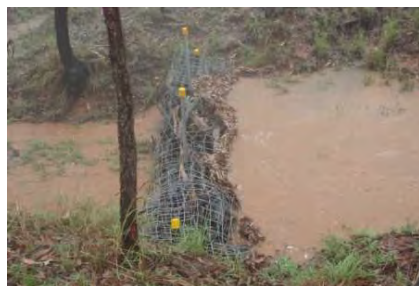
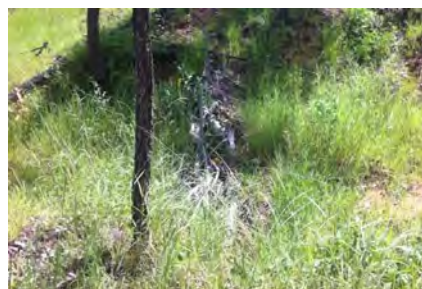
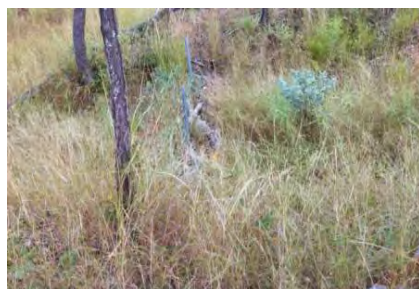
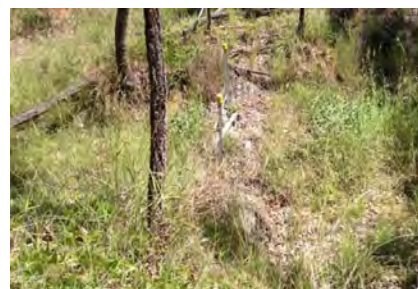
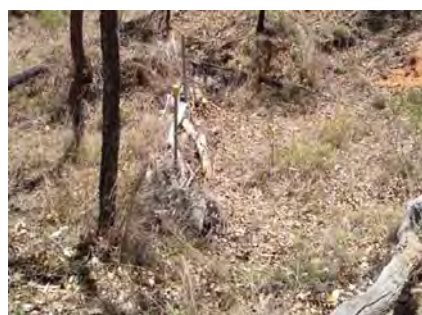
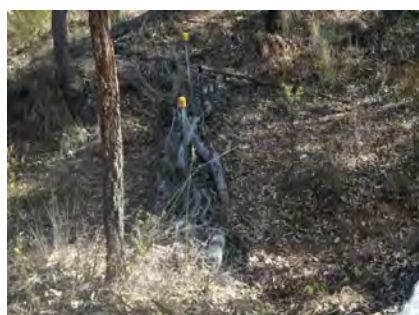
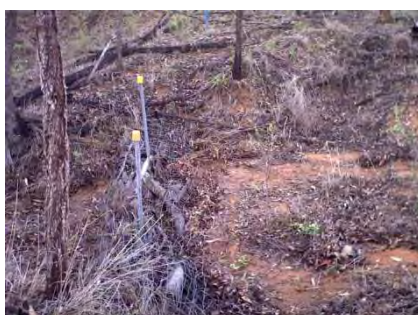
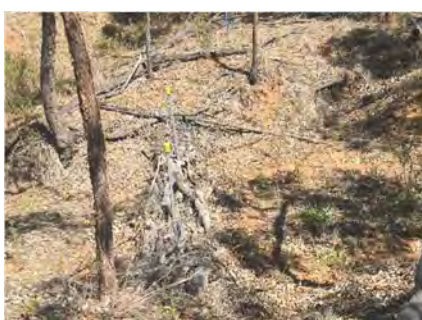
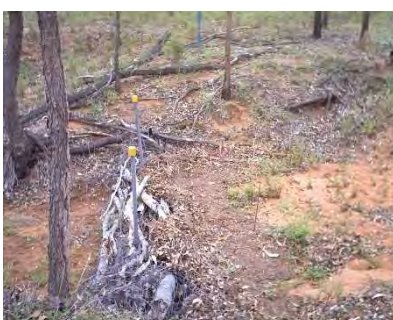
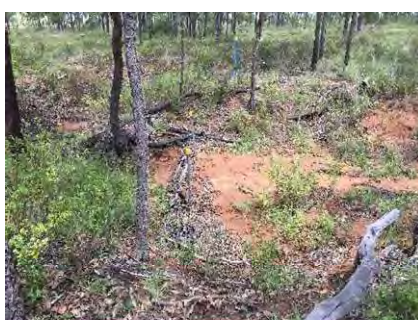
**Figure 10: Changes in the vegetation adjacent to a check-dam structure (#1) in the Treatment gully (upstream is to the right) (adapted from Wilkinson et al., 2015b).**

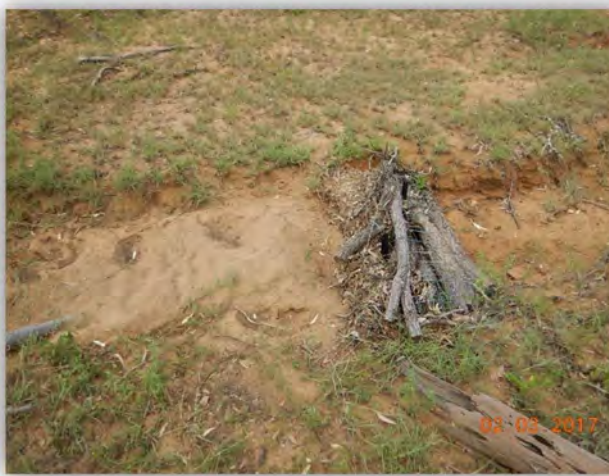
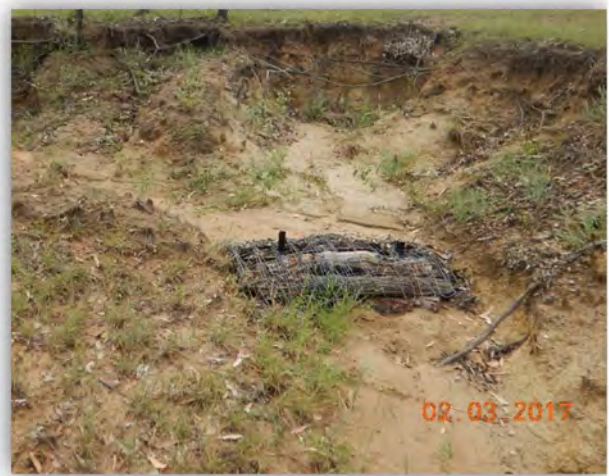
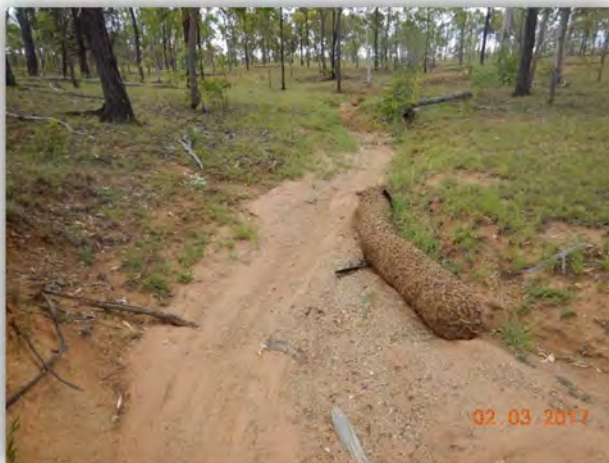
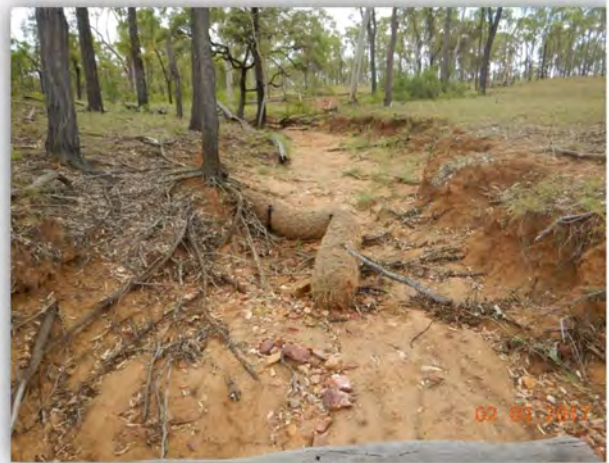
**Figure 14: The Minnievale site showing (A) in-tact stick trap in a side gully; (B) partial failure of a stick trap that has had been outflanked on one side (C) complete failure of a coir log and (D) and partial failure of a coir log in the main gully (Photos: Greening Australia).**

Of the 135 structures installed, there was a large (95%) failure rate of coir logs in the main channel (Table 5). The coir logs were more effective in the smaller side channels of the gully which suggests that the coir logs are not suitable for locations that receive high runoff depth and discharge (Figure 14). The stick traps had a good (~80%) success rate, however, these structures were only installed in the smaller side gullies. The direct cost associated with the installation of coir logs (~\$167 each) is much lower than stick traps (~\$350-\$400 each depending on the width required).

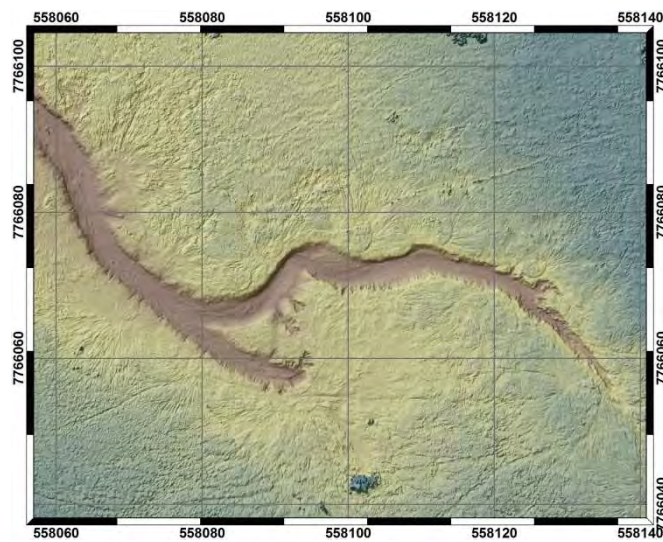
Figure 24: Strathbogie control: (a) 2016 DEM, (b) 2017 DEM, and (c) DoD.

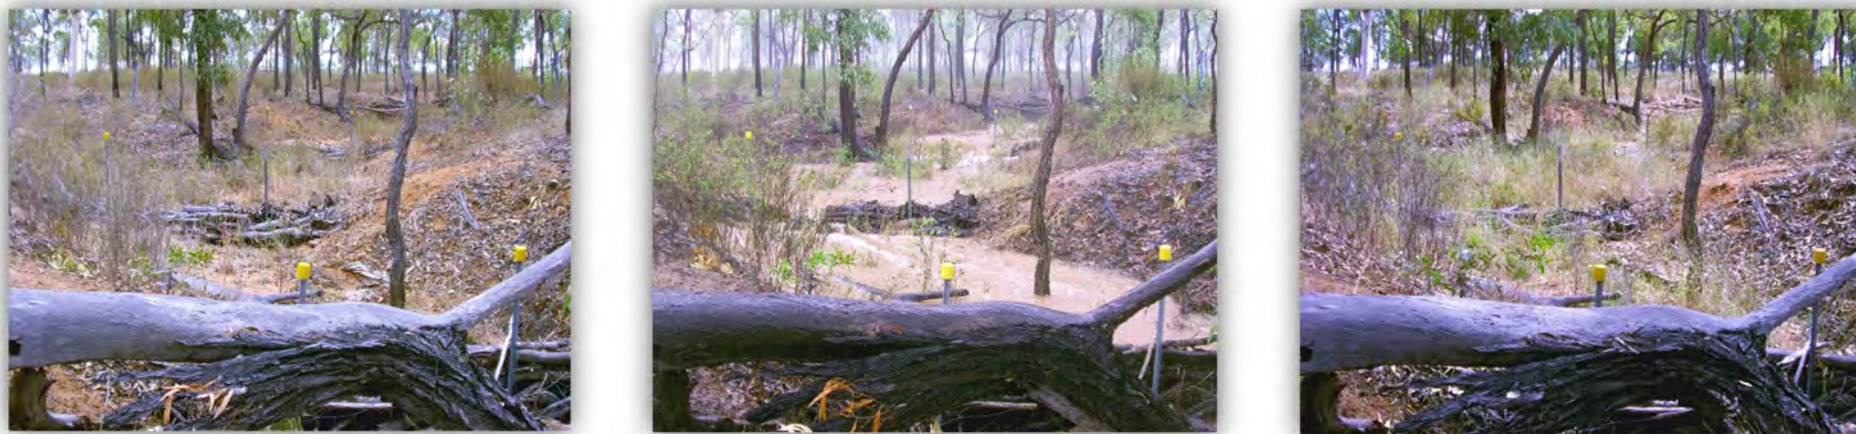
**Figure 27: Treatment gully at Virginia Park before (left) and during (middle) an event and at the end of reporting period (April 2017)**

A summary of the rainfall, runoff and water quality data collected during the 2016/17 wet season (November 1 to April 30, 2017) for each of the sites is presented in Table 11. The rainfall and hydrographs for the wet season for each site are presented in Appendix B. Images of each of the four treatment gullies before, during and after an event are presented in Figure 27 to Figure 30.

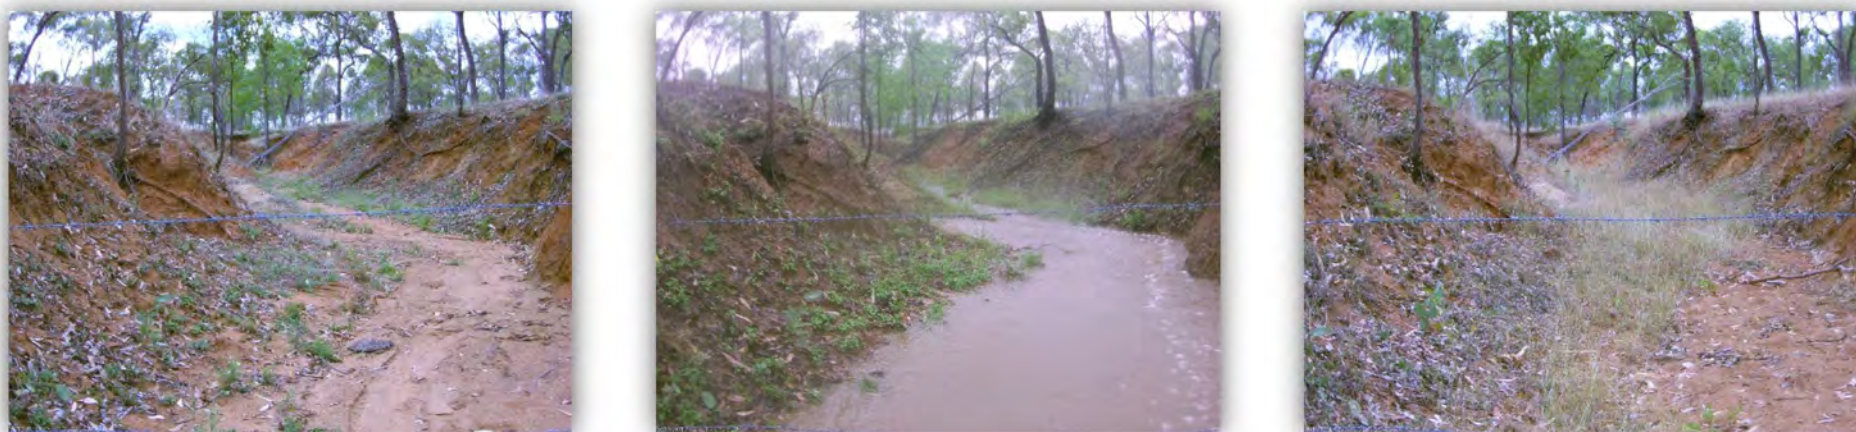
**Figure 28: Treatment gully at Meadowvale before (left) and during (middle) an event and at the end of reporting period (April 2017)**

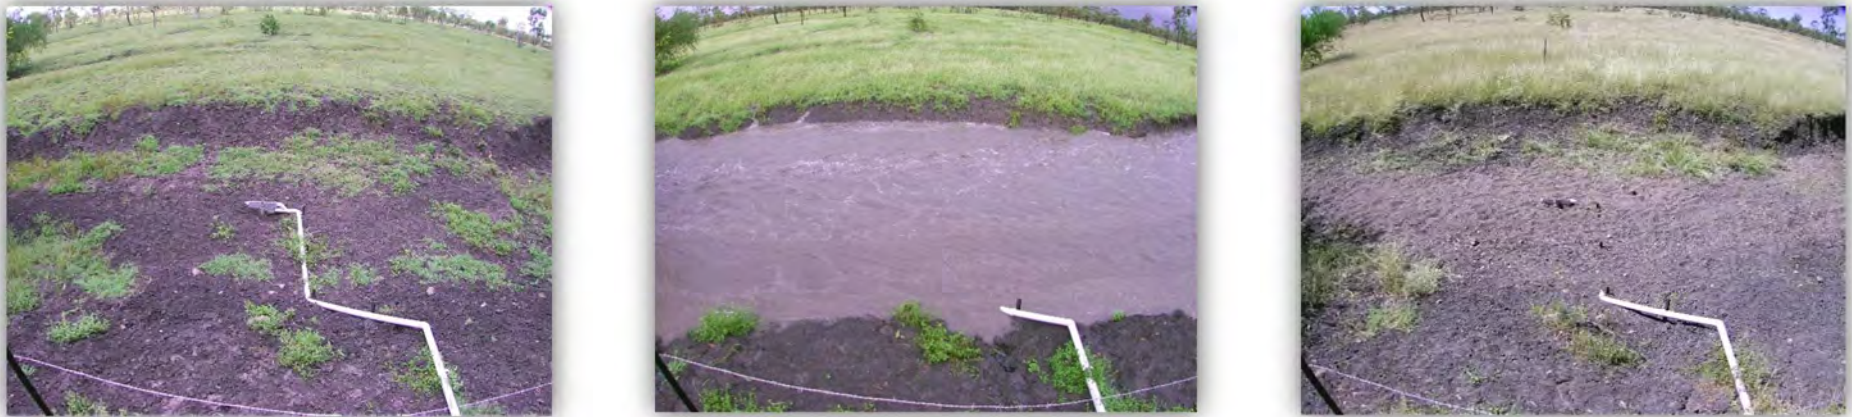
Figure 29: Treatment gully at Strathbogie before (left) and during (middle) an event and at the end of reporting period (April 2017)

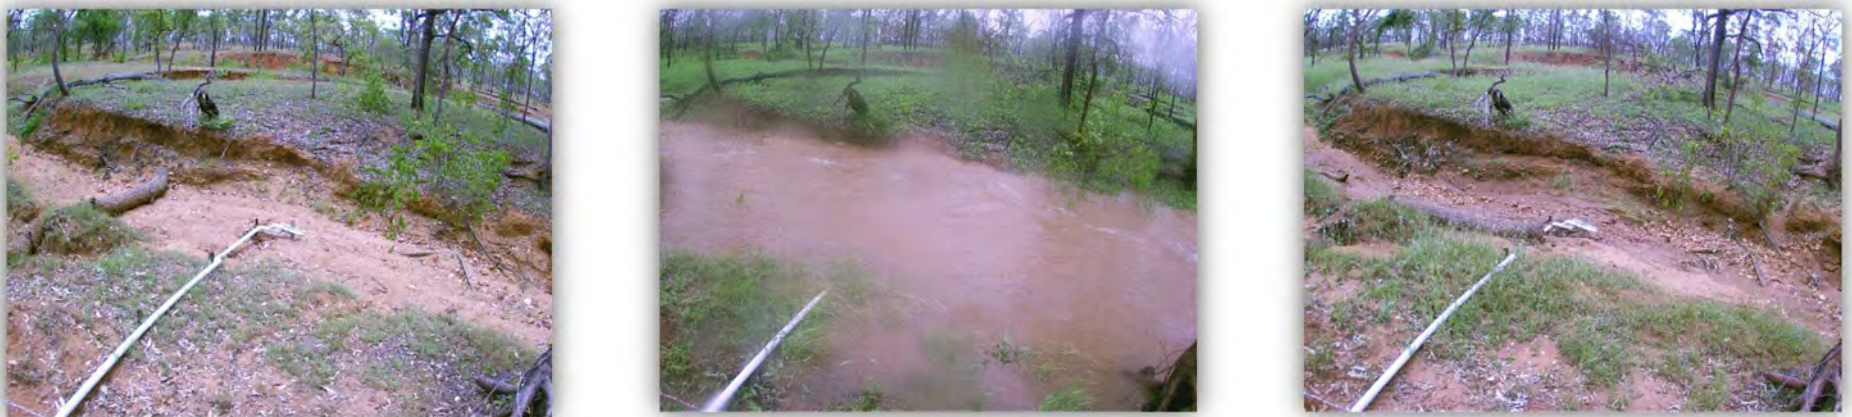
Figure 30: Treatment gully at Minnievale before (left) and during (middle) an event and at the end of reporting period (April 2017)
