## **Reducing sediment sources to the Reef: Managing alluvial gully erosion**

Project 1.7: Reducing sediment sources to the Reef: testing the effectiveness of managing alluvial gully erosion

Brooks, A., Spencer, J., Curwen, G., Shellberg, J., Garzon-Garcia, A., Burton, J. & Iwashita, F. (2016) *Reducing sediment sources to the Reef: Managing alluvial gully erosion*. Report to the National Environmental Science Programme. Reef and Rainforest Research Centre Limited, Cairns (375pp.).

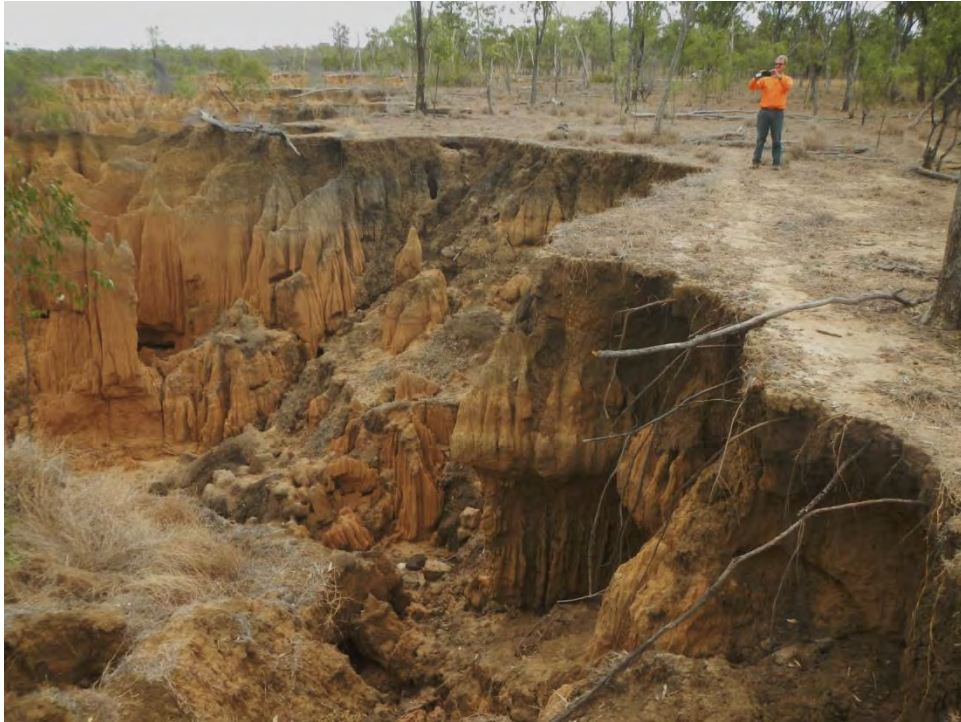
**Figure 4:** Large alluvial gully complex along Parrot Ck, a tributary entering the Bowen River just downstream of the Bowen Development Rd

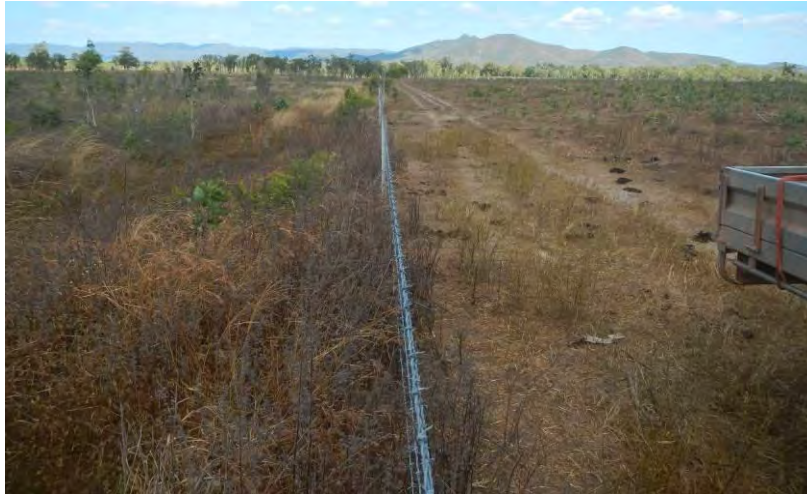
**Figure 23:** Grass and weed cover inside the cattle exclusion fence (left) and outside (right) in June 2015.

Before the fence was installed, the % perennial grass cover was greater outside the proposed fence area than inside. Over time and after the fence was installed, this pattern shifted, with the median % perennial grass cover greater inside the fence than outside between Apr-12 and Nov-15 (**Figure 21b**). Increases in both grass and weed cover were quickly observed inside the fenced area between Nov-11 and Nov-12 (**Figure 22ab**), with less detectable changes outside (**Figure 22cd**). The below average rainfall in 2015 dramatically reduced the perennial grass cover both inside and outside the fence (**Figure 21**). However, the grass cover inside the fenced area remained elevated compared to outside even in dry conditions (**Figure 21b**; **Figure 23**).

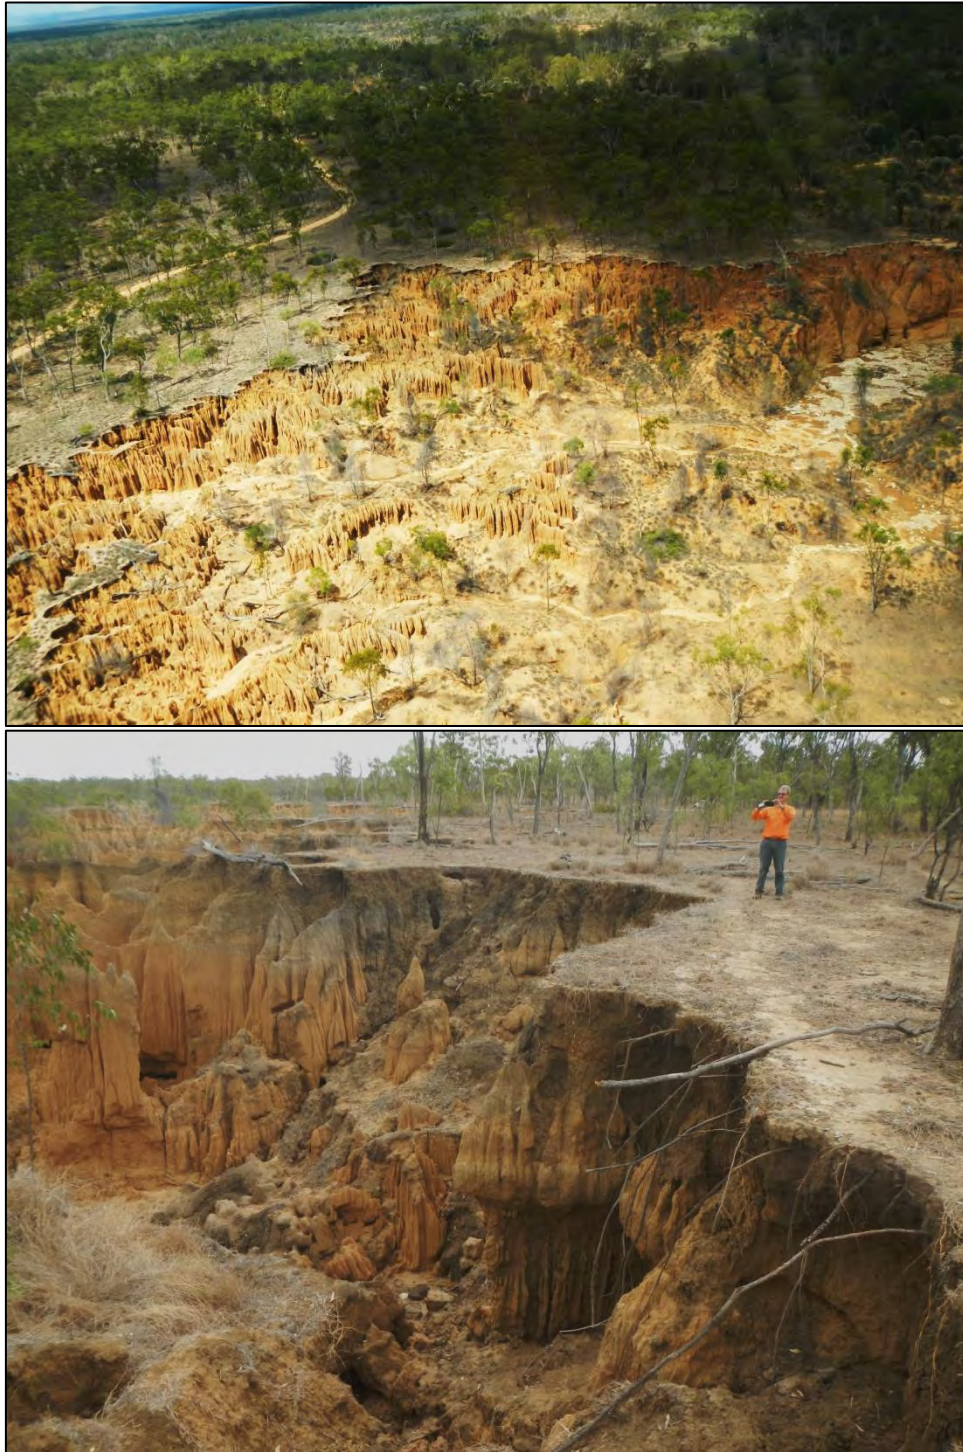
**Figure 51:** Large alluvial gully complex along Parrot Ck, a tributary entering the Bowen River just downstream of the Bowen Development Rd

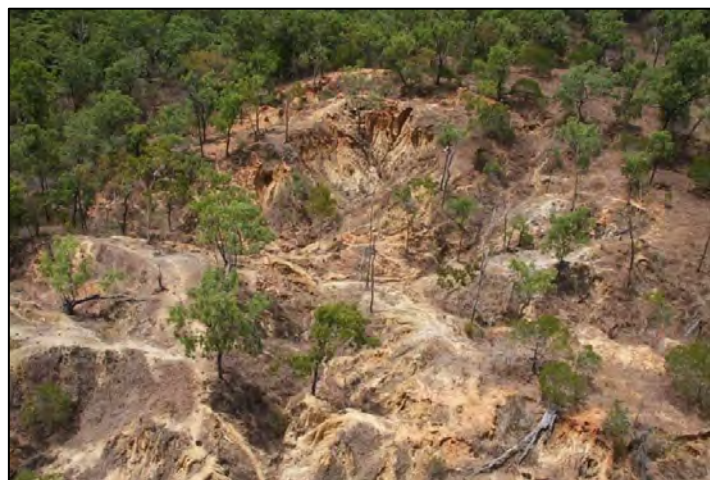
**Figure B6:** Aerial view (Nov-2011) of the West Normanby gully complex where cattle exclusion started in September 2012. Note network of pre-existing cattle trails on gully ridges and valleys.

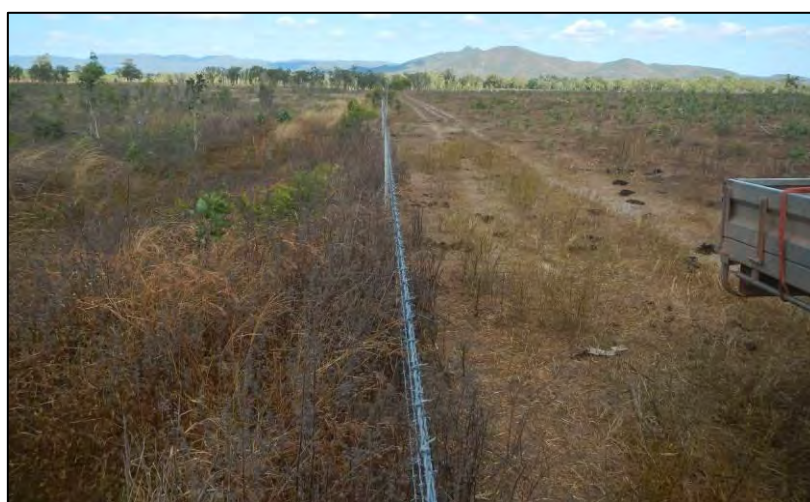
**Figure B17:** Grass and weed cover inside the cattle exclusion fence (left) and outside (right) in June 2015.
