# **Investing in riparian zone management to reduce erosion from stream channels: how do we evaluate success?**

Rebecca Bartley, Seonaid Philip, Anne Henderson and Dan Tindall

Supported by the Australian Government's  
National Environmental Science Programme  
Project 2.1: Developing an approach to evaluate the effectiveness of investments in riparian  
management in the GBR catchments

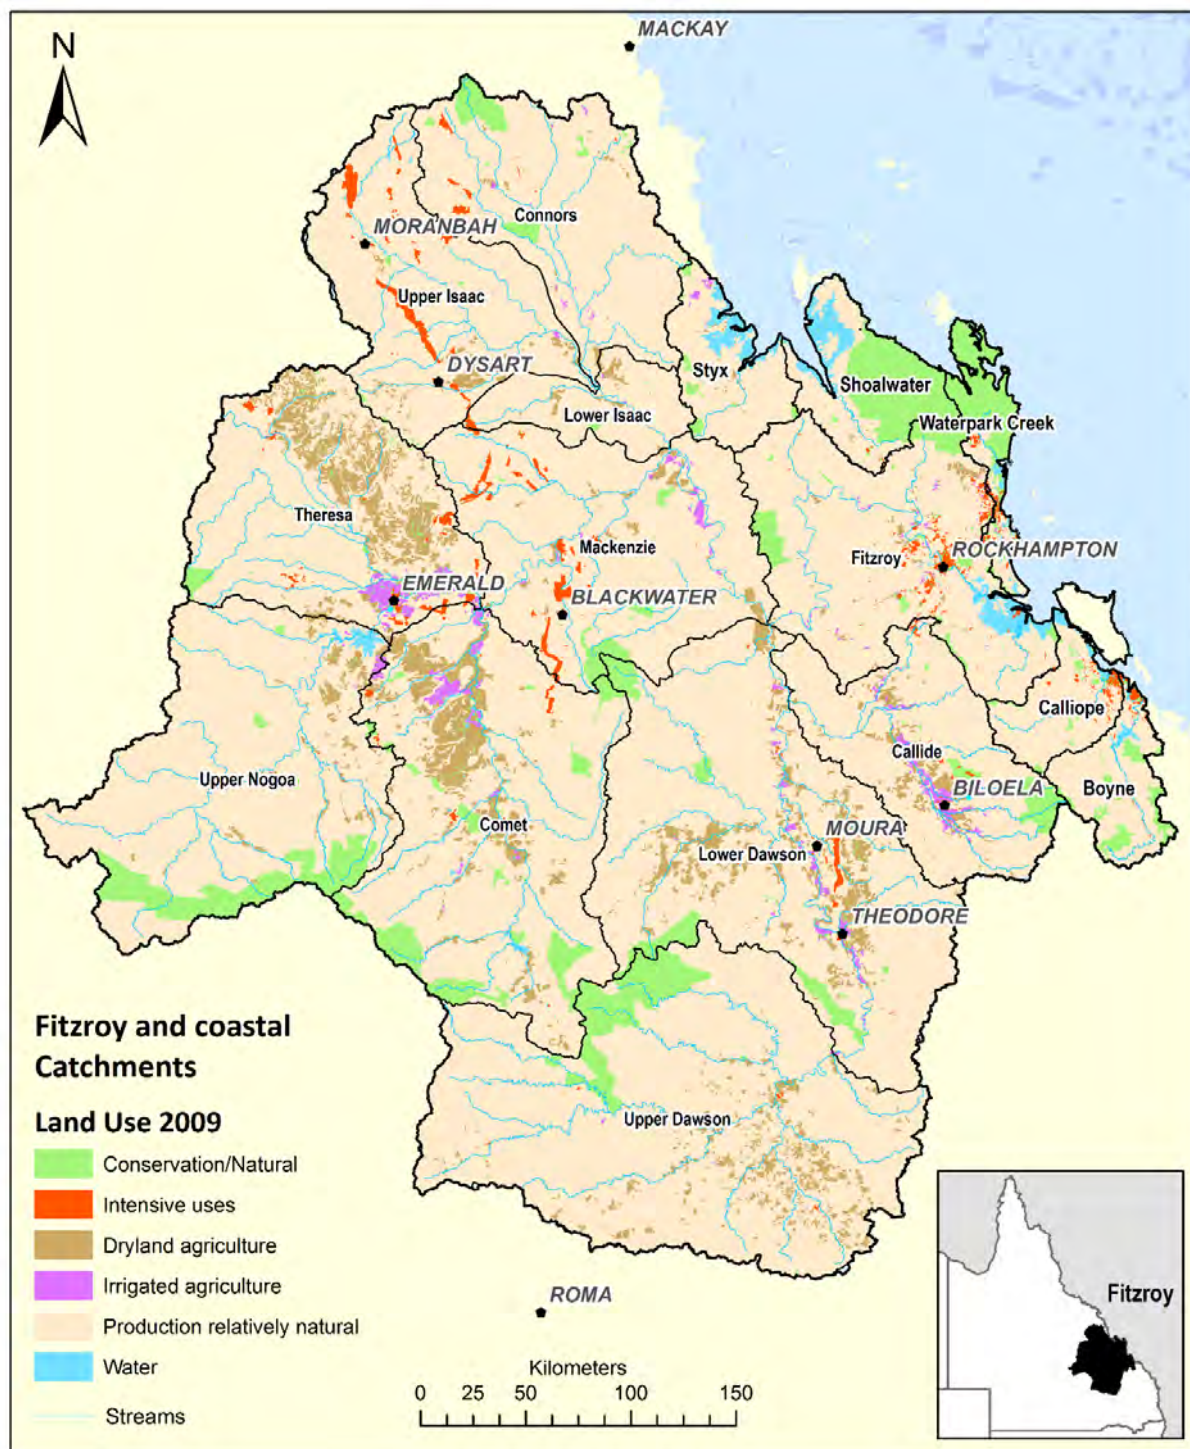
**Figure 2:** Major Land uses of Fitzroy and coastal catchments.

The Fitzroy catchment has relatively diverse land use, however cattle grazing is the dominant industry (Figure 2). There are large areas of dryland cropping in the western part of the catchment, largely on basaltic soils which have been identified as a major source of fine sediment delivered to the coast (Douglas et al., 2008). Significant irrigated cropping also occurs around the townships of Emerald, Theodore and Biloela. Mining is also a major industry particularly near Moranbah, Dysart, Blackwater and Moura (Figure 1).

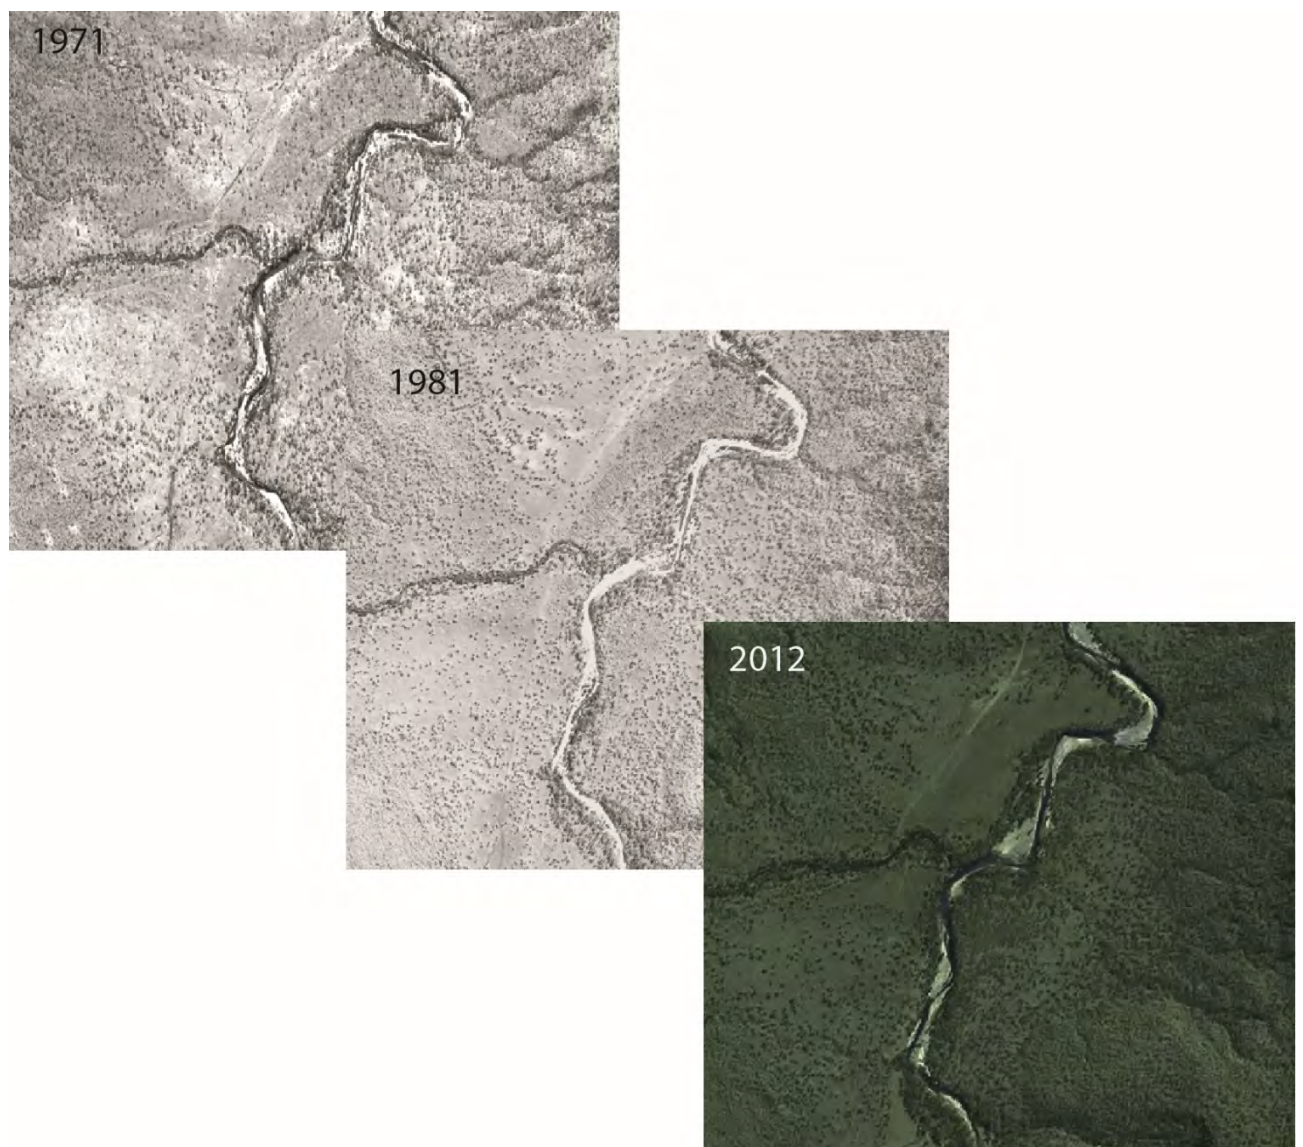
**Figure 10:** An example of a control site (~95% riparian vegetation) on the Fitzroy River (Control site 4).

It was not possible to present images of all the aerial photos used in this report. Instead, examples for a control, impacted and remediation site from the Fitzroy catchment are shown Figure 10 to Figure 12. Despite the control site (Figure 10) having an average of 95% riparian vegetation the channel underwent an average of  $0.43 \text{ m yr}^{-1}$  of channel expansion between 1971 and 2012. Four out of five control reaches underwent channel expansion, and only one reach underwent channel contraction. The impacted site example (Figure 11), has  $\sim 31\%$  riparian vegetation but has undergone  $\sim 0.46 \text{ m yr}^{-1}$  of channel contraction (as opposed to expansion or erosion), between 1983 and 2012 which suggests that the period of channel expansion, possibly caused by a lack of riparian vegetation, may have occurred prior to first aerial photo in 1962. The remediation site (Figure 12) appears to have been relatively stable with only  $0.08 \text{ m yr}^{-1}$  of channel expansion between 1957 and 2012. The implications of these results will be discussed in more detail in Section 6.

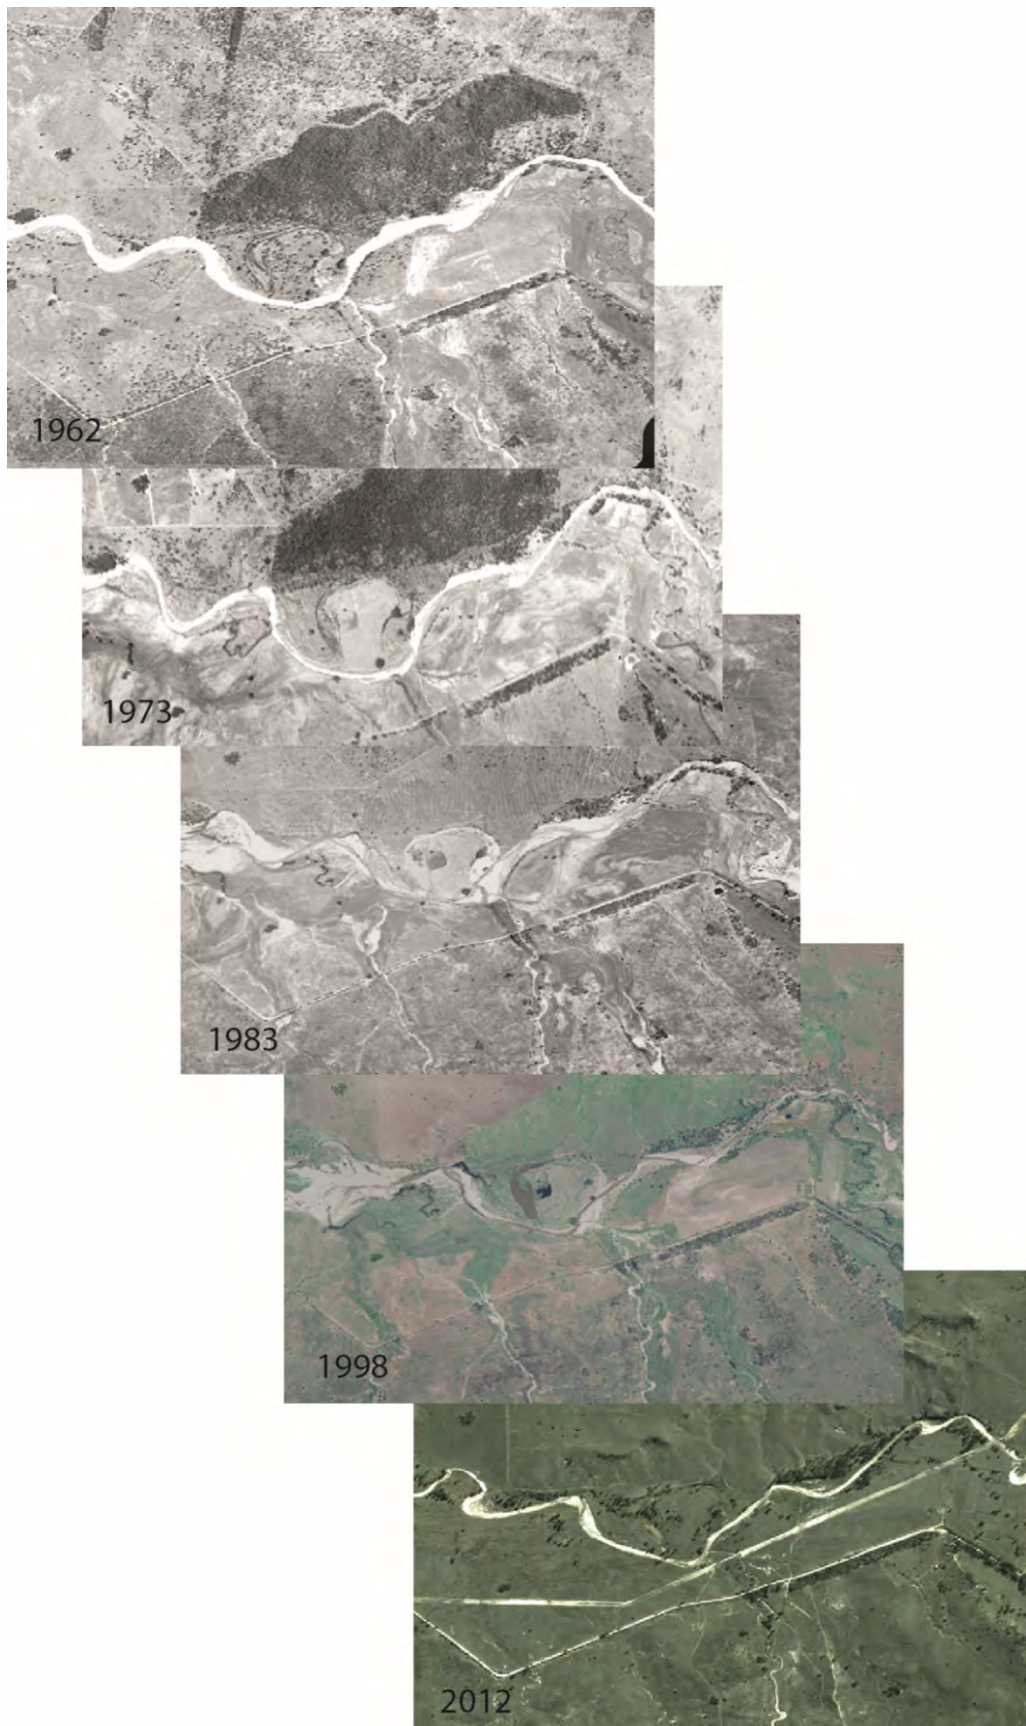
**Figure 11:** An example of an impacted site (~31% riparian vegetation) on the Fitzroy River (Impact site 3).

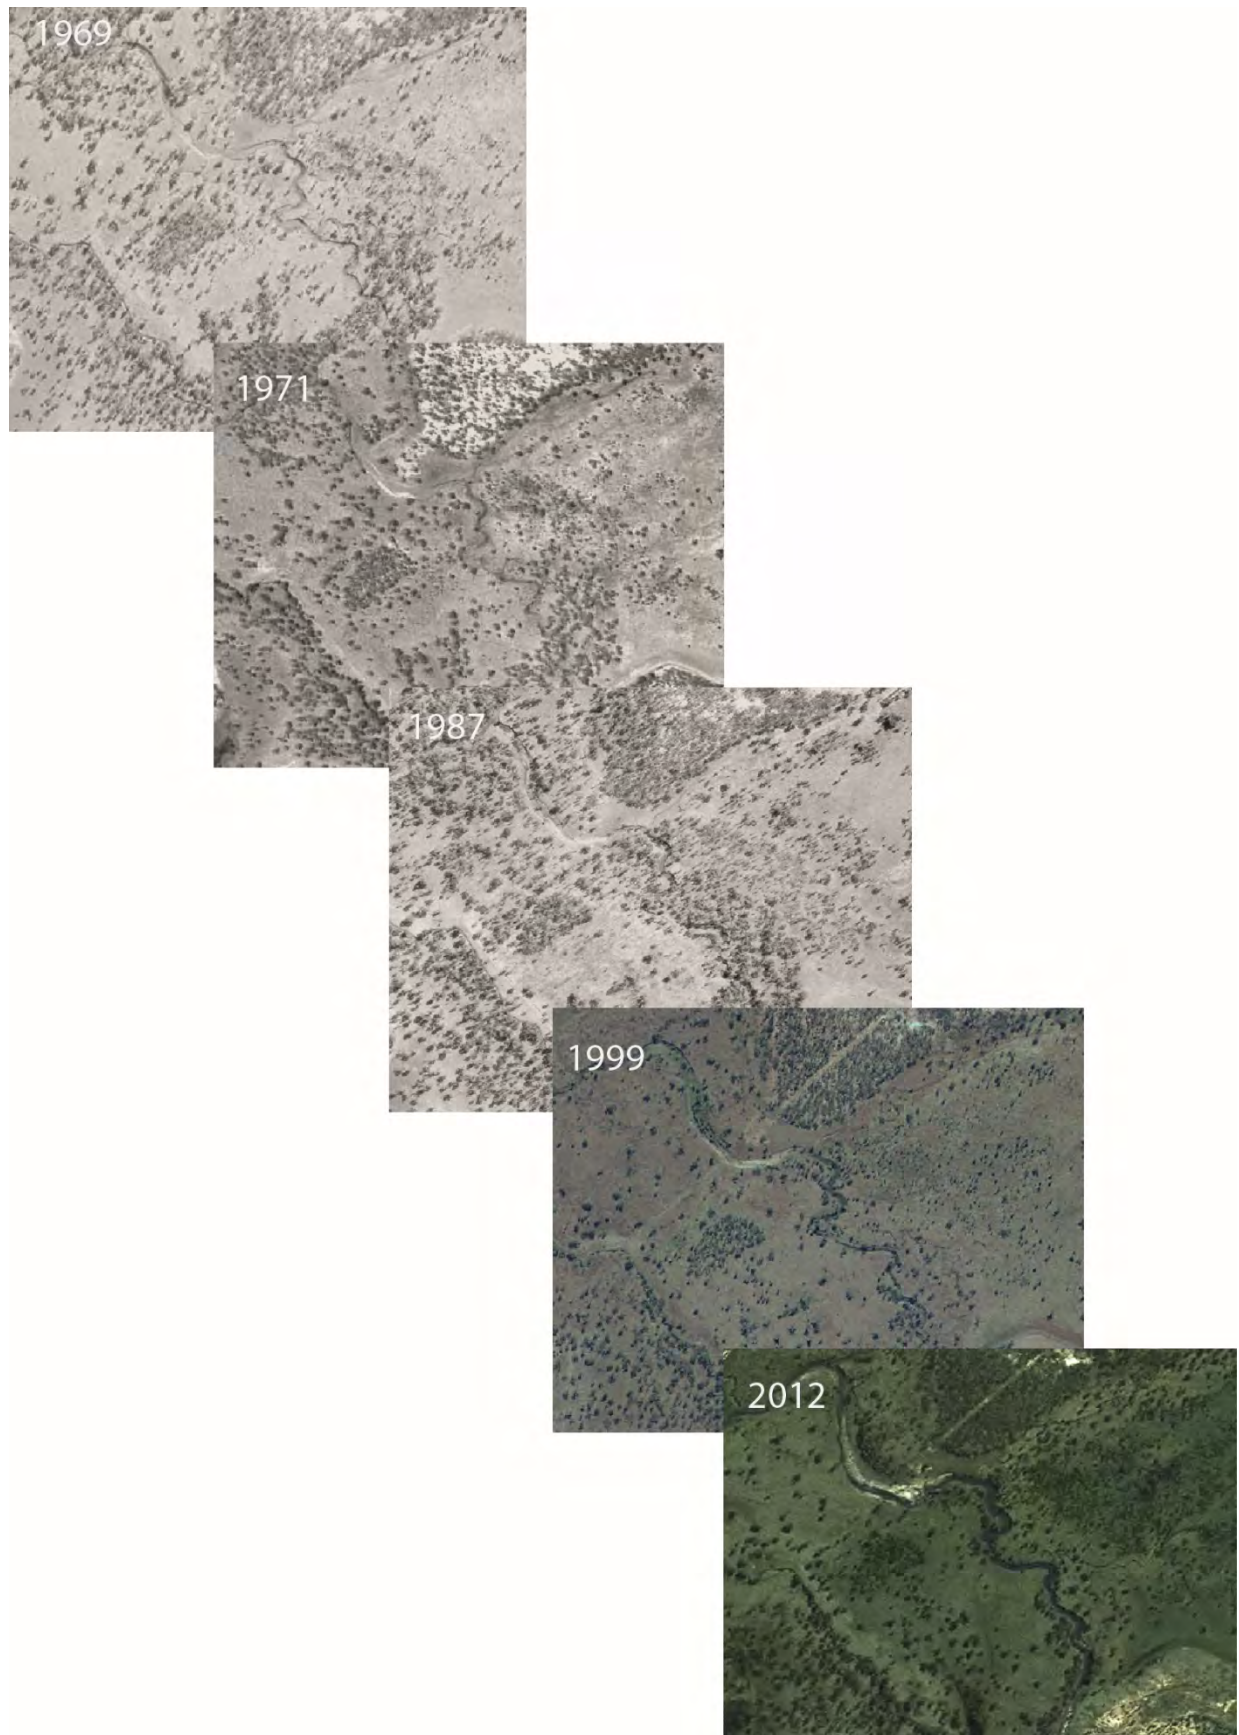
**Figure 12:** An example of a remediated site (~71% riparian vegetation) on the Fitzroy River (Remediation site 5).

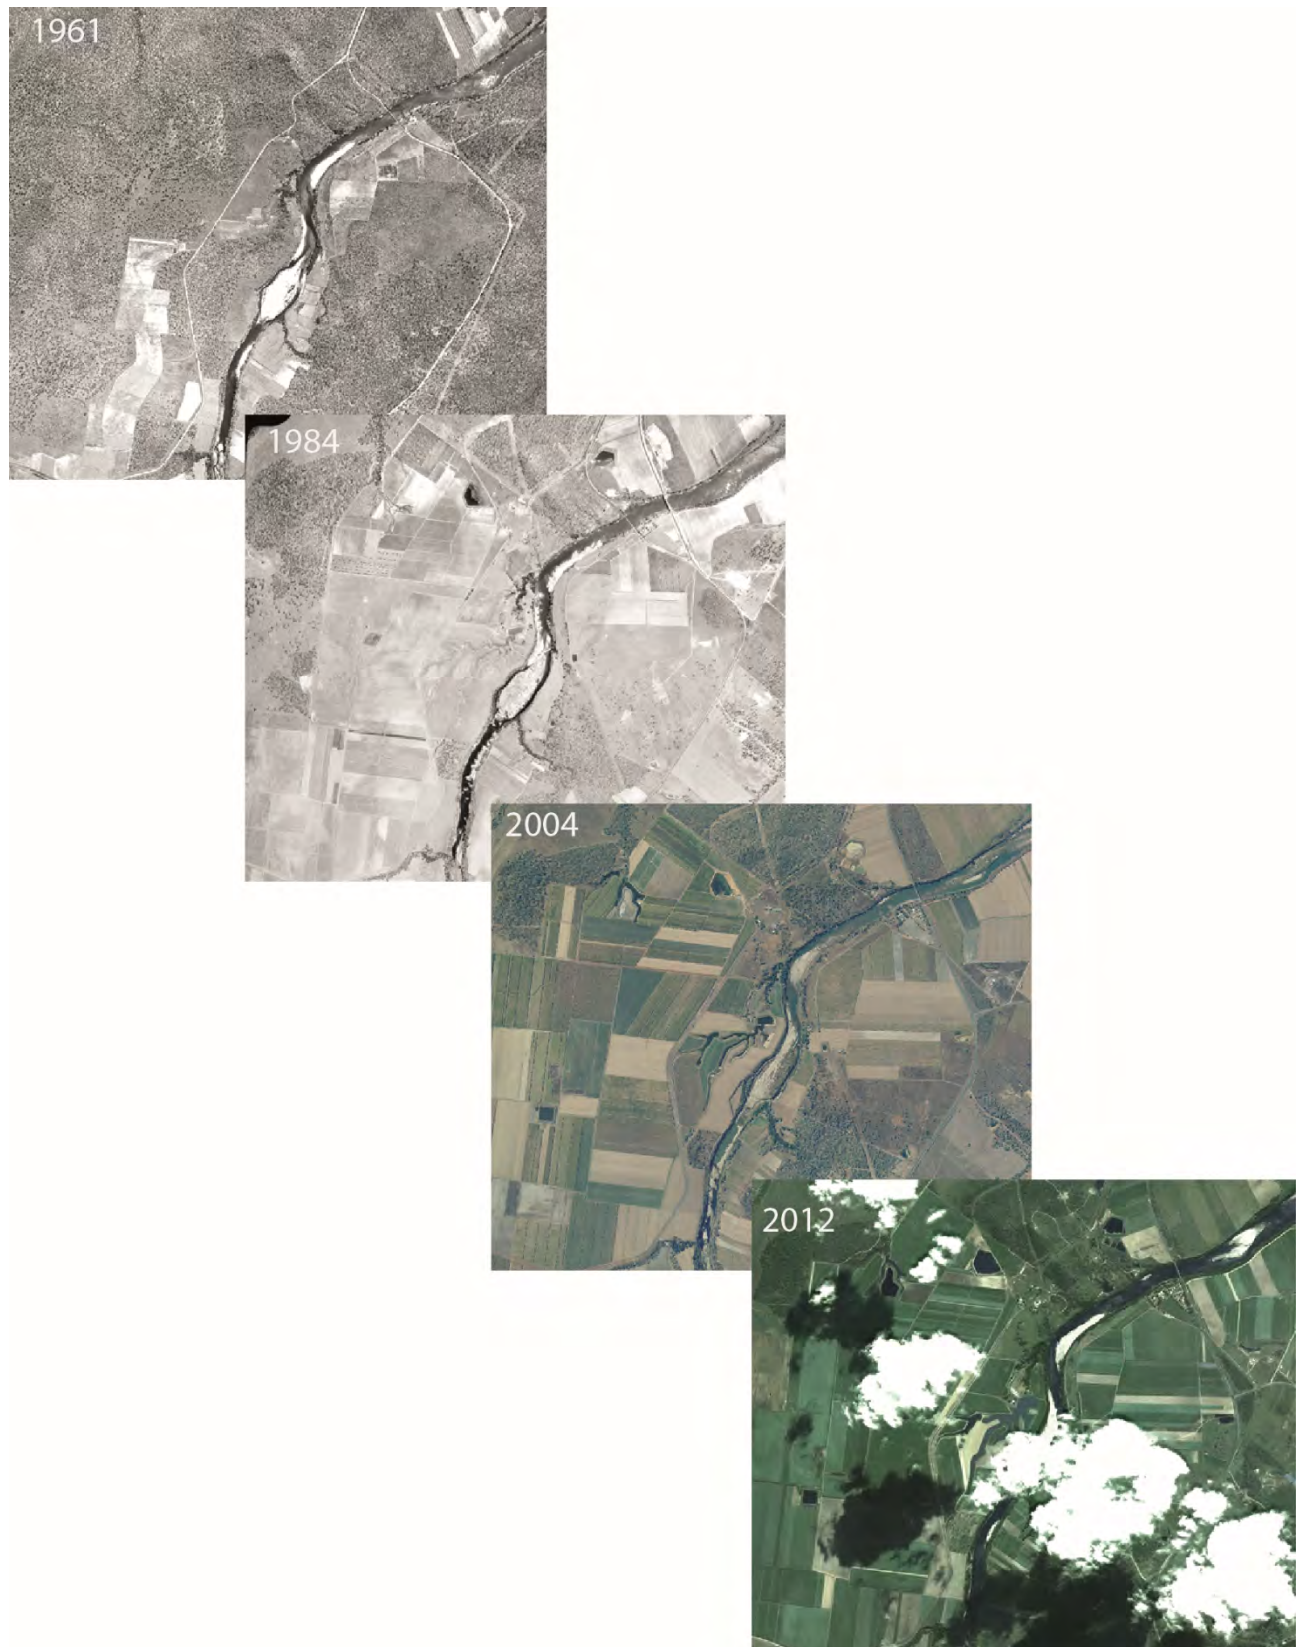
**Figure 16:** An example of an impacted site (~47% riparian vegetation) in the Mackay Whitsunday catchment (Impact site 2).

Figure 15 to Figure 17 provide examples of the change in channel location and planform, for a control, impacted and remediation site. In the control site example (Figure 15), the channel appears is relatively stable due the confinement of the channel within the valley walls, and although the right bank is extensively vegetated, the amount of vegetation on the left bank, particularly adjacent to the large bend at the centre of the photo, has decreased considerably between 1970 and 2012. The impacted site example (Figure 16) is set amongst an extensively cropped area and the remnant riparian zone is very narrow. The macro-channel has remained rather stable between 1961 and 2012 despite the reduction in riparian vegetation. However, the wetted perimeter, that includes mid-channel bars and sand deposits, has moved considerably over the air photo period. This lateral within channel movement is considered a natural process, and occurs on well vegetated rivers, and does not represent bank erosion or channel change. The final example is the most interesting (Figure 17). Using repeat LiDAR from 2010 and 2014, and subsequent DEM's of difference, this site was identified as having recently undergone  $\sim 100,000 \text{ m}^3$  of bank erosion (Figure 18)(Alluvium, 2014). In response to the Alluvium study, Reef catchments undertook remediation to stabilise this site and reduce erosion. This was conducted using log groins and bank re-shaping (Figure 19). The aerial photo analysis undertaken in this study has been able to provide a longer term context ( $\sim 50$  year period) to compare to the four years of LiDAR channel change data. What the aerial photos show is that the main channel (or thalweg) was on the left side of the macro-channel in 1961 and there was a minor secondary flood-runner on the right had side of the channel. It appears that the minor flood- runner on the right

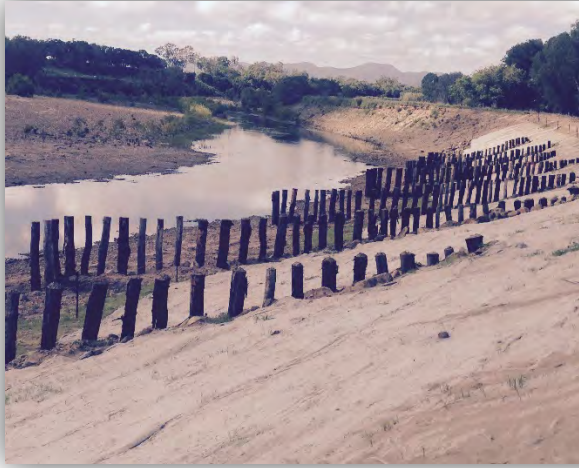
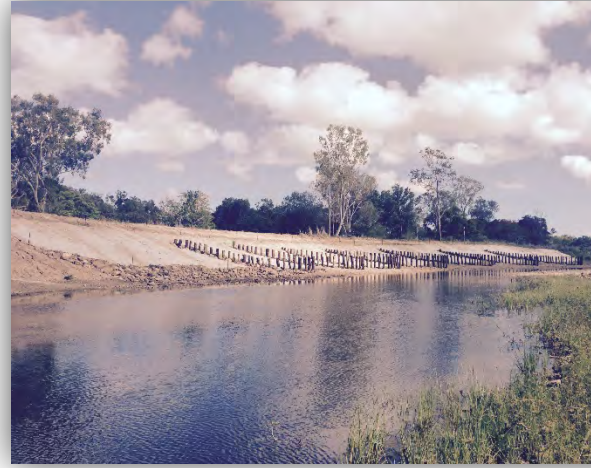
**Figure 19:** Recent remediation using log groins work at remediation site 6 (Source: Chris Dench, Reef Catchments).

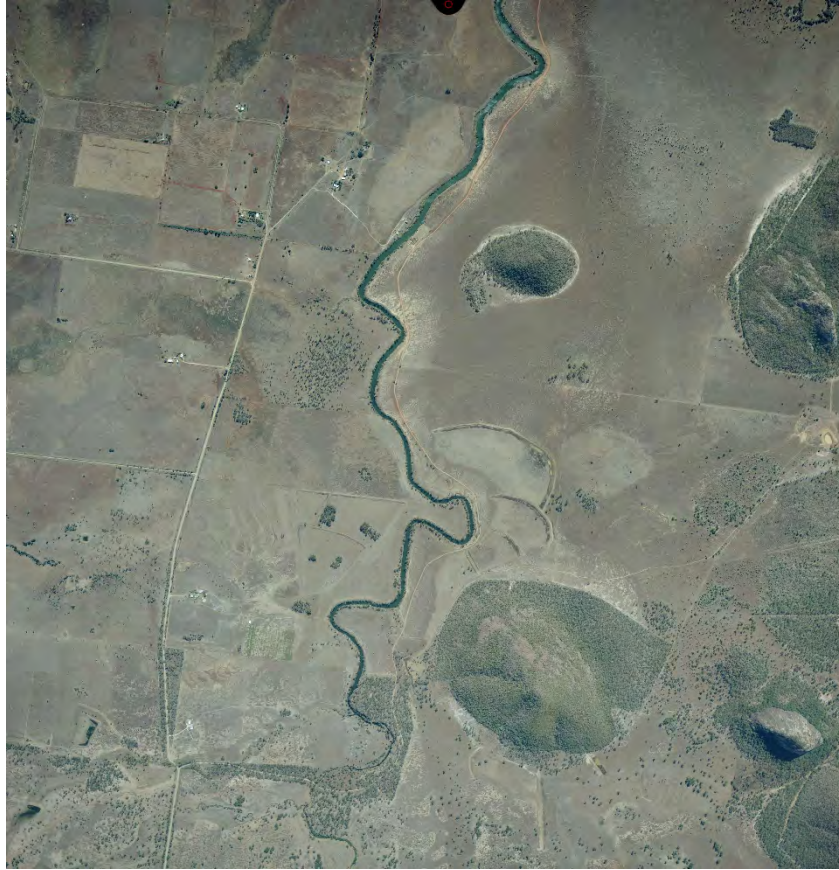
**Figure 20:** Example of land clearing along an impacted reach in the Fitzroy catchment. This reach is estimated to have ~46% riparian vegetation, however, the surrounding and upstream landscape has very low ground cover. The thin thread of riparian vegetation is not going to compensate for the altered landscape condition.

- (2) The total (amount and condition) of upstream vegetation is important for reducing runoff, and by consequence, reducing stream powers and improving water quality downstream. So promoting the establishment of riparian management on its own is unlikely to have the water quality improvements anticipated. The riparian zone should not be evaluated independently of the land use type and condition upstream. That is, if the land upstream of a given reach is in poor condition with low cover, severe gullyng and scalded areas, then having an in-tact 100 m riparian zone is unlikely to compensate for the changed hydrology and sediment delivery from the degraded areas above (for example, see Figure 20).
