## Highway Overpass Evaluation of Effectiveness: Kuranda Range Road Upgrade Project

Miriam Goosem, Robyn Wilson, Nigel Weston and Martin Cohen

School of Earth and Environmental Sciences  
James Cook University, Cairns

Supported by the Australian Government's  
**Marine and Tropical Sciences Research Facility**  
Project 4.9.3 Impacts of urbanisation on North Queensland  
environments: managements and remediation  
and the **Raiforest CRC / QDMR Strategic Alliance**

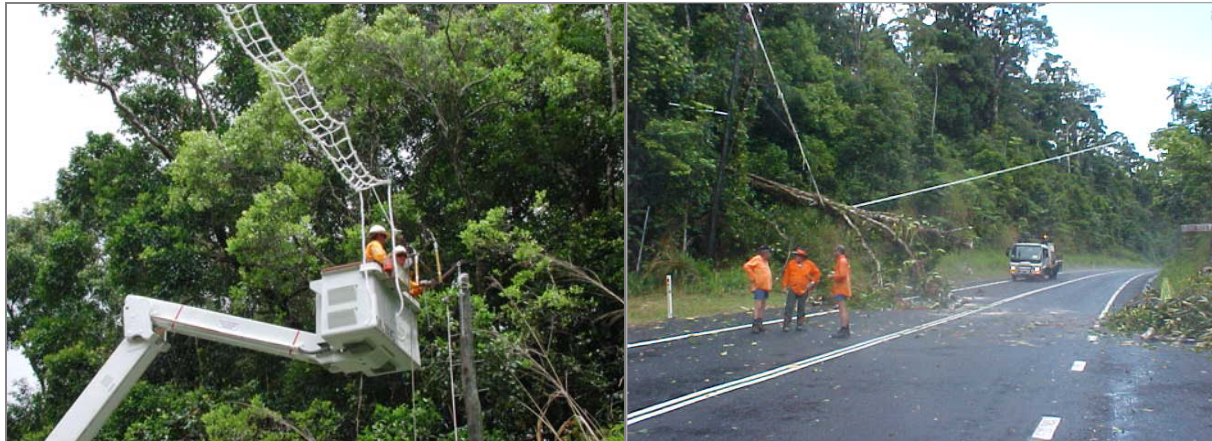
**Figure 1.11** (Left) Attaching the rope ladder to telegraph pole, and (right) the rope ladder one month after installation after a tree collapsed on top of it. Photos courtesy of Robyn Wilson.

A tree collapsed through one of the overpasses a month after installation (Figure 1.11) but this overpass was replaced in the following week. All overpasses remained intact following the passage of Cyclone *Larry* through the area (Figure 1.12). An information sign to inform drivers of the purpose of the overpasses was erected at the approach to them in November 2006 (Figure 1.13).

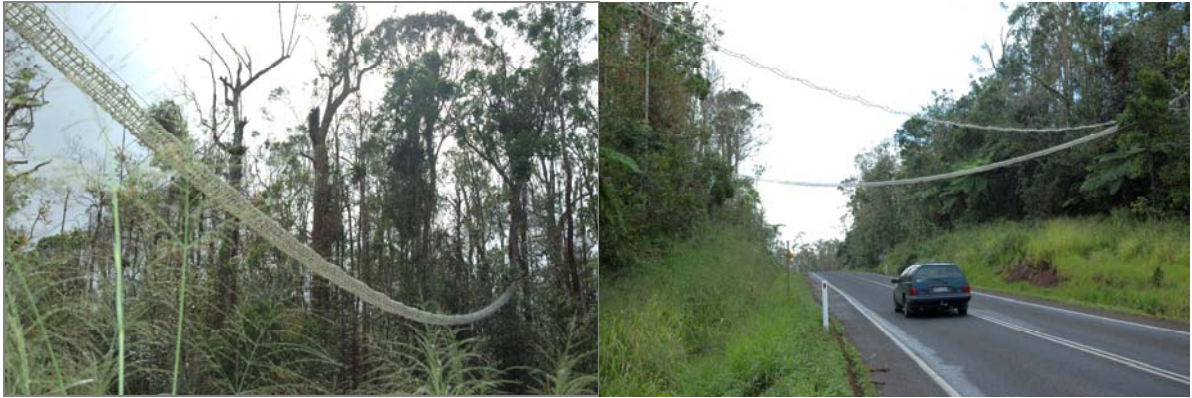
**Figure 1.12** (*Left*) rainforest destruction, and (*right*) the rope tunnel two months after Cyclone Larry. Note the width of the canopy gap over the road. Photos courtesy of Robyn Wilson.

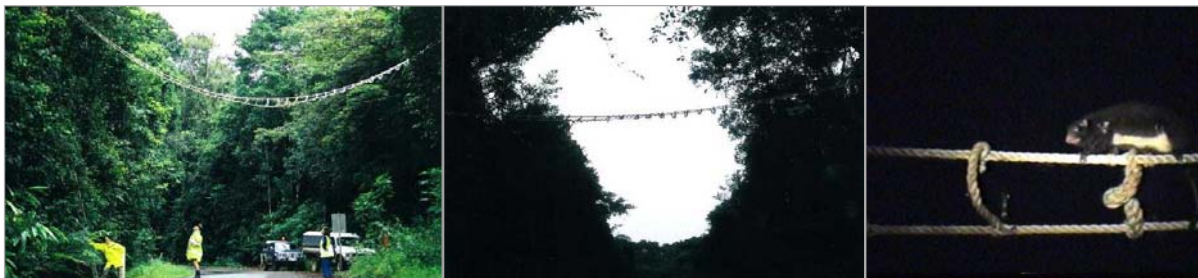
**Figure 2.2** (Left and centre) Rope ladder erected over the Old Palmerston Highway, and (right) being used by a Herbert River Ringtail possum.

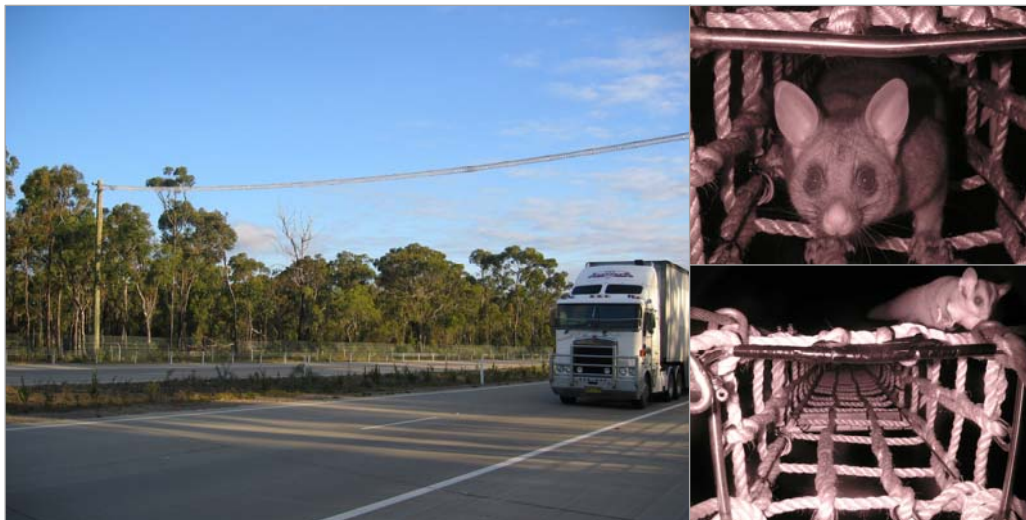
**Figure 2.3** (Left) The long rope tunnel constructed by Thiess Pty Ltd over the divided four-lane highway at Karuah, near Newcastle, NSW, with (above right) brushtail possum and (below right) squirrel glider making use of it. Photos courtesy of Bob Bax.

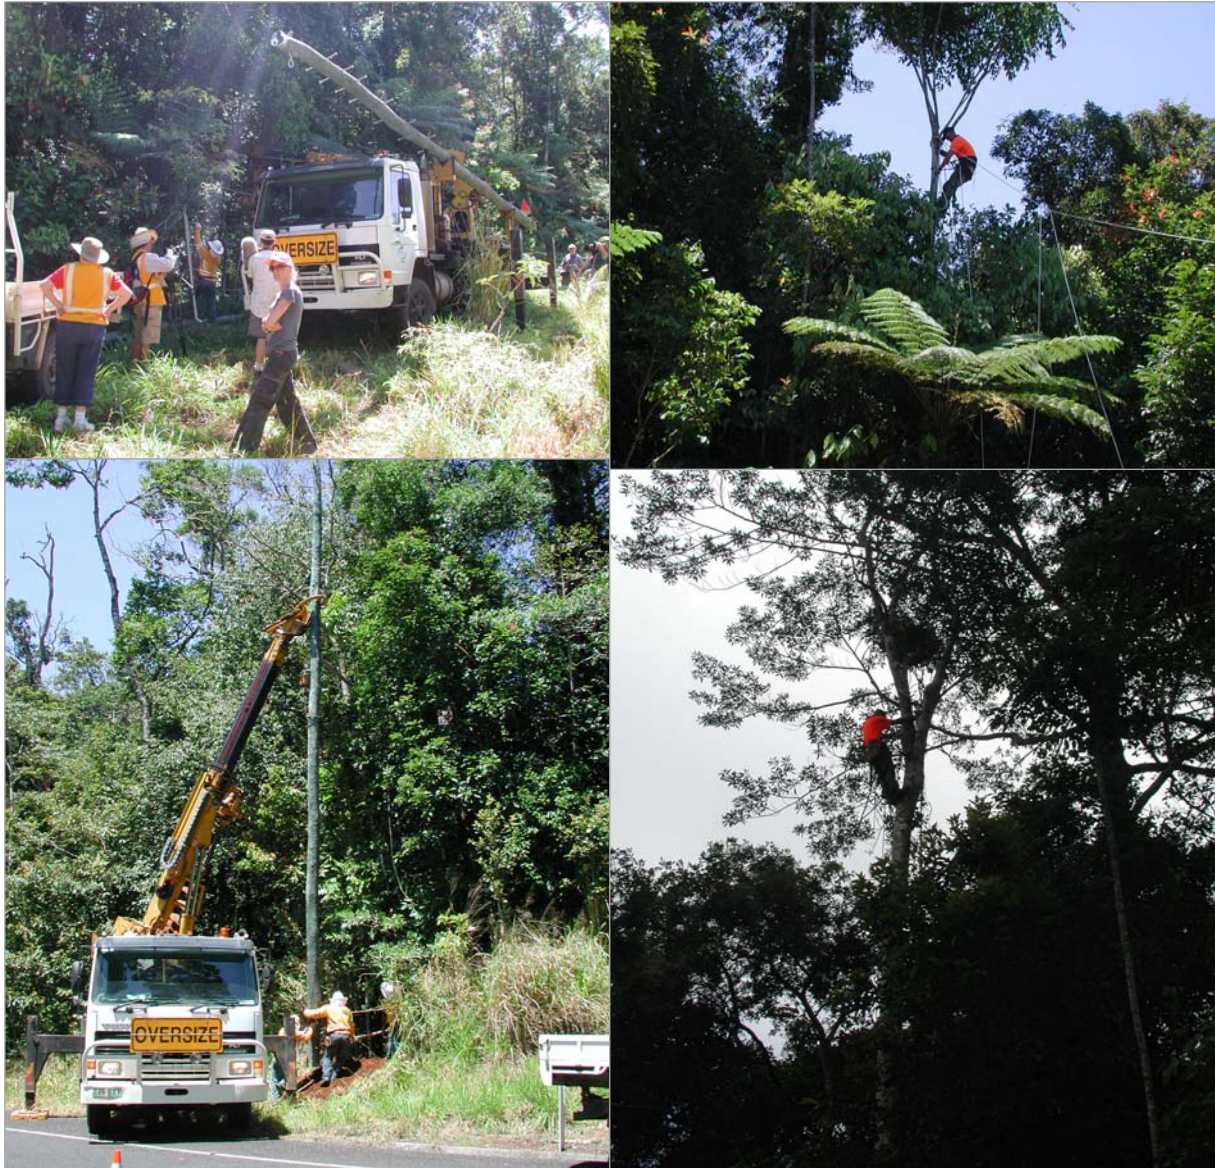
**Figure 2.4** Canopy bridges were installed between an electricity pole on one side of the road and a large, solid, healthy tree on the other side. Photos courtesy of Birgit Kuehn.

The final design comprised two stainless steel cables strung between an electricity pole on one side of the road and a large, solid, healthy tree on the other (Figure 2.4). The poles were braced back to footings in the ground by cables. The canopy bridges were attached to trees using bolted wooden supports, created in Mr David Rivett's home workshop with the assistance of Mr Nigel Weston. Wooden supports were attached by tree climbers to avoid tree damage (Figures 2.5, 2.6). The rope tunnel was spliced from 22mm diameter marine grade 'silver rope' by Gulf Net Menders Chandlery, Cairns (Figure 2.7). Finer diameter rope was used for the cross-members to reduce weight (Figure 2.8). The tunnel included stainless steel frames every metre (Figure 2.8) to which D-shackles were attached which then slid along the cables for erection (Figure 2.9). The Ergon Energy cherry picker was then used to thread the tunnel into position from the pole to the tree (Figure 2.10). Chains and turnbuckles attached to the pole eyelets or wooden support eyelets were used for tightening the cable (Figure 2.11).

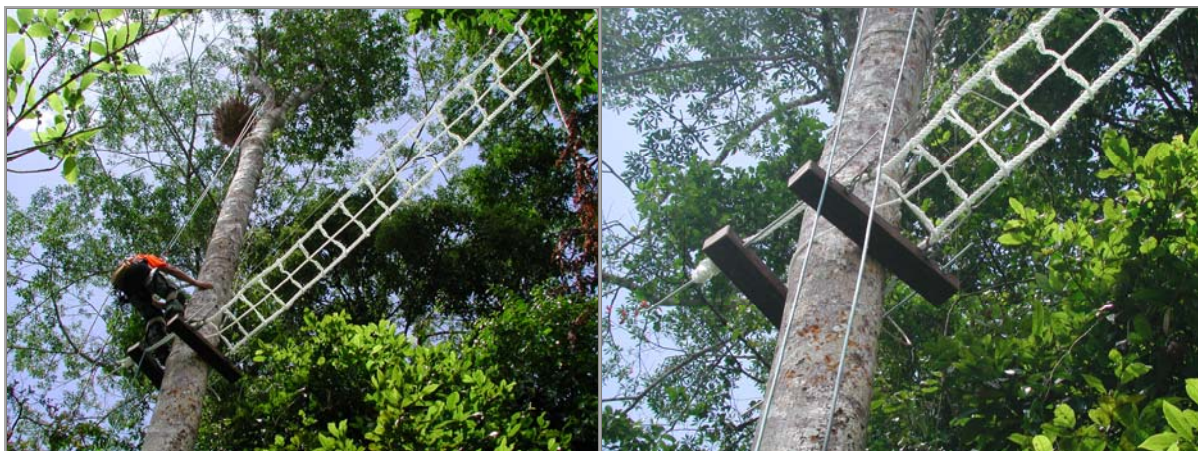
**Figure 2.5** Canopy bridges were attached to trees using wooden supports to prevent damage to the tree. Photos courtesy of Birgit Kuehn.

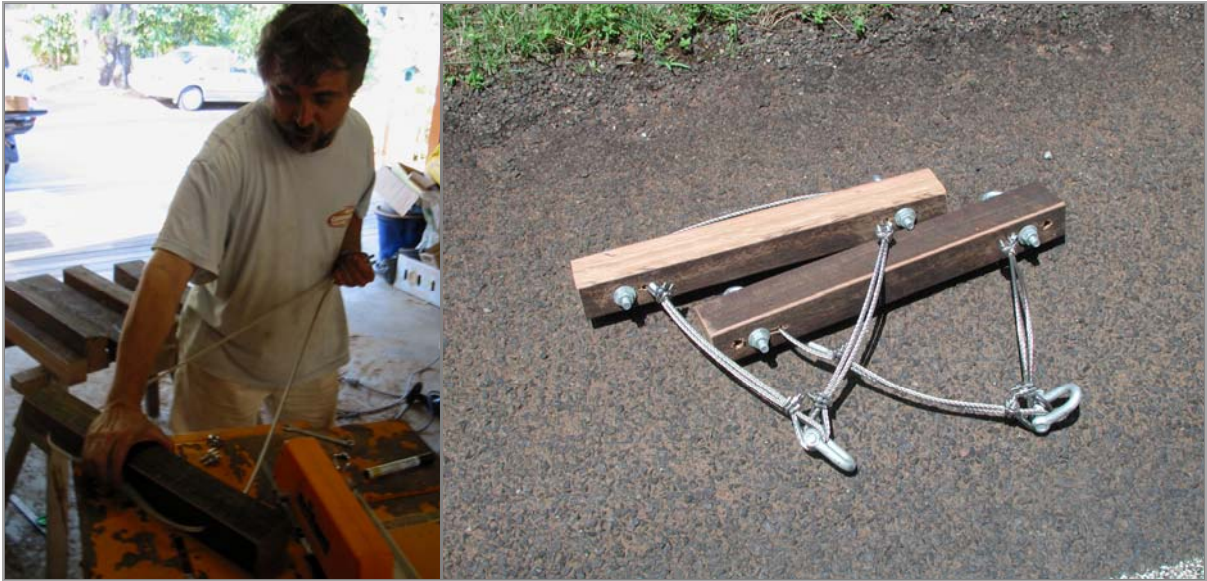
**Figure 2.6** Wooden supports used in attaching the canopy bridges to tree trunks, (*left*) created in the home workshop, and (*right*) the final product. Photos courtesy of Nigel Weston.

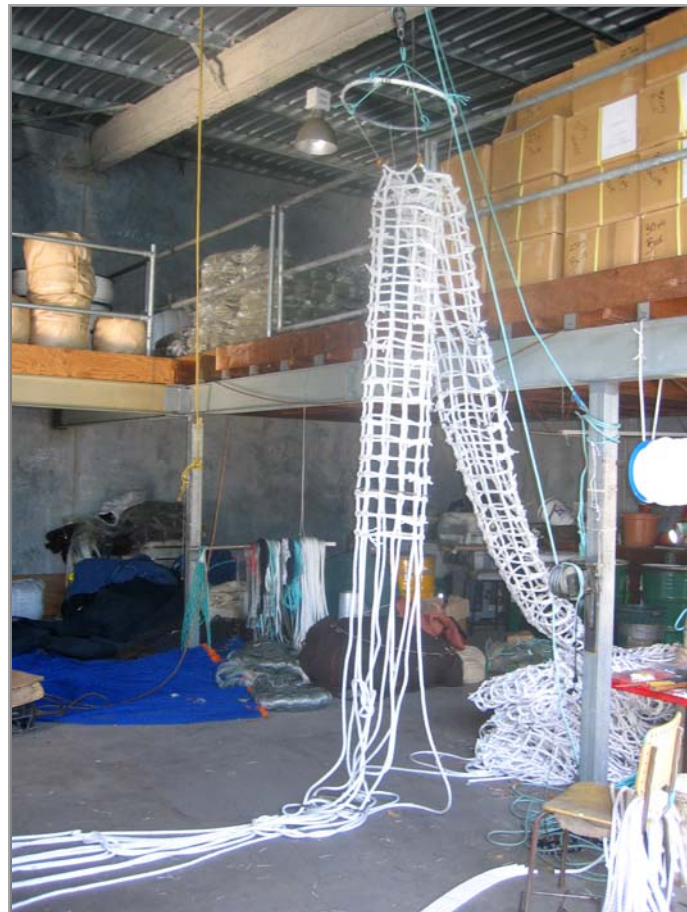
**Figure 2.7** Rope tunnel under construction at Gulf Net Menders Pty Ltd. Photo courtesy of Nigel Weston.

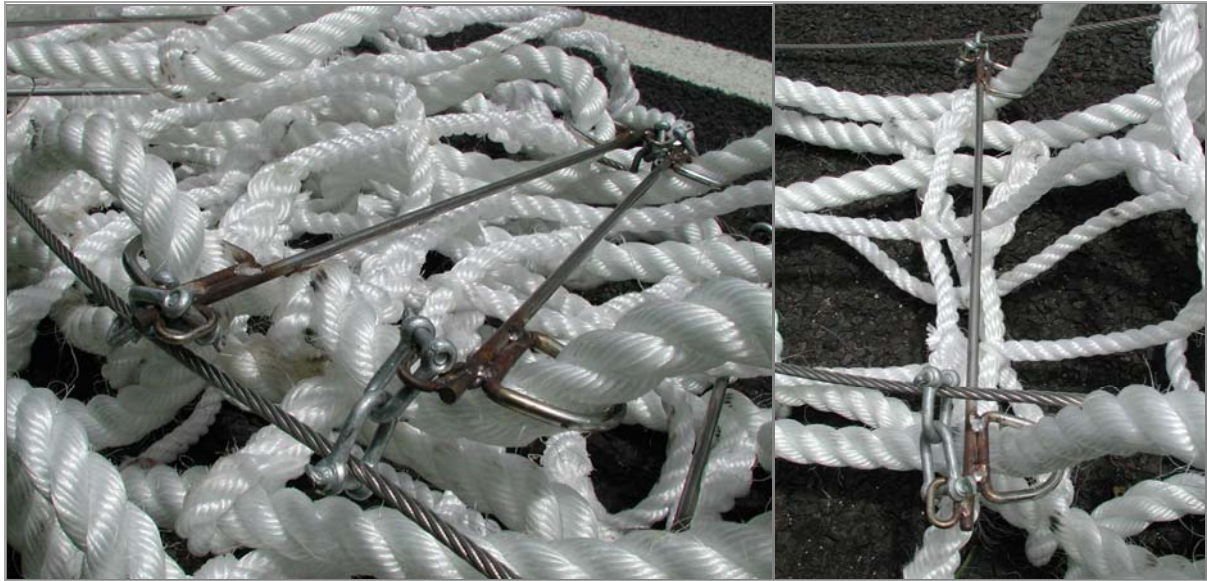
**Figure 2.8** Rope tunnel showing (*left*) stainless steel framework and D-shackles attached to the cable, and (*right*) finer rope cross-members. Photos courtesy of Nigel Weston.

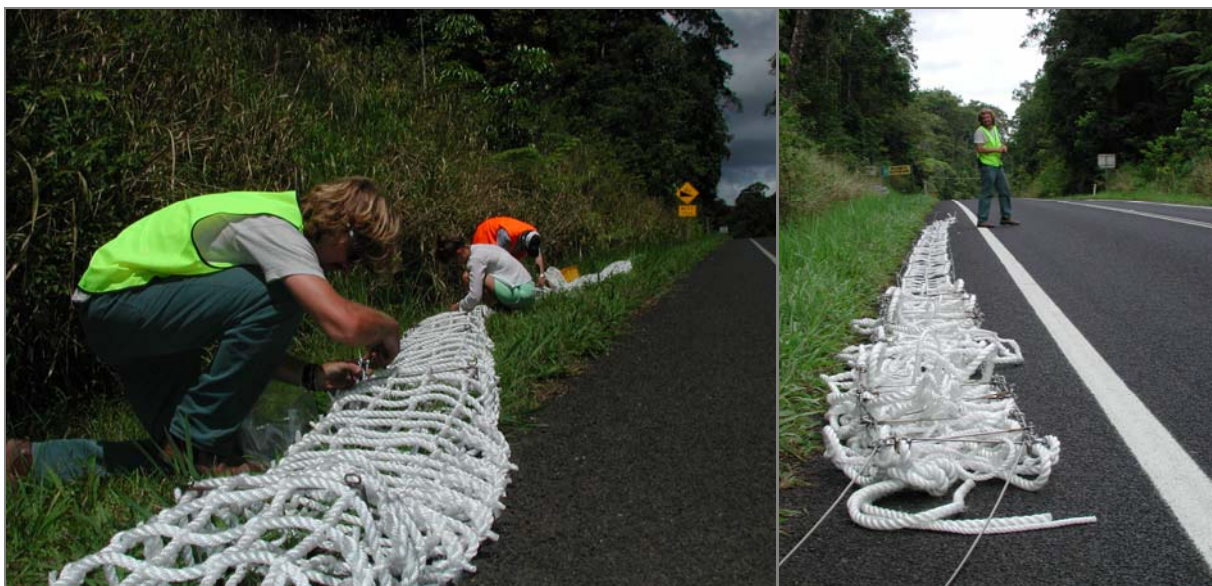
**Figure 2.9** Attaching D-shackles and threading the cable for erection. Photos courtesy Birgit Kuehn.

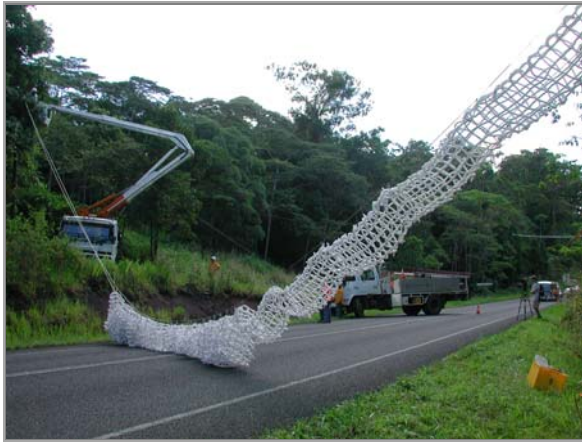
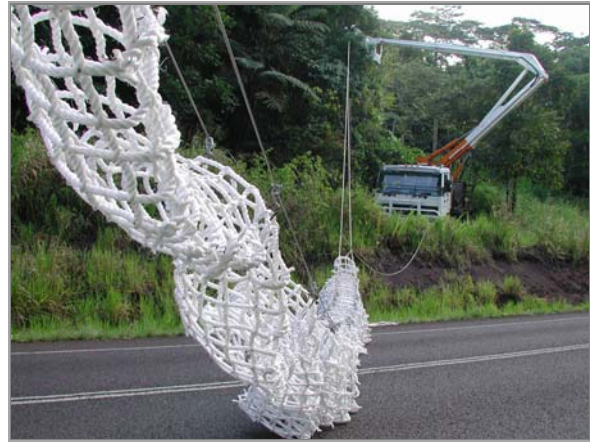
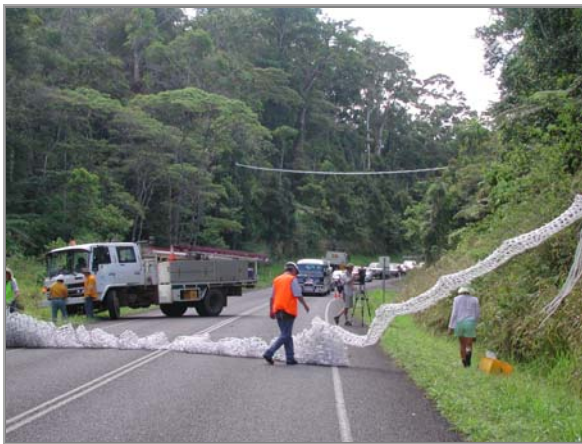
**Figure 2.10** Ergon Energy cherry picker used to thread tunnel into position from electricity pole to tree support. Photos courtesy of Birgit Kuehn.

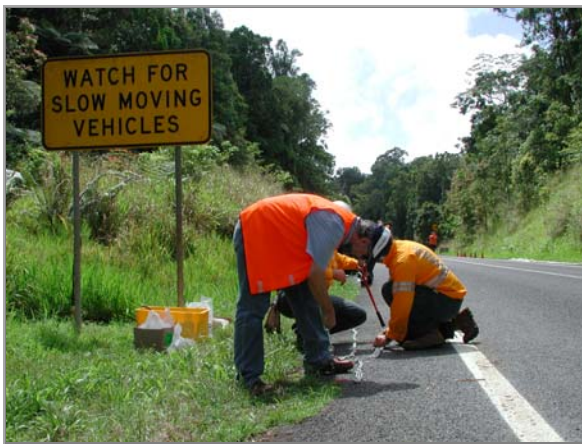
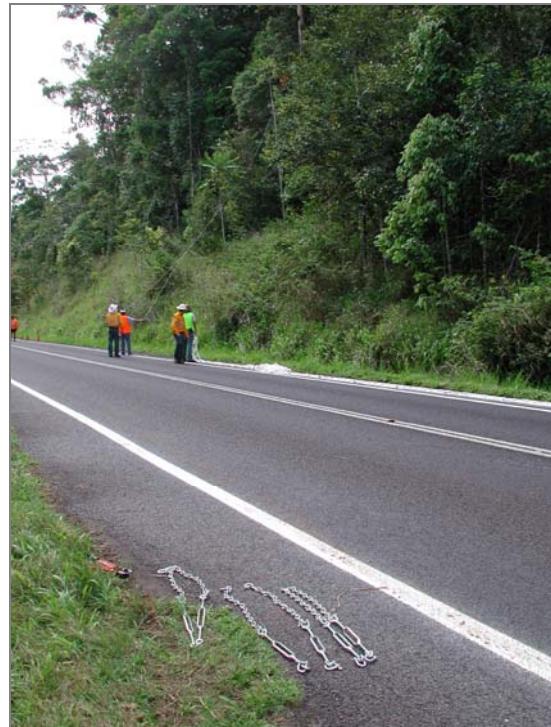
**Figure 2.11** Turnbuckles and chains for attachment to pole and wooden supports on trees. Photos courtesy of Nigel Weston.

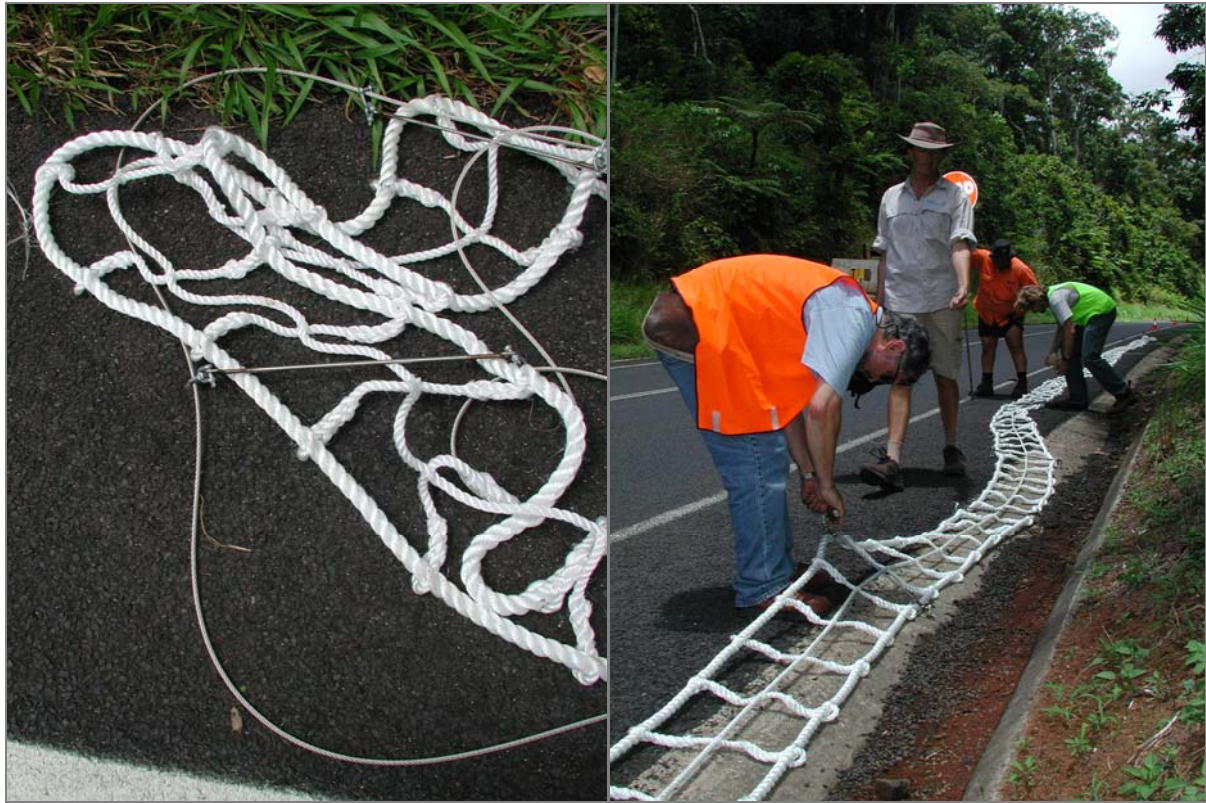
**Figure 2.12** Rope ladder design showing finer rope cross-members spliced to 22 mm main length and stainless steel supports and attached to D-shackles threaded onto cable supports. Photos courtesy of Birgit Kuehn.

Rope ladders were based on a similar design, using the 22 mm diameter silver rope with finer silver rope cross members (Figure 2.12). Cable, attachments, supports and erection were as for the rope tunnel construction (see above) (Figure 2.13).

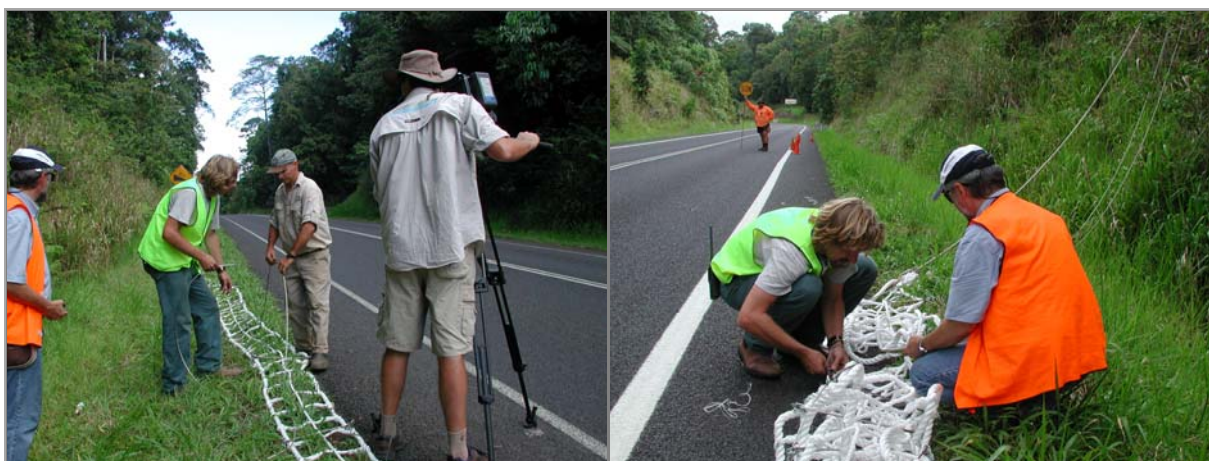
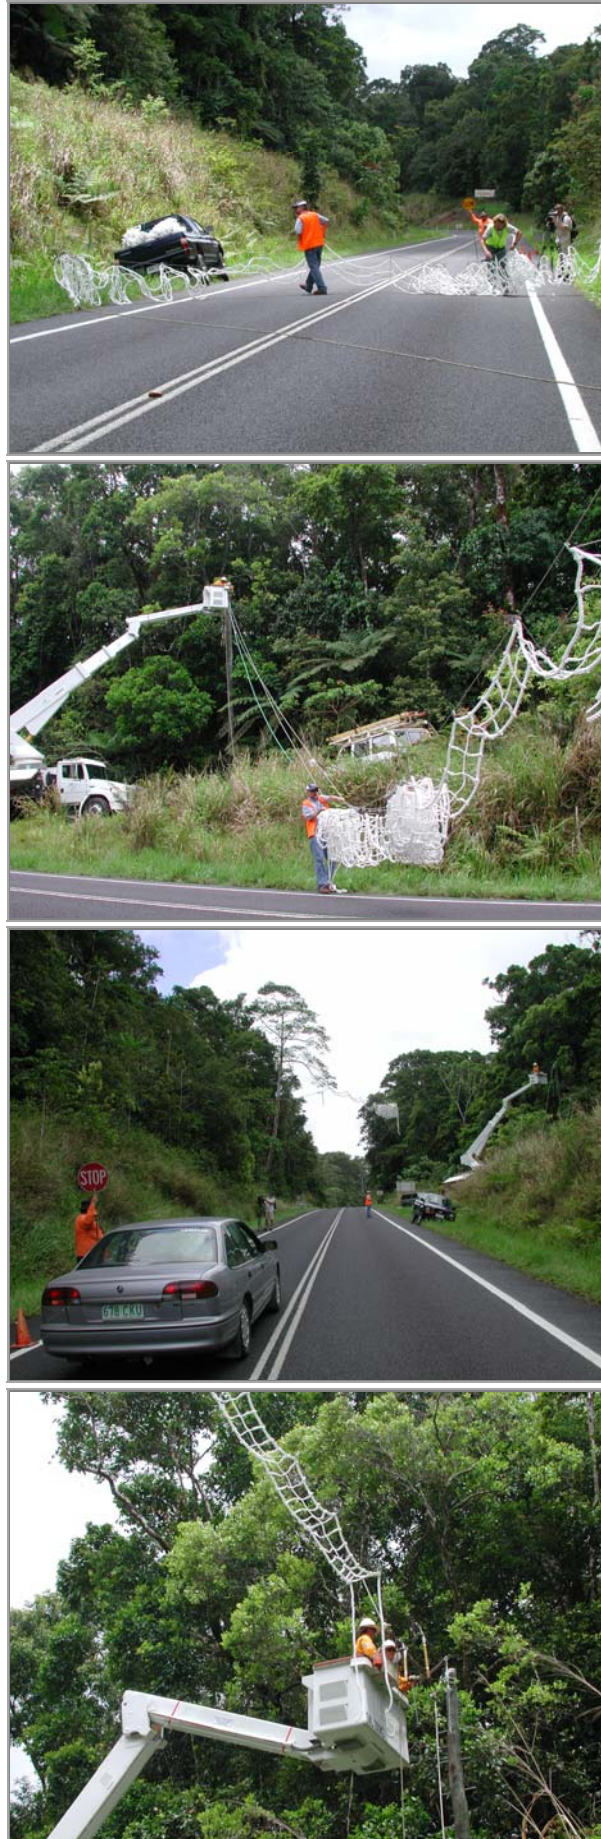
**Figure 2.13** Erection of rope ladder canopy bridges. Photos courtesy of Birgit Kuehn.

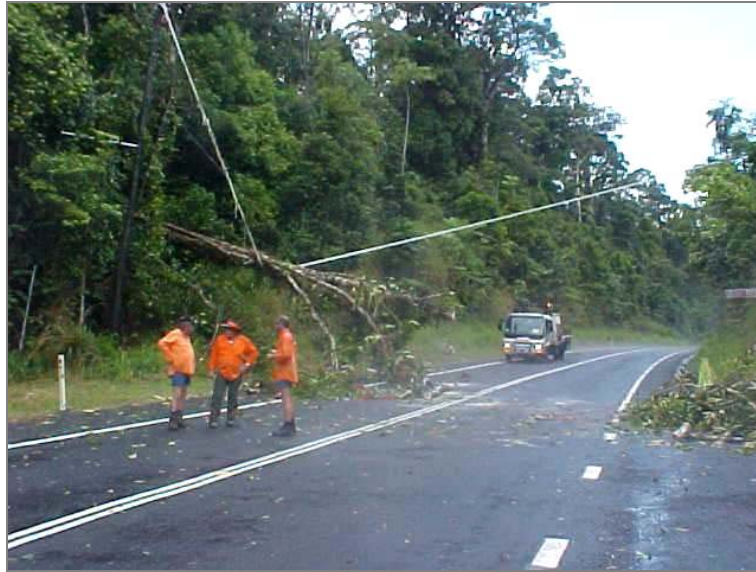
**Figure 2.14** Fallen tree supported by rope ladder overpass. Photo courtesy of Robyn Wilson

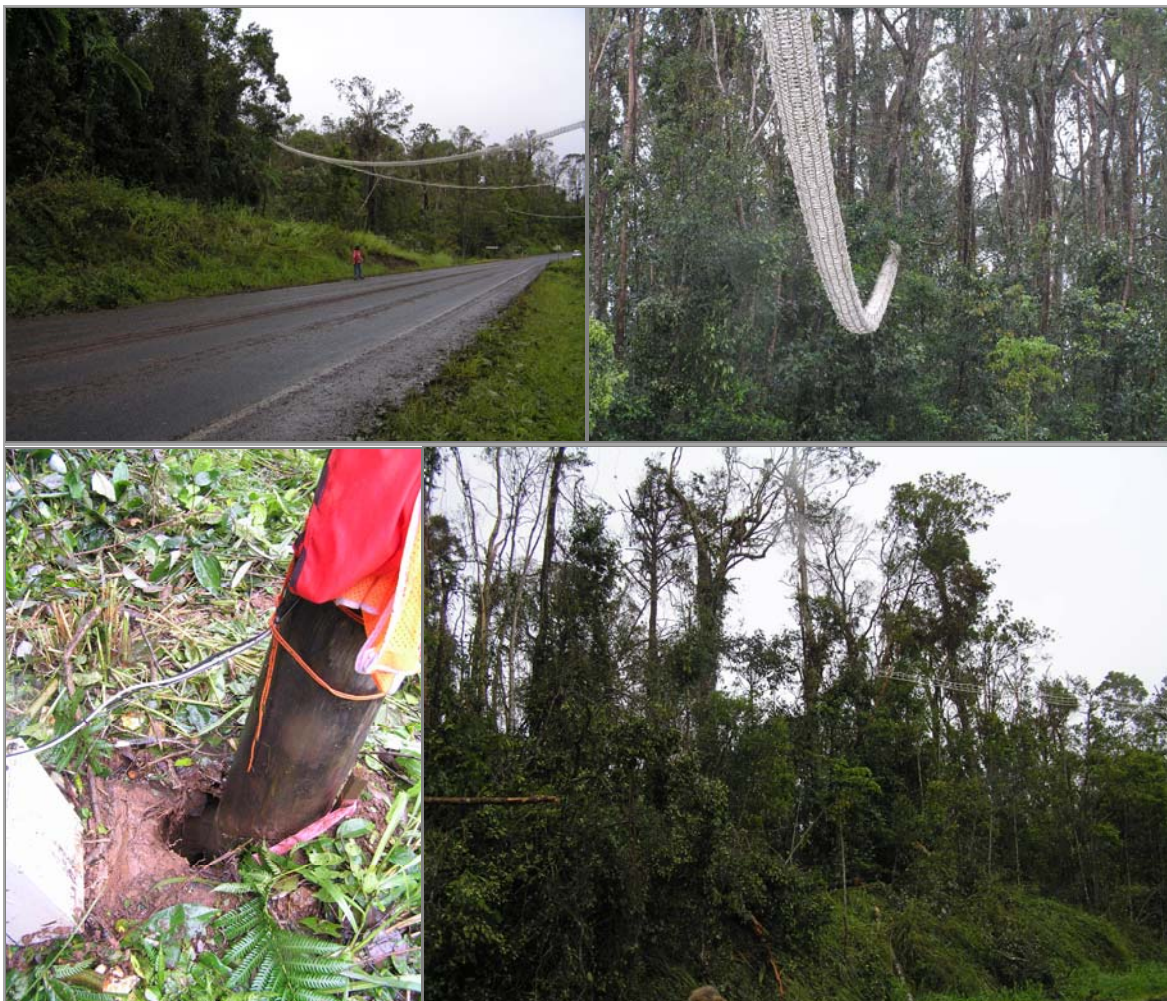
**Figure 2.15** Photographs taken three days after category 4 Tropical Cyclone *Larry* passed almost directly over the Palmerston Highway and its canopy bridges. The bridges are still in place although with slight sagging of the rope tunnel, a pole loosened in ground, and damage next to one of the ladders. Photos courtesy of Steve Goosem.

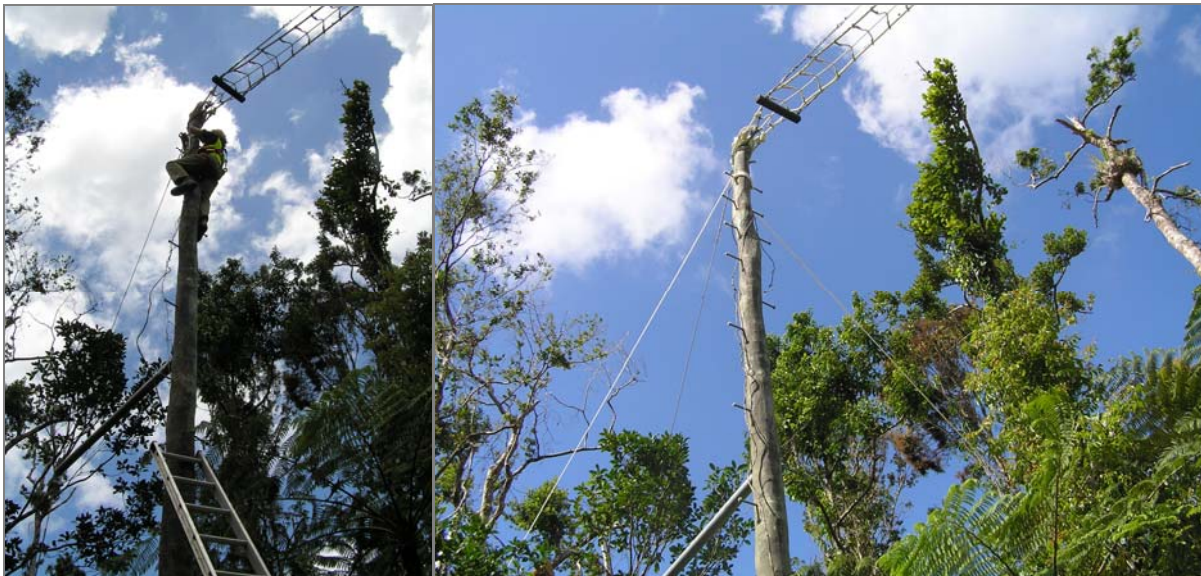
**Figure 2.17** Installation of ropes from poles to neighboring trees, where poles were somewhat isolated from adjacent foliage. Photos courtesy of Miriam Goosem.

In November 2006, ropes connecting the two electricity poles that were more isolated from neighbouring trees were installed to encourage possums to access the canopy bridges (Figure 2.17). Further ropes were added to the pole attached to the rope tunnel and rope ladder in November 2007.

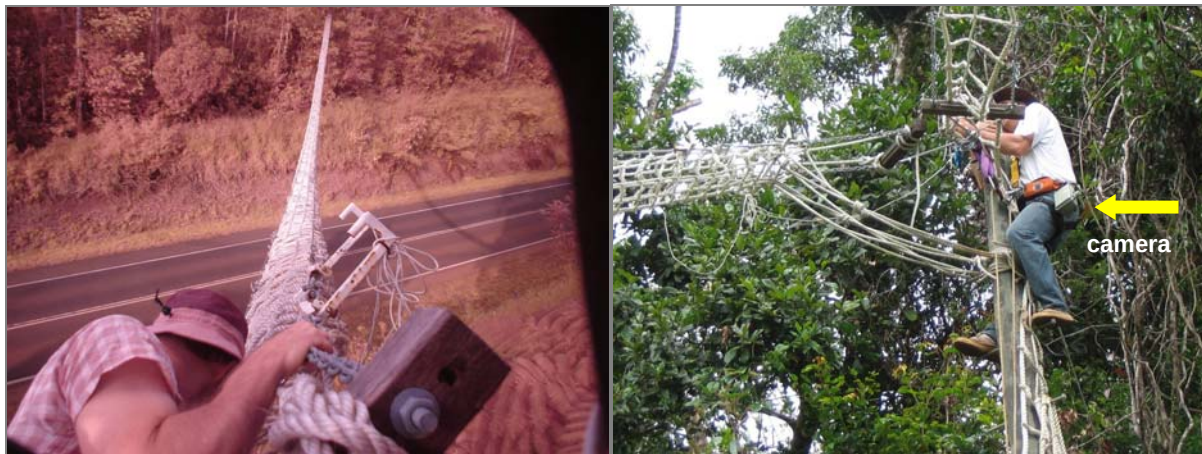
**Figure 3.1** (Left) Installation of infrared-beam sensors on the rope tunnel canopy bridge, and (right) climbing the pole to the rope tunnel – note the camera housing ready to install, attached to the climber's hip. Photos courtesy of M. Cohen and J. Cooper.

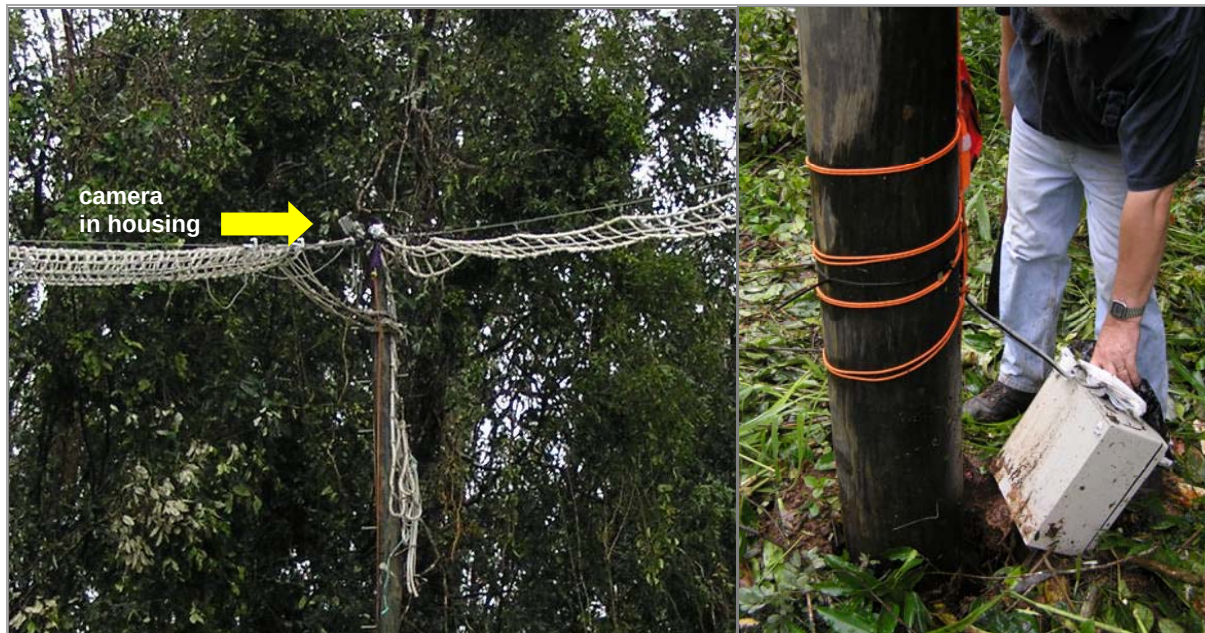
**Figure 3.2** (Left) Inconspicuous camera in position facing along the rope tunnel, and (right) the control box for downloading images and battery with cable leading down from camera. Photos courtesy of Steve Goosem and Miriam Goosem.
