# **Quantifying the effectiveness of gully remediation on off-site water quality: Preliminary results from demonstration sites in the Burdekin catchment (second wet season)**

Supported by the Australian Government's  
National Environmental Science Program  
Project 2.1.4 Demonstration and evaluation of gully remediation on downstream water quality  
and agricultural production in GBR rangelands

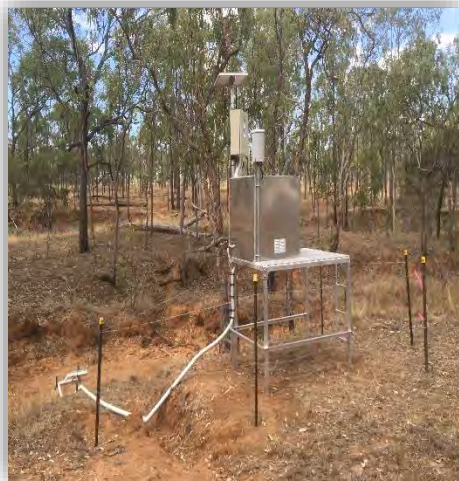
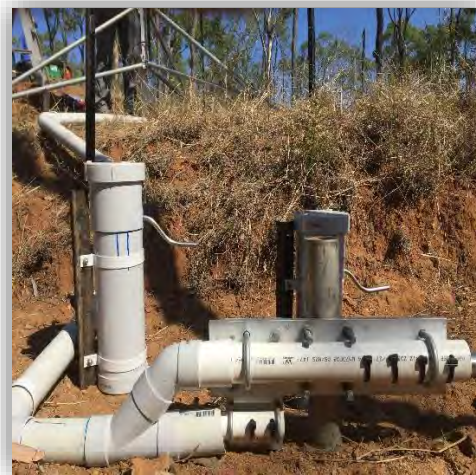
**Figure 7: (A) Example of a treatment gully set up and (B) and example of a control gully set up including two rising stage samplers**

Unidata Starflow QSD ultrasonic doppler was installed above the turbidity sensor at each site in 2017. The sensor measures the velocity of particles or bubbles in the water (presumed to be the same velocity as the water) using the doppler shift between transmitted and received ultrasonic signals. The sensors are mounted facing downstream to reduce the impact of particles damaging the sensor face and debris build up on measurement. The sensors require reconfiguration from factory default settings to capture data in gully systems.

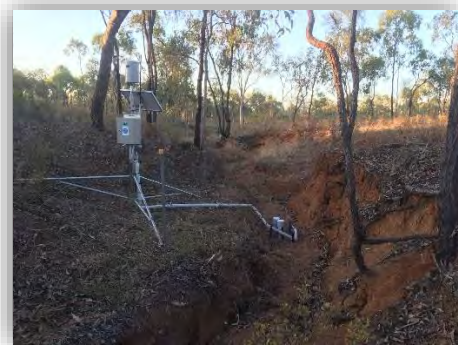
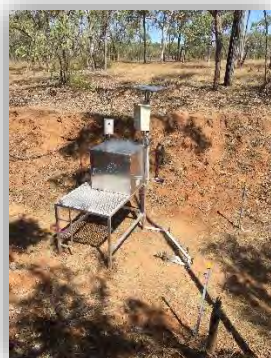
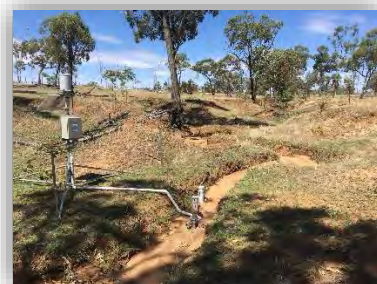
**Figure 8: The treatment (left) and control (right) instrumented gullies at each property. (A) Virginia Park (B) Meadowvale (C) Strathbogie, (D) Minnie Vale and (E) Mt Wickham**

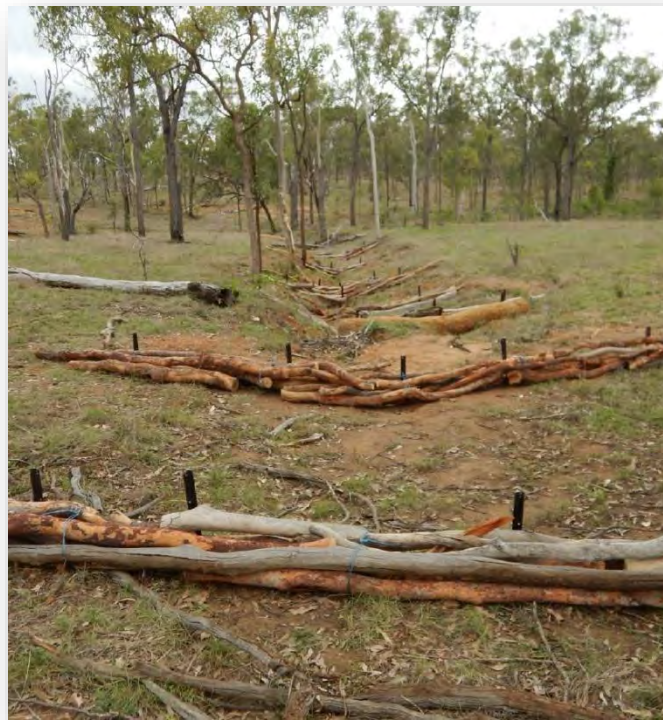
**Figure 13: Example of the stick traps installed at Minnievale station**

The Minnievale site is a Reef Trust 2 gully remediation site being managed by Greening Australia. This site has had the most significant number of remediation works undertaken. The main treatment gully has been fenced off (~4 km of fencing). A total of 135 within gully structures installed in 2016. There were two types of structures (coir logs and stick traps or PCDs); they were installed in the main gully and the side arms of the main gully (Figure 14). Many of the coir logs failed during the 2016/17 wet season (95% failure rate), and subsequently they were replaced with ~147 stick trap dams (Figure 13) in 2017 (Figure 15).

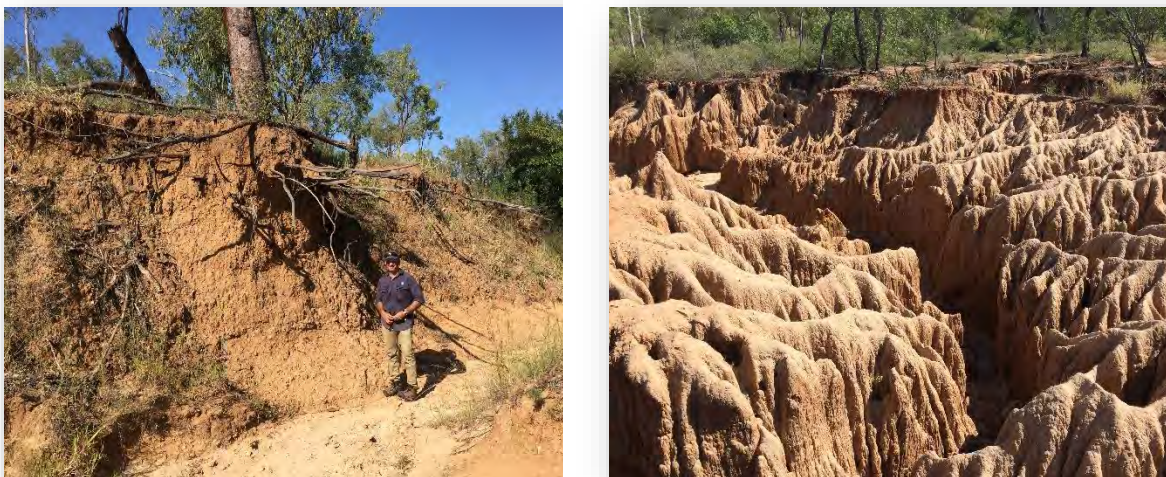
**Figure 16: (left) Single channel gully and (right) highly sodic soil resulting in Badlands or alluvial gully formation. Both gully types are found on Mt Wickham Station**

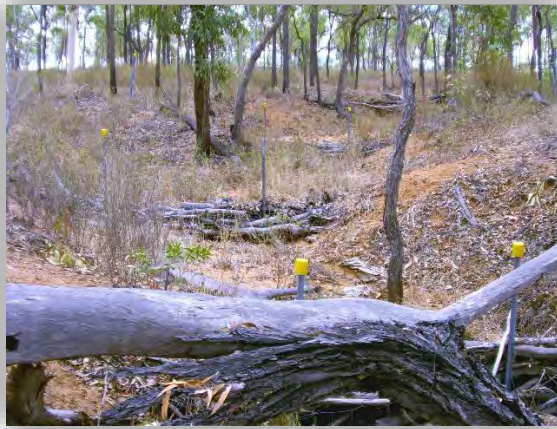
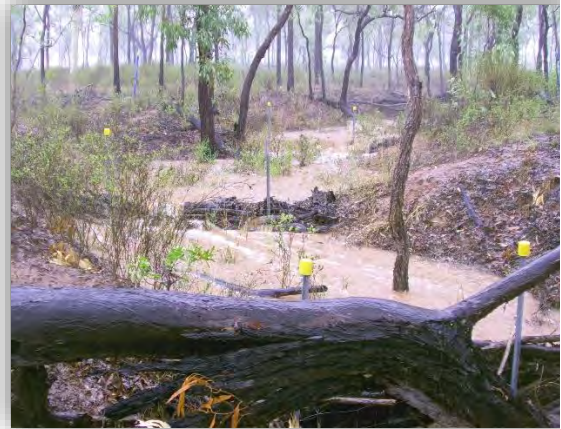
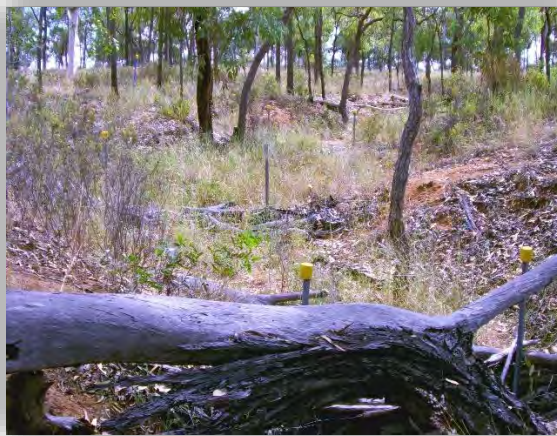
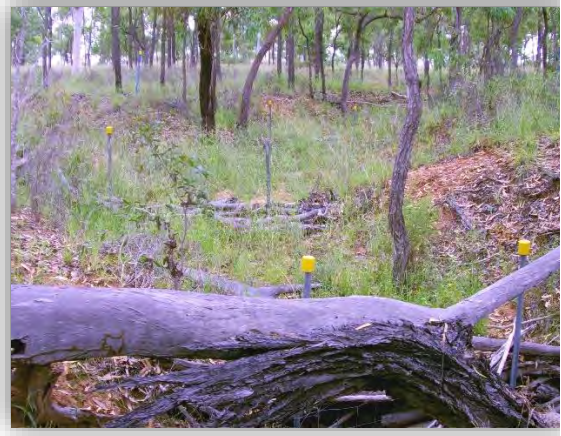
**Figure 24: Treatment gully at Virginia Park in (A) 2016 (B) during an event in 2017 and (C) at the end of reporting period in April 2017 and (D) at the end of reporting period in April 2018**

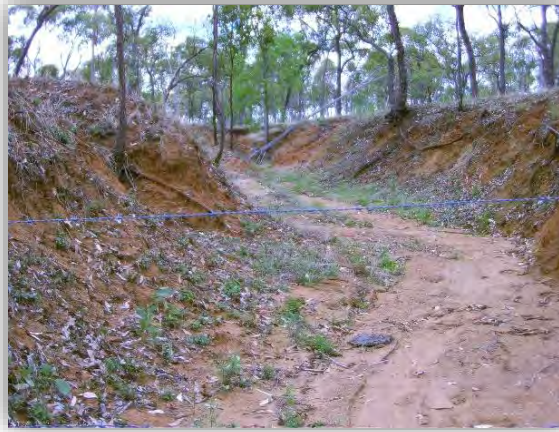
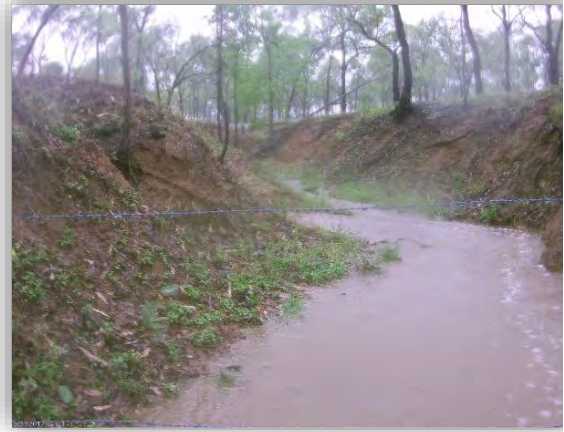
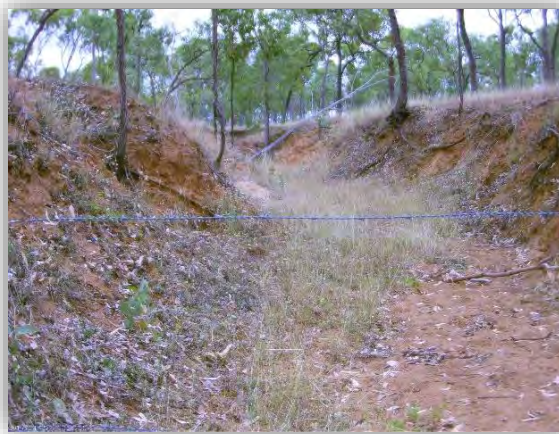
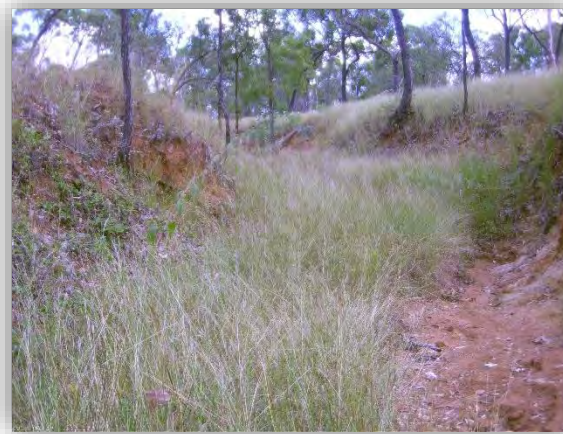
**Figure 25: Treatment gully at Meadowvale in (A) 2016 (B) during an event in 2017 and (C) at the end of reporting period in April 2017 and (D) at the end of reporting period in April 2018**

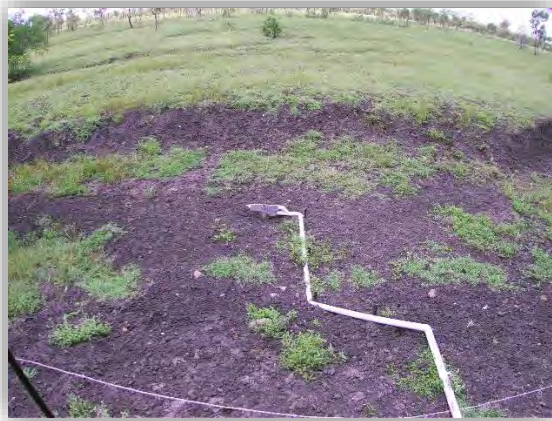
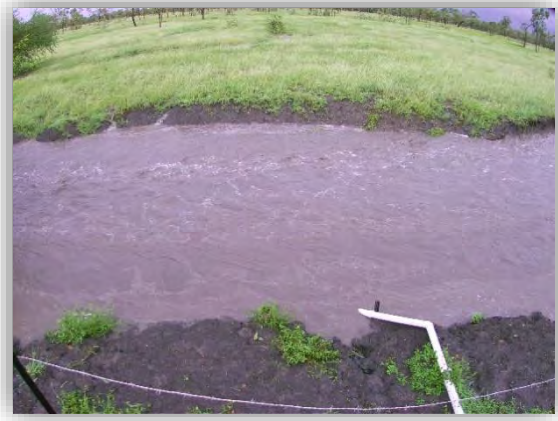
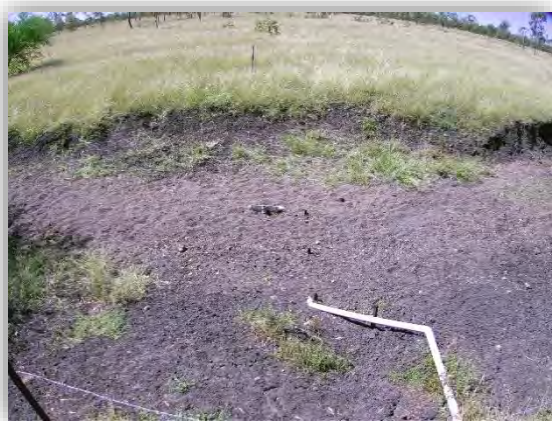
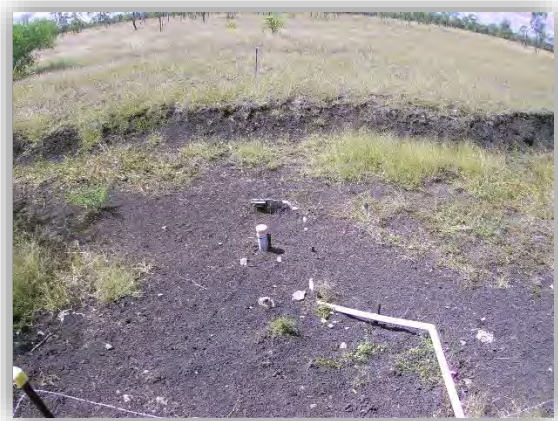
**Figure 26: Treatment gully at Strathbogie in (A) 2016 (B) during an event in 2017 and (C) at the end of reporting period in April 2017 and (D) at the end of reporting period in April 2018**

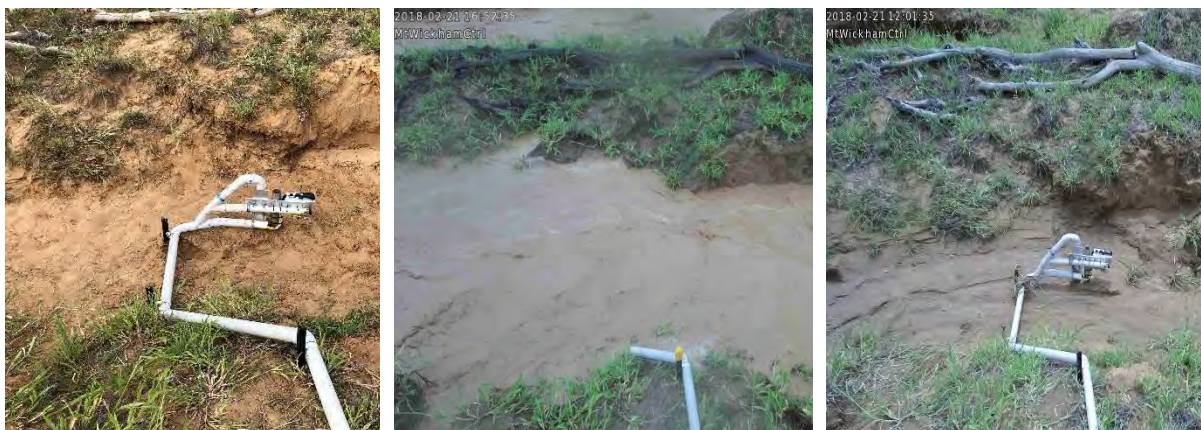
Figure 28: Control gully at Mt Wickham before (left) and during (middle) an event and at the end of reporting period (April 2018)
