# **Quantifying the effectiveness of gully remediation on water quality: preliminary results from demonstration sites in the Burdekin catchment (third wet season)**

Supported by the Australian Government's National Environmental Science Program  
Project 5.9 Demonstration and evaluation of gully remediation on downstream water quality and agricultural production in GBR rangelands

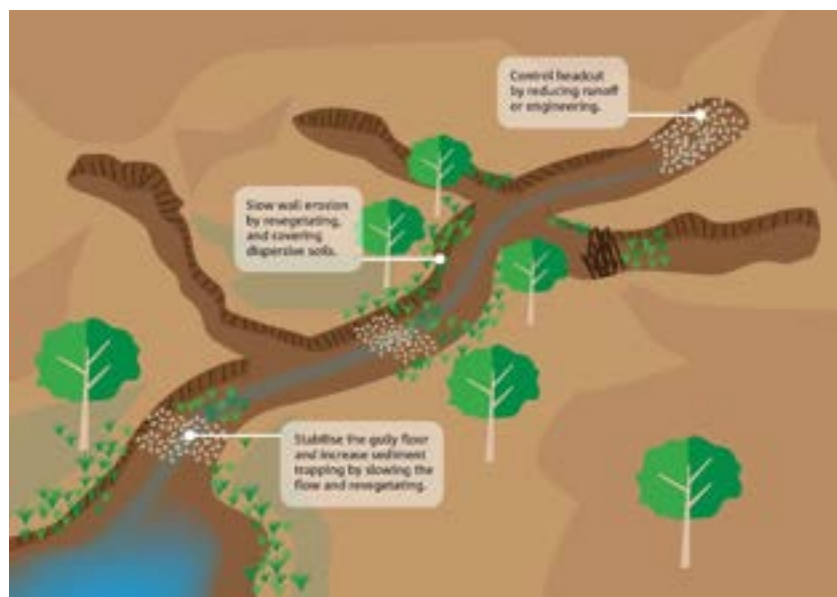
**Figure 2: Conceptual model of the outcome of various treatment options within a gully (Wilkinson et al., 2019).**

The Gully Erosion Toolbox, a document prepared for the Reef Trust gully remediation program (Wilkinson et al., 2015c), outlines a range of treatment options suitable for gully remediation. The treatment options are based on evidence of the effectiveness of studies elsewhere in the world (see review undertaken in Bartley et al., 2017 NESP TWQ Hub report). The evidence from these published studies highlights that although gully remediation can be effective, there is also significant risk associated with gully remediation, with many studies having a high failure rate of within gully structures (e.g. Nyssen et al., 2004). Therefore, the treatment options in this study are primarily based on using vegetation, fencing and low-cost engineering structures. The logic also being that if these options are effective, then it should be possible to treat a larger area for a given cost. A conceptual diagram of the relative role of some of these options on runoff and sediment/nutrient losses are described in Figure 2 and Table 3.

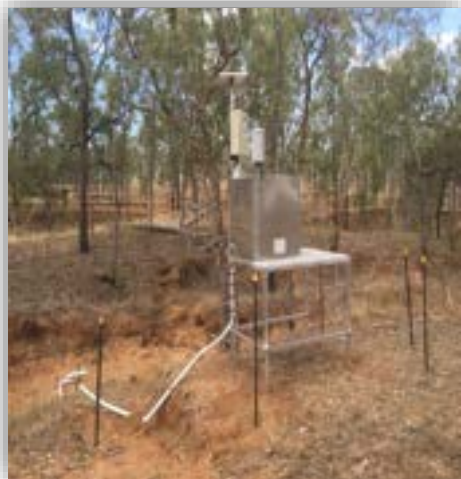
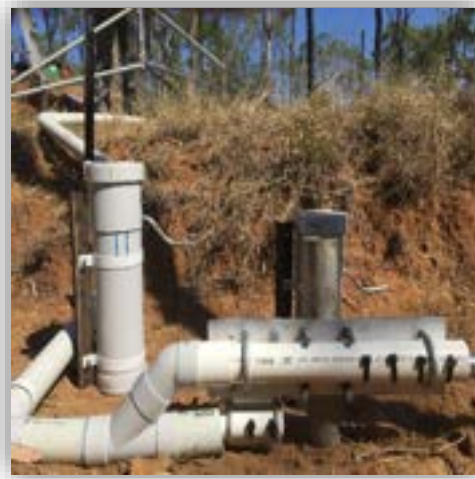
**Figure 9: (A) Example of a treatment gully set up and (B) and example of a control gully set up including two rising stage samplers**

An automatic monitoring station was installed at each of the treatment gullies (Figure 9A). The monitoring station recorded rainfall, stage height, turbidity and water temperature at 1-min intervals during runoff events. The station also housed an ISCO auto-sampler that collected 1-L water samples at programmed intervals across the hydrograph. These samples were processed according to the methods in Section 4.4. A camera was installed at the treatment sites to capture photos during runoff events.

Each of the control sites were fitted with a simpler tripod monitoring station that measured rainfall, stage height and turbidity. Bulk water quality samples were collected manually after each (accessible) event using poly-pipe rocket structures (Figure 9B). Data from both the treatment and control sites had telemetered communications to allow remote access of data.

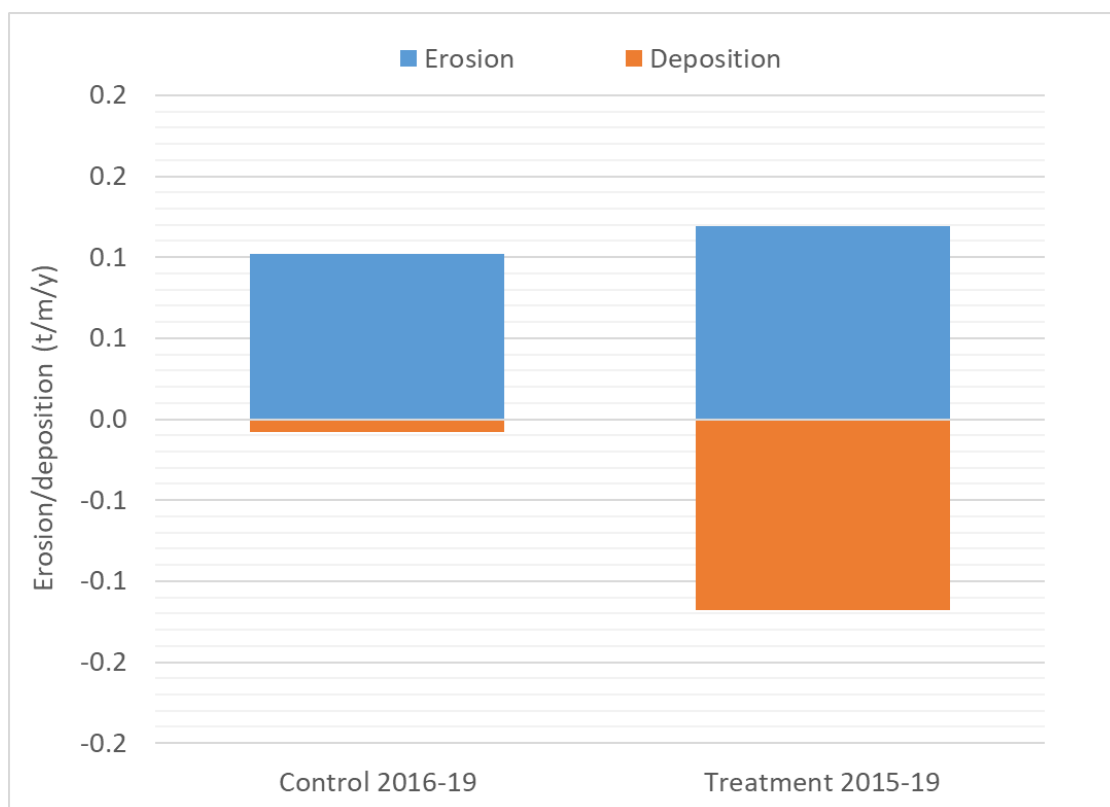
**Figure 20: Net sediment movement (tonnes per metre surveyed per year, t/m/y) for Virginia Park (using a measured soil bulk density of 1.66 t/m<sup>3</sup>) for the 2016-19 period. Erosion is represented by positive (+ve) values and deposition negative (-ve) values.**

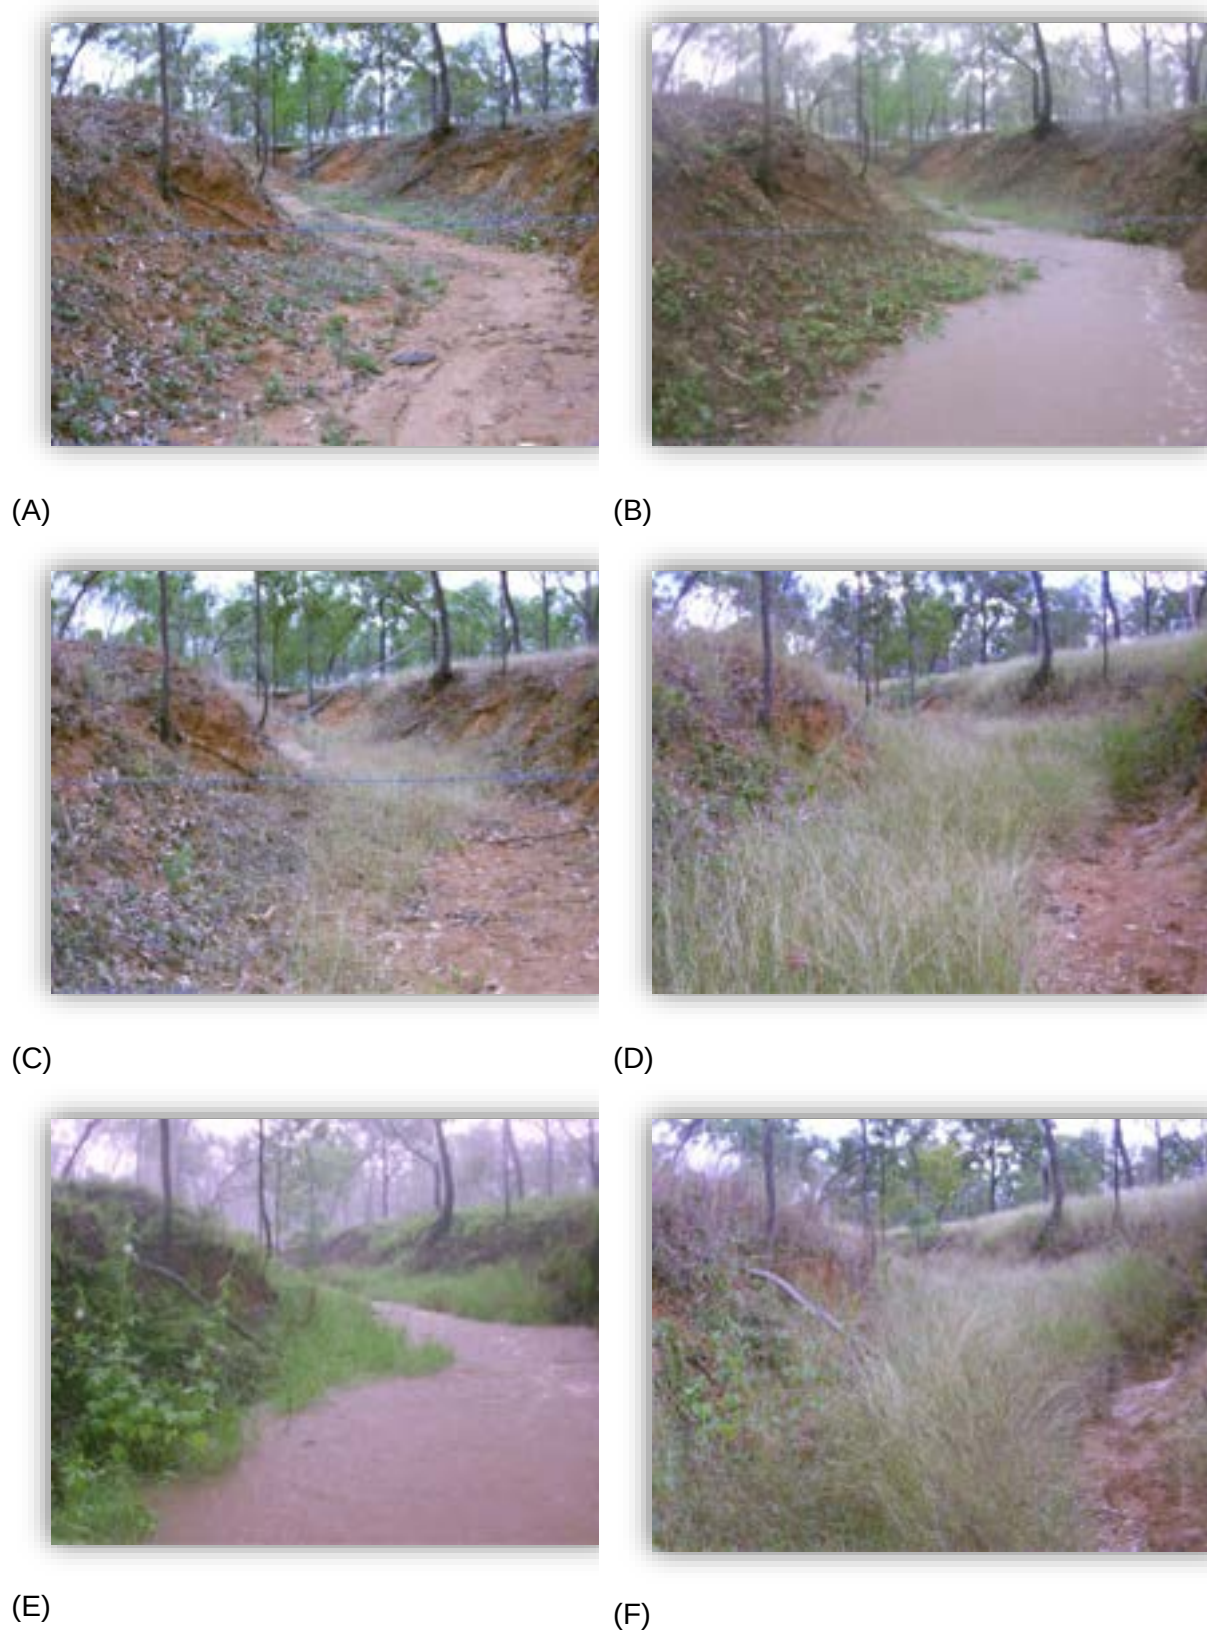
**Figure 25: Treatment gully at Meadowvale in (A) 2016 (B) during an event in 2017 (C) at the end of reporting period in April 2017 (D) at the end of reporting period in April 2018 (E) an event in 2019 and (F) at the end of wet season in 2019**

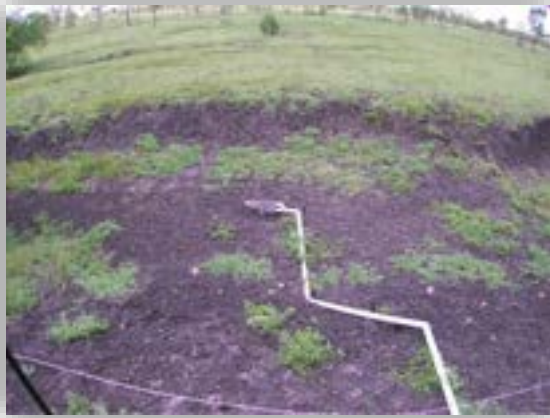
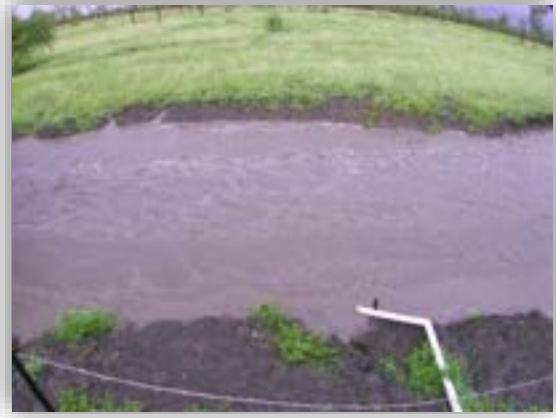
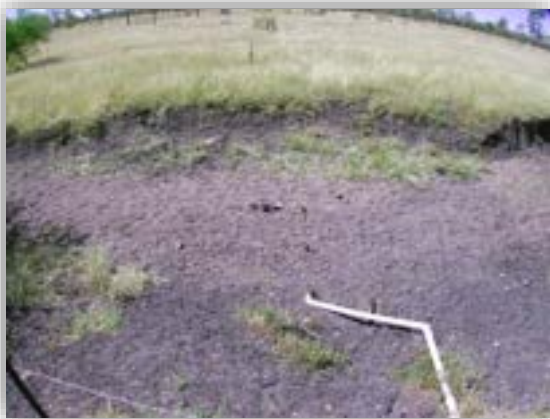
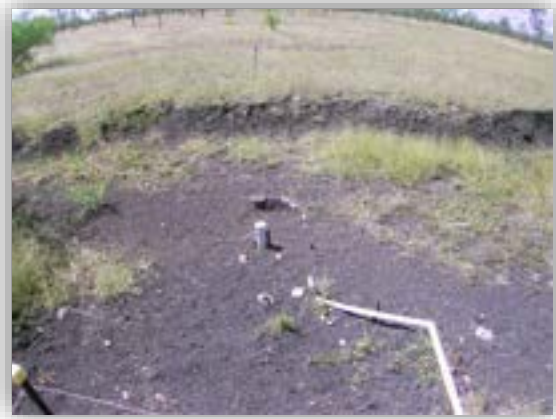
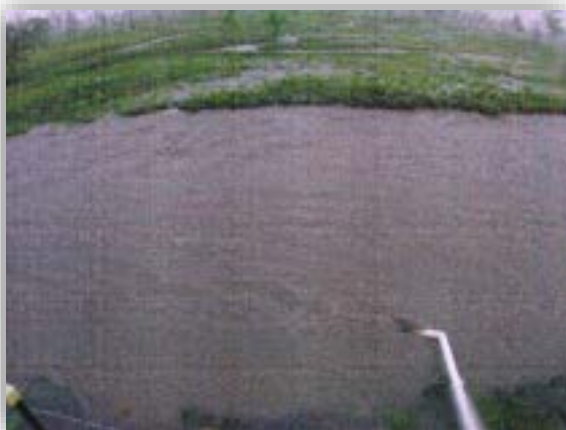
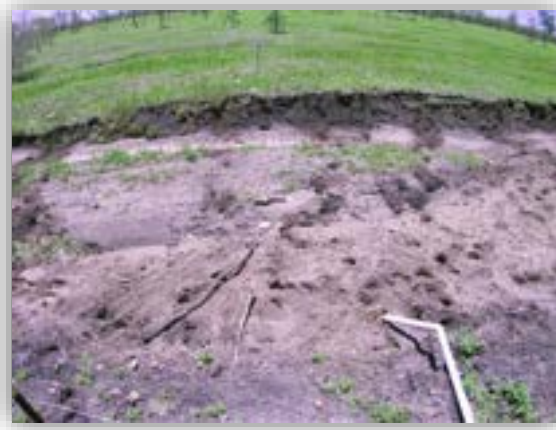
**Figure 32: Old Treatment (now control) gully at Strathbogie in (A) 2016 (B) during an event in 2017 (C) in April 2017 and (D) at the end of reporting period in April 2018 (E) during an event in 2019 and (F) at the end of January 2019**

The Strathbogie site was a Reef Trust 2 gully remediation site, that is now being managed by NQ Dry Tropics under their LDC program. This site has not yet undergone remediation treatment (Figure 31). There was a remediation plan in progress in 2016/17 that was delayed, and then after Cyclone Debbie, the landholder withdrew from the project. Given the baseline data collected at this site, and the significant erosion at the control site, we switched the control and treatment sites over and installed matching water quality instrumentation so that both the treatment and control sites have ISCO samplers. The new treatment site instrumentation was installed during the dry season in 2018. At the same time, NQ Dry Tropics reengaged the landholder and a remediation treatment plan were prepared by contracted consultants. The treatment works were to be installed in January 2019, however, the site received over 400 mm in two days in early January, and the works were not completed. The remediation is expected to be completed during the dry season in 2019.

Fortuitously, we now have three years of pre-treatment data at both the treatment and control sites. All data presented below is from two non-treated sites. For those readers familiar with these data and sites, it is important to note that the control and treatment sites have been swapped. The new control is named (SBT) and the new treatment is named (SBT2). Figure 32 shows the field sites at Strathbogie during different event and dry conditions over the last three wet seasons.

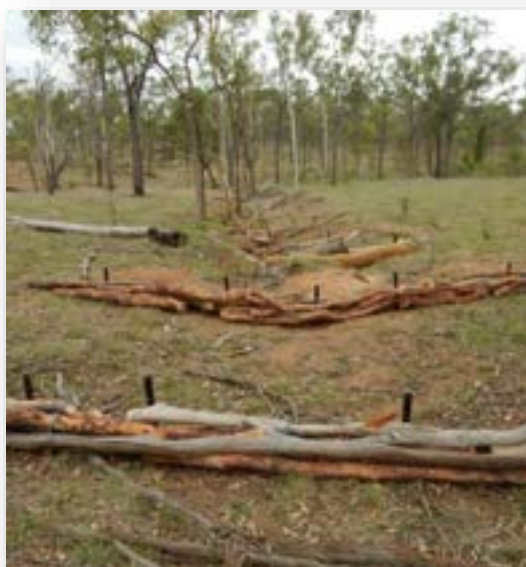
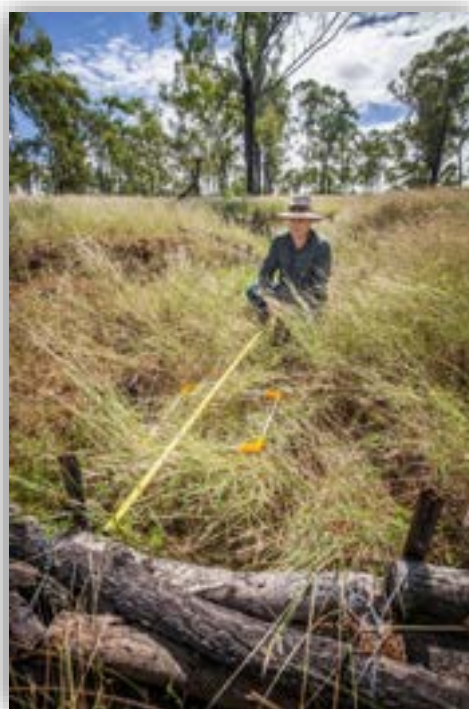
**Figure 38: (A) Example of the stick traps installed at MinnieVale station and (B) measurements of the vegetation cover and biomass behind the stick straps at this site in April 2019.**

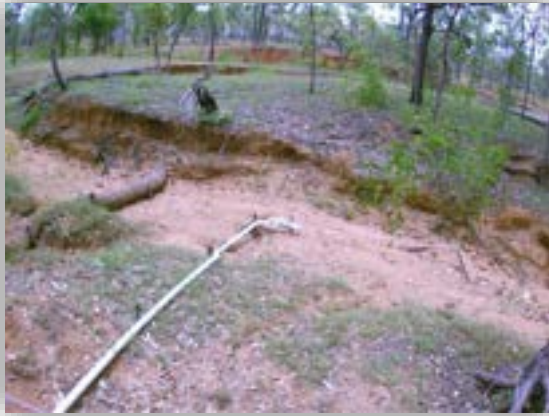
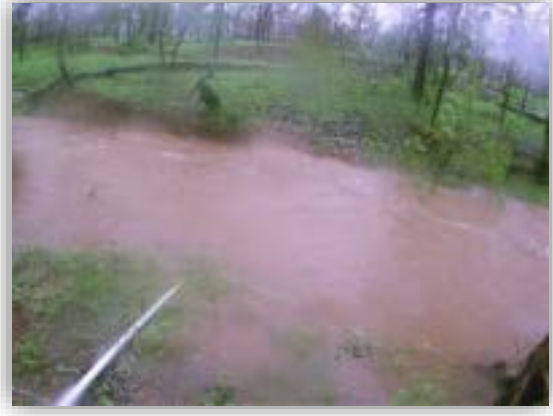
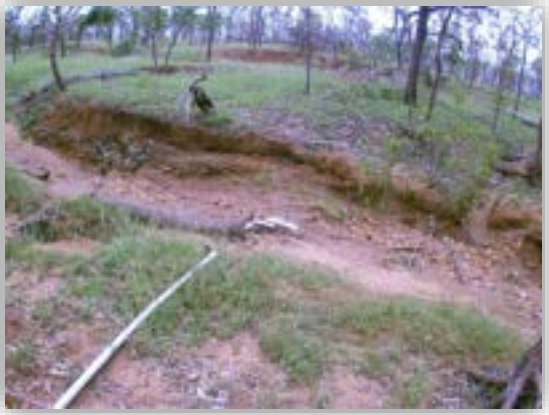
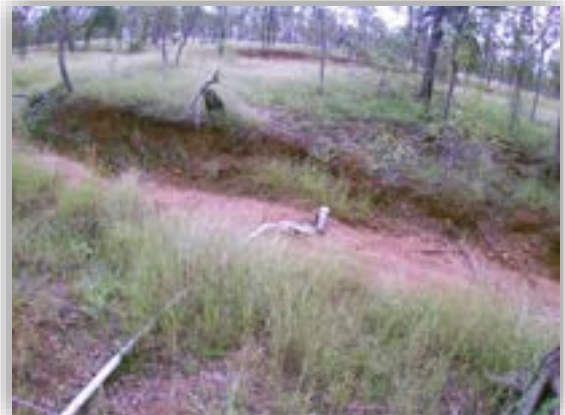
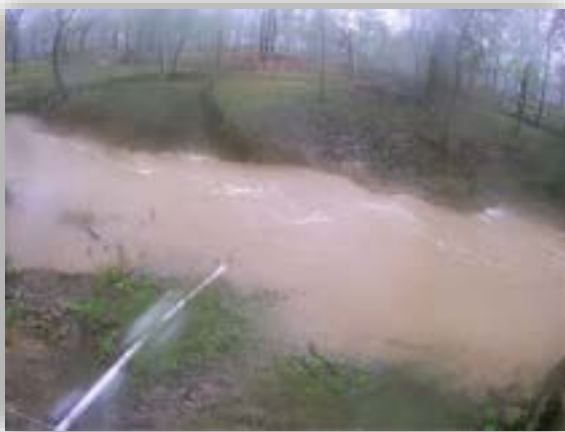
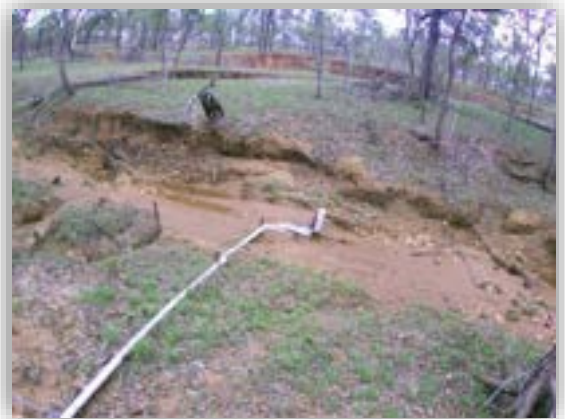
**Figure 40: Treatment gully at MinnieVale in (A) 2016 (B) during an event in 2017 (C) in April 2017 and (D) at the end of reporting period in April 2018 (E) during an event in Dec 2018 and (F) after the event in December 2018.**

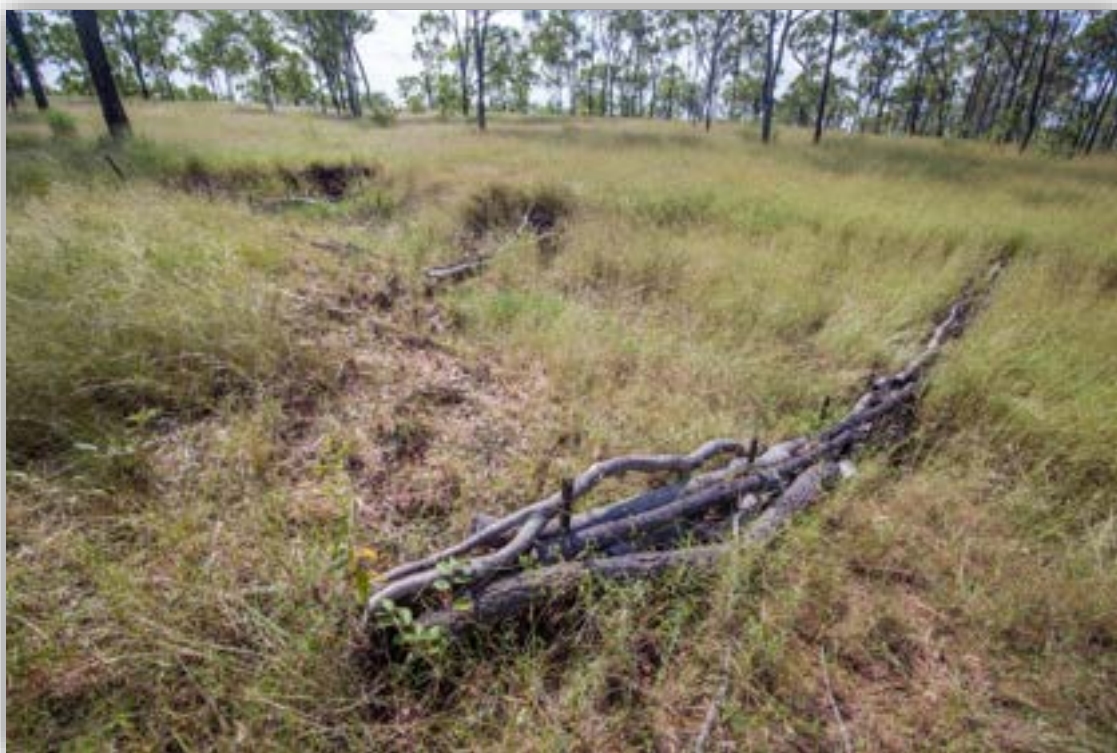
Figure 41: Increased biomass at the Minnievale treatment site in 2018/19

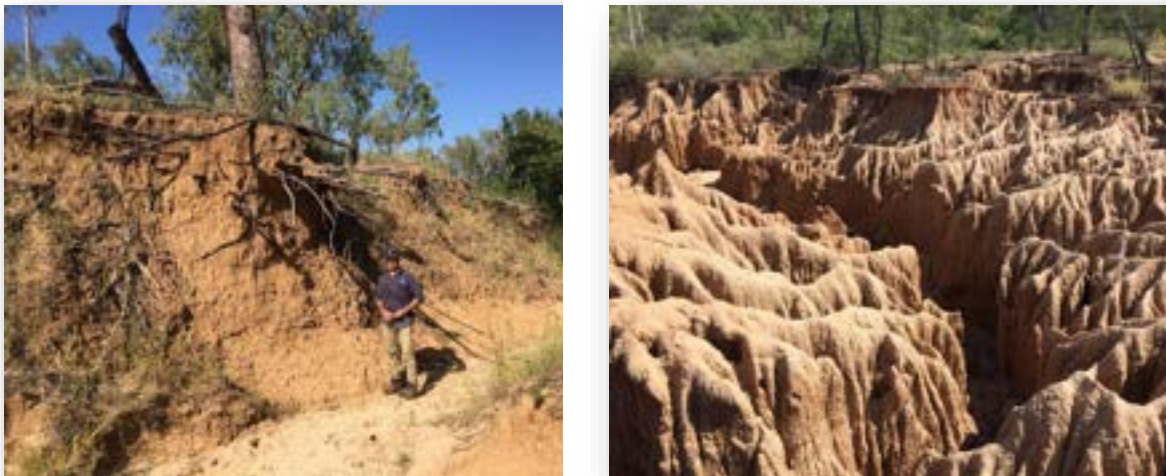
**Figure 47: (left) Single channel gully and (right) highly sodic soil resulting in Badlands or alluvial gully formation. Both gully types are found on Mt Wickham Station.**

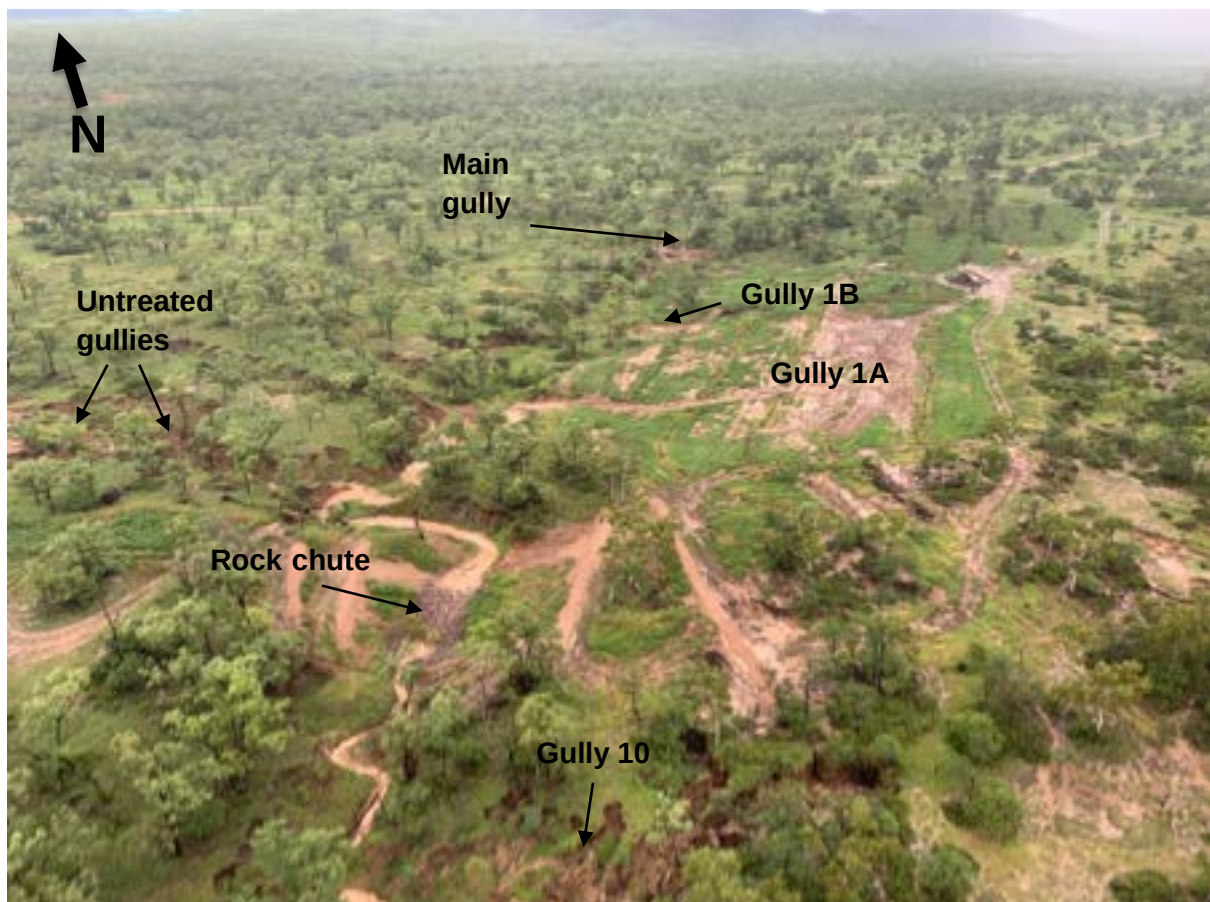
Figure 49: Image taken during sample collection for the January/February rainfall event (Photo credit: Damon Telfer). Note the area under the gully 1A text with little vegetation as a result of works to repair holes and tunnel erosion following the heavy rainfall in July (Source: NQ Dry Tropics)

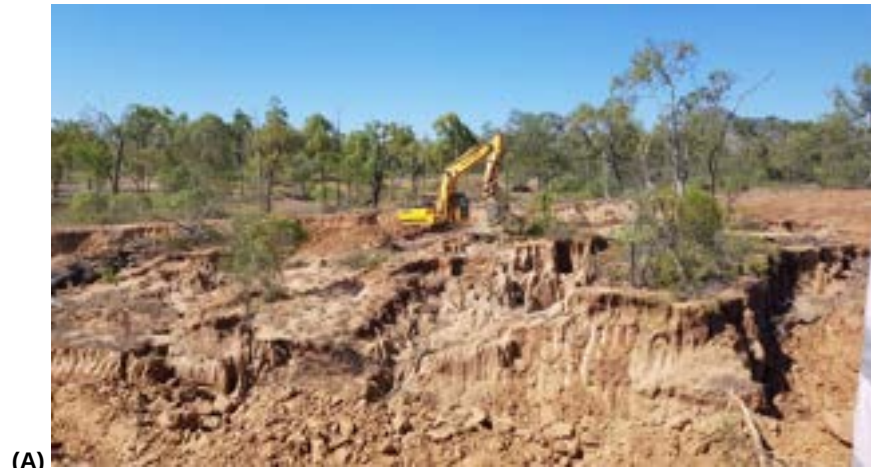
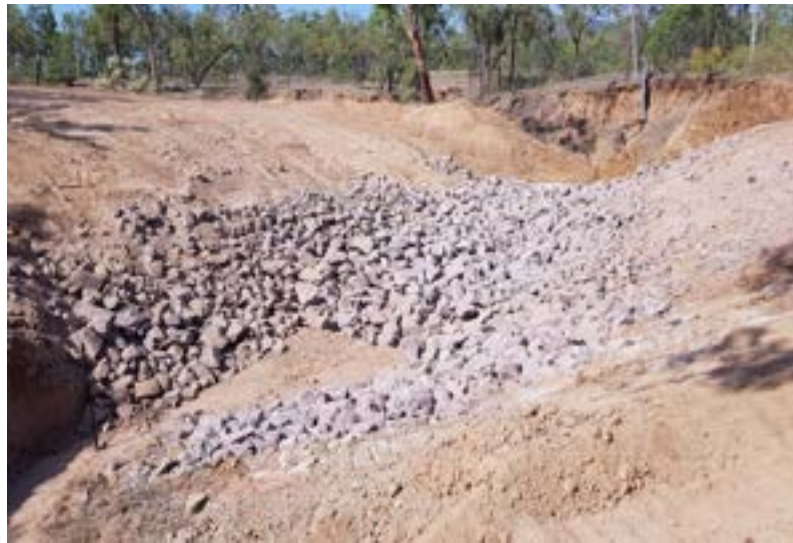
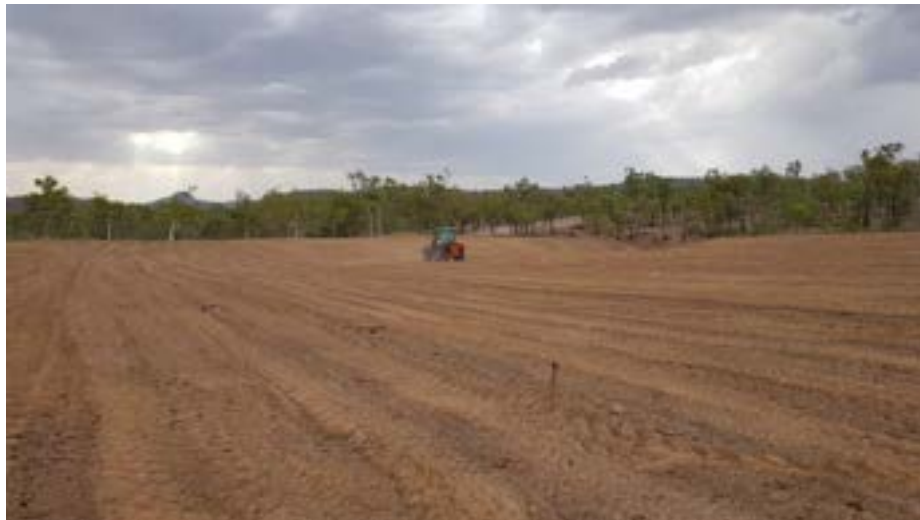
**Figure 50: (A) Gully 1A during excavation, looking across the gully towards Blue Valley Road (B) Rock chute 5 looking upstream in the main gully; (C) Gully 1A being ripped with harrows. Looking towards the outlet (Source: NQ Dry Tropics).**

The remediation of the treatment site commenced on the 22<sup>nd</sup> of October 2018 following the site plan completed by Verterra and Alluvium consulting services (Figure 48). The remediation plan involves a combination of grade control rock chutes, re-contouring of the badland area, soil amelioration using a range of chemical treatments and revegetation using a range of pasture and legume species (Figure 50). Phase II of the on-ground works is planned for the beginning of the dry season in 2019. Further works will include remediation of the untreated gullies on the western side of the main gully channel. Involving excavating, reshaping, ameliorating and construction of rock chutes. Images of the control and treatment water quality monitoring equipment before, during and after events in the 2018/19 wet season are shown in Figure 52.
