# **Quantifying the effectiveness of gully rehabilitation on water quality: results from demonstration sites in the Burdekin catchment**

Rebecca Bartley, Aaron Hawdon, Anne Henderson, Brett Abbott,  
Scott Wilkinson, Nick Goodwin, Kahlytah Ahwang

Supported by the Australian Government's National Environmental Science Program  
Project 5.9 Gully remediation effectiveness  
and the Landholders Driving Change Program (LRP17 - 003 and LME17- 009)

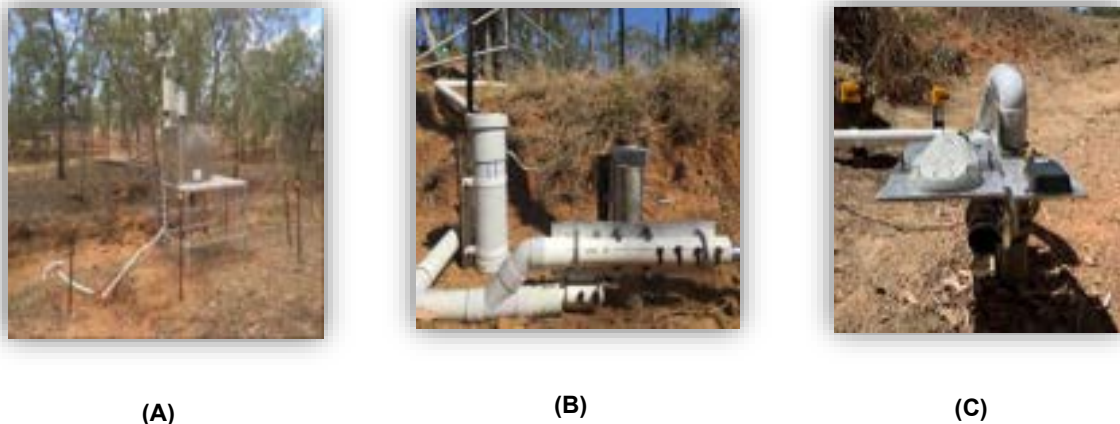
**Figure 4: (A) Example of a treatment gully set up using an ISCO sampling system (B) example of a control gully set up including rising stage samplers (RSS) and (C) example of LDC instrumentation configuration with two velocity sensors.**

- **Wet season 2 (2017/18):** given the modelling didn't work, low cost (~\$2k each) Unidata Starflow QSD ultrasonic doppler sensors were installed above the turbidity sensor at each site in 2017. The sensor measures the velocity of particles or bubbles in the water (presumed to be the same velocity as the water) using the doppler shift between transmitted and received ultrasonic signals. The sensors are mounted facing downstream to reduce the impact of particles damaging the sensor face and debris build up on measurement. Unfortunately, the manufacturer supplied settings didn't provide measured water velocity in natural environments and no data were collected that season. The sensors required reconfiguration from factory default settings to capture data in gully systems.

- **Wet season 3 (2018/19):** the settings in the velocity sensors were corrected and velocity data was collected from 9 out of 10 NESP sites (the only site without velocity data didn't flow). However, the quality of the data was highly variable between sites and the load estimates had high uncertainty.
- **Wet season 4 – (2019/20):** The same Starflow ultrasonic Doppler velocity sensors (~\$2k) were installed at the LDC sites. In addition, six (~\$7k, research grade) acoustic Doppler Sontek IQ sensors were purchased using CSIRO and project funds to calibrate and test the Starflow sensors. These were installed beside the Starflow sensors at Mt Wickham, Mt Pleasant and Glen Bowen prior to the start of the wet season (Figure 4C). A comparison of the results from the different sensors are presented below, and recommendations for future velocity sampling discussed.

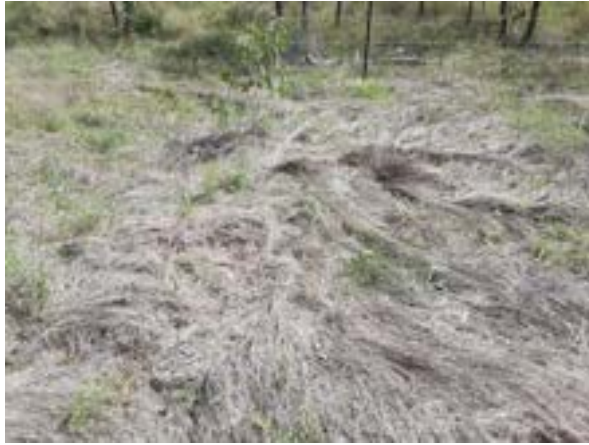
**Figure 6: Example of *Bothriochloa pertusa* (Indian couch) die-back observed at most properties.**

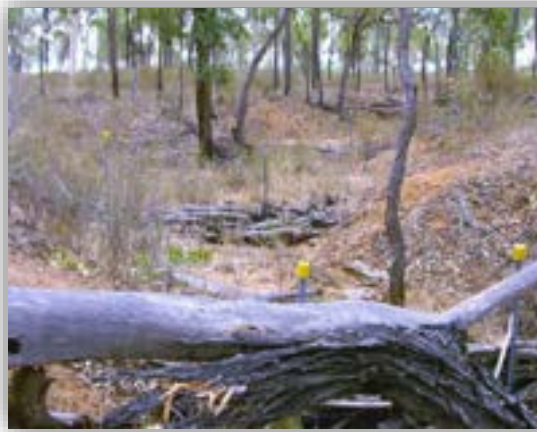
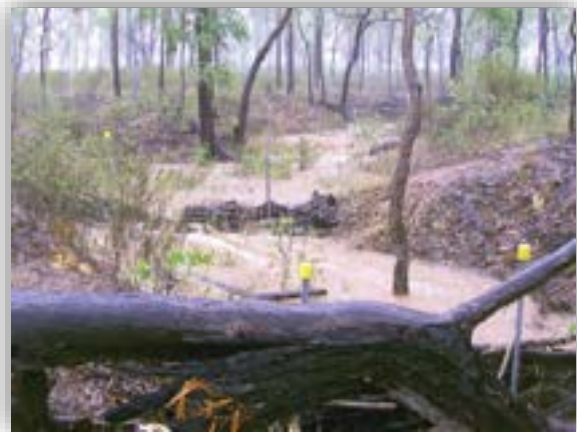
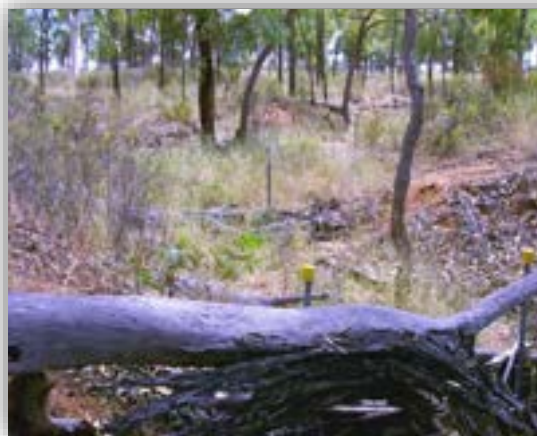
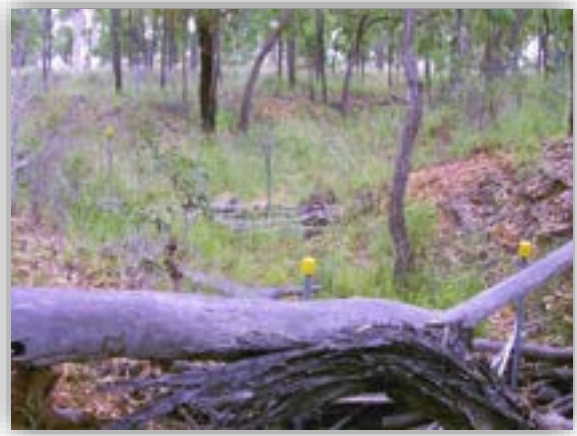
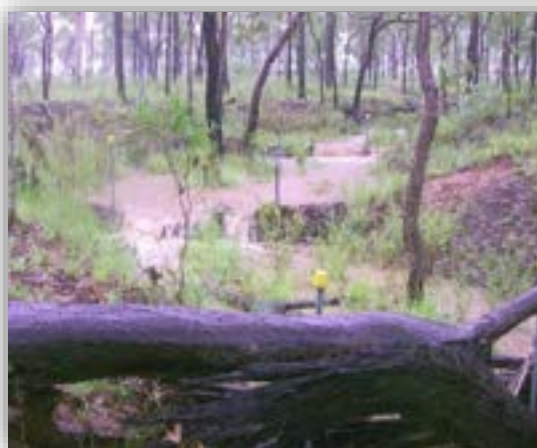
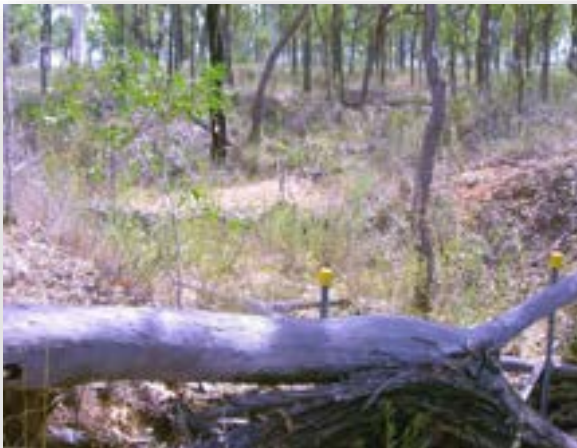
**Figure 18: Treatment gully at Virginia Park in (A) 2016 (B) during an event in 2017 (C) at the end of reporting period in April 2017 (D) in April 2018 (E) during an event in 2019 and (F) at the end of April 2020**

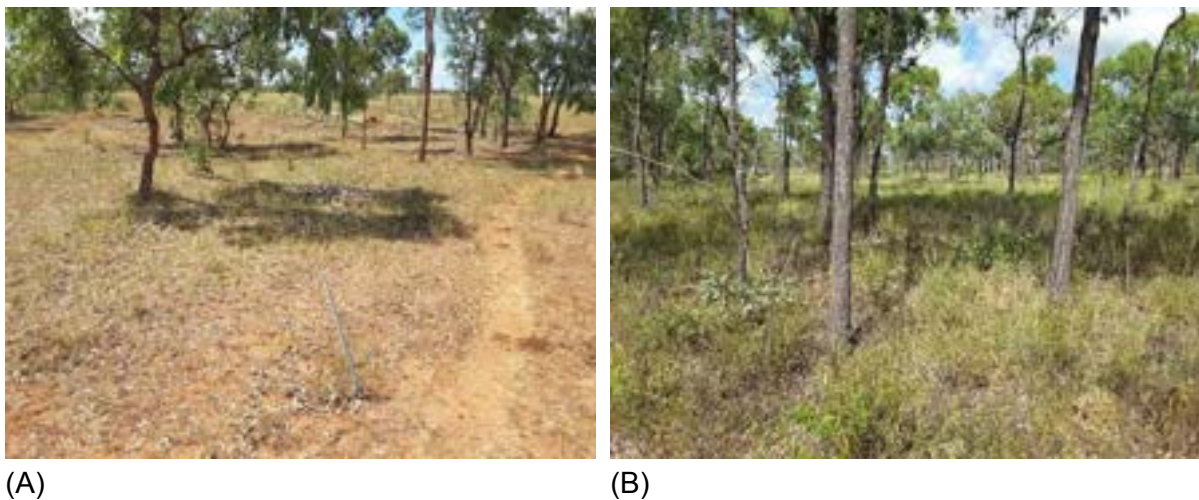
**Figure 19: Virginia Park hillslope above (A) control gully and (B) the treatment gully hillslope which has a partial cattle exclusion fence.**

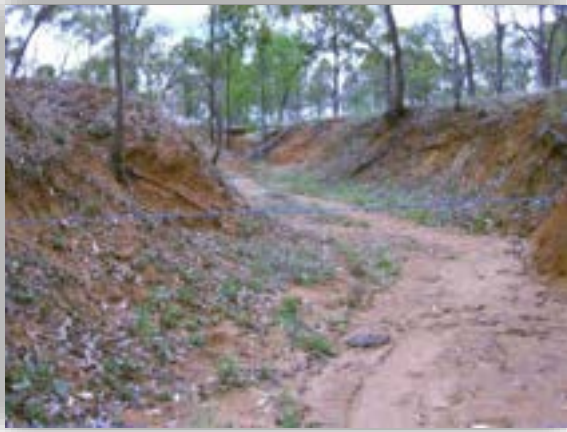
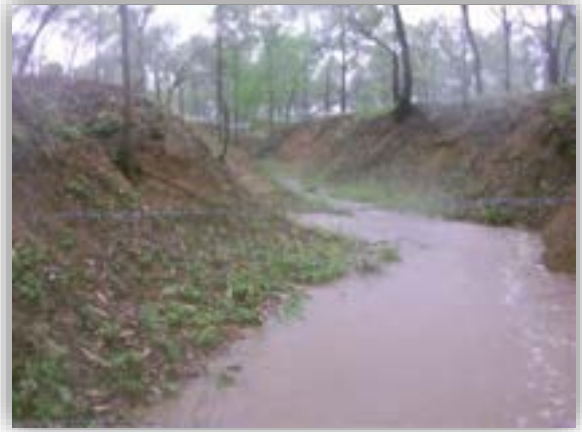
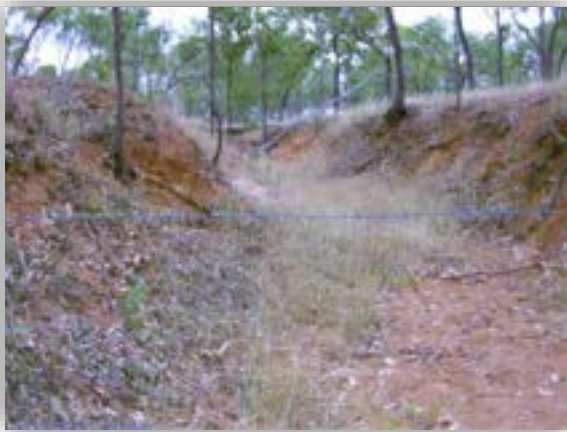
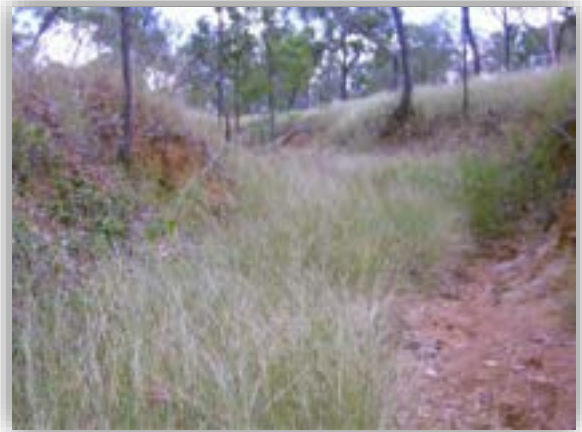
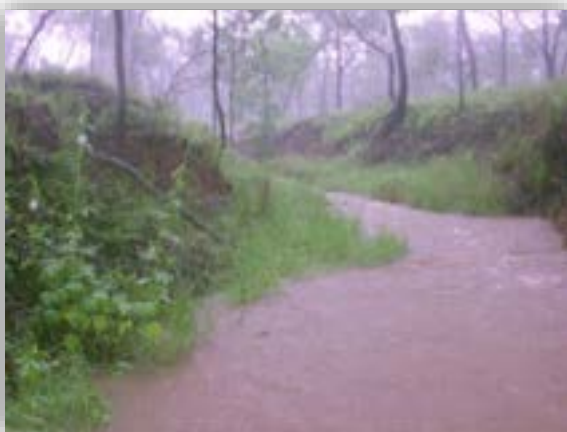
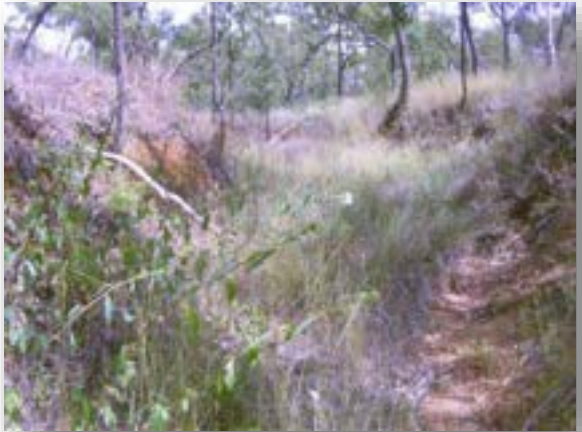
**Figure 26: Treatment gully at Meadowvale in (A) 2016 (B) during an event in 2017 (C) at the end of reporting period in April 2017 (D) at the end of reporting period in April 2018 (E) an event in 2019 and (F) at the end of wet season, April 2020**

The control gully at Meadowvale has been monitored over 20 years (1999 – 2020) using erosion pins, topographic survey techniques and vegetation transects. Figure 26 shows the field sites at Meadowvale under different flow event and dry conditions over the last three wet seasons. The improved grass cover in the channel or floor on the treatment gully is visible over the three-year monitoring period.

Figure 28 presents the end of wet season % cover and biomass data for the hillslope above the control and treatment gully at Meadowvale as well as the gully walls and gully floor. The results demonstrate that there has been a significant increase in hillslope % cover ( $p < 0.001$ ) and biomass ( $p < 0.001$ ) at the treatment site in 2019/20. There is a significant difference in the end of wet (EOW) % cover ( $p = 0.001$ ) and biomass ( $p = 0.009$ ) on the gully floor in 2019/20. There has also been a significant change in % cover ( $p = 0.001$ ) and biomass ( $p = 0.009$ ) on the gully walls during the 2019/20 wet season. The % cover on the gully floor and walls has increased from ~20% at the beginning of the trial (with no fencing) to ~80% in 2019/20 after just three years of cattle stock exclusion. The dramatic change in within gully condition is shown in Figure 26.

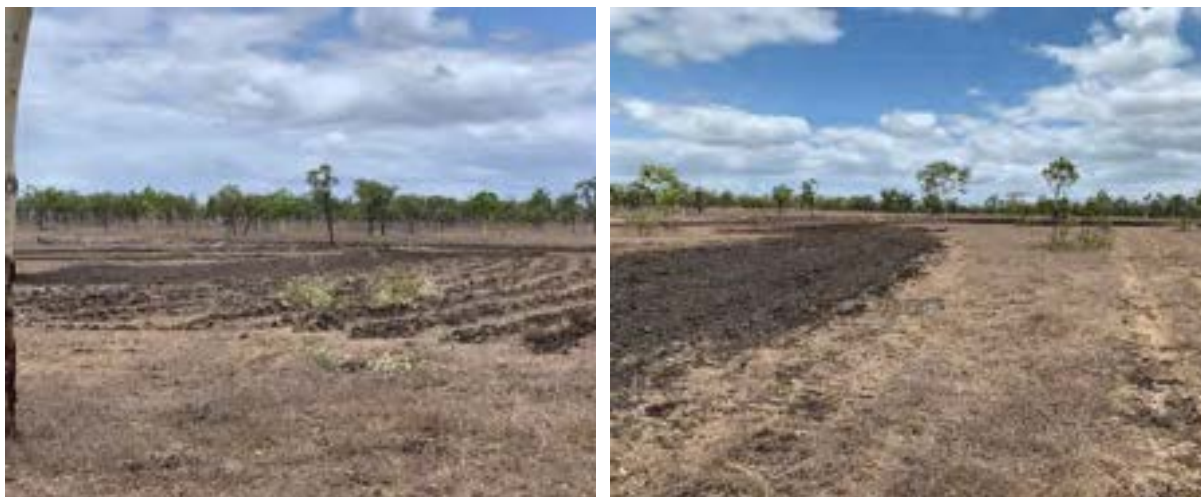
**Figure 33: Hillslope rehabilitation in progress at Strathbogie Treatment gully hillslope**

The interventions involved four main activities: (1) hillslope diversion banks, (2) rock revetment on a gully side headcut (3) pasture ripping (using a yeoman's plough) (Figure 33) and (4) permanent 3-barb fencing around the paddock containing both the control and treatment gullies. On the hillslopes above the treatment gully ~5 diversion banks were installed (Figure 34 and Figure 35). Three of the larger diversion banks were above the secondary channel incision (Figure 35A). Two of the smaller diversion banks were directly above the main headcut on the gully (Figure 35B). Two of the diversion banks also had drains located along the diversion bank. In addition to the diversion banks, there were several small rock chutes which were used to treat some of the gully side wall extensions (Figure 35C). The areas above the diversion banks underwent pasture ripping to increase runoff infiltration (Figure 33 and Figure 35D). The entire paddock, containing both the control and treatment gully has also been re-fenced for grazing management, although no specific grazing management strategies had been implemented during the 2019/20 wet season.

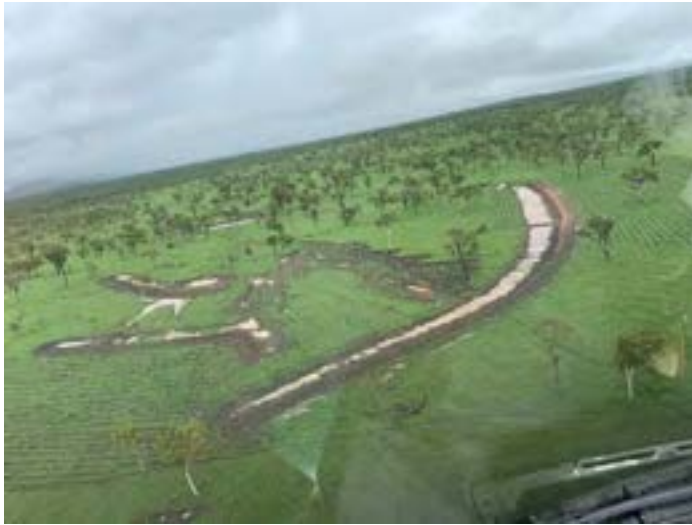
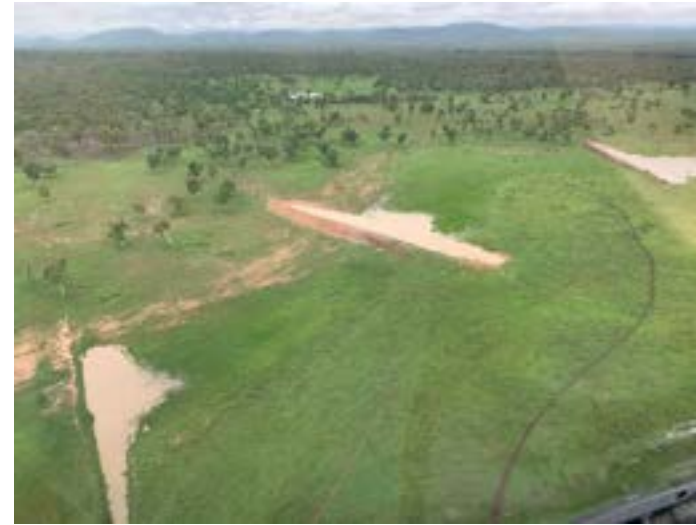
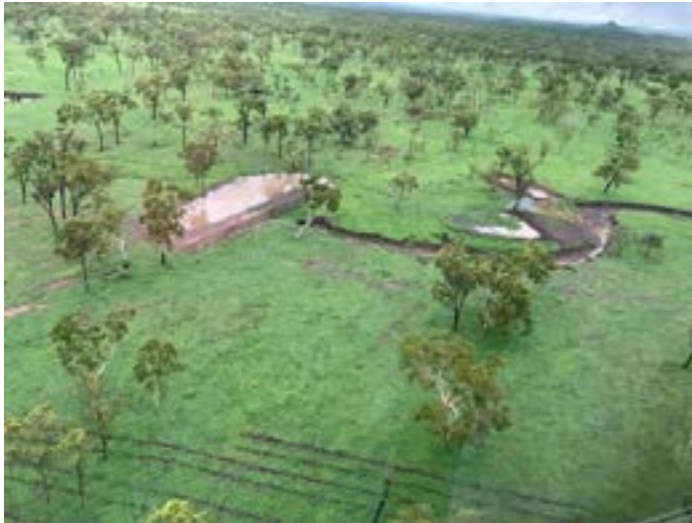
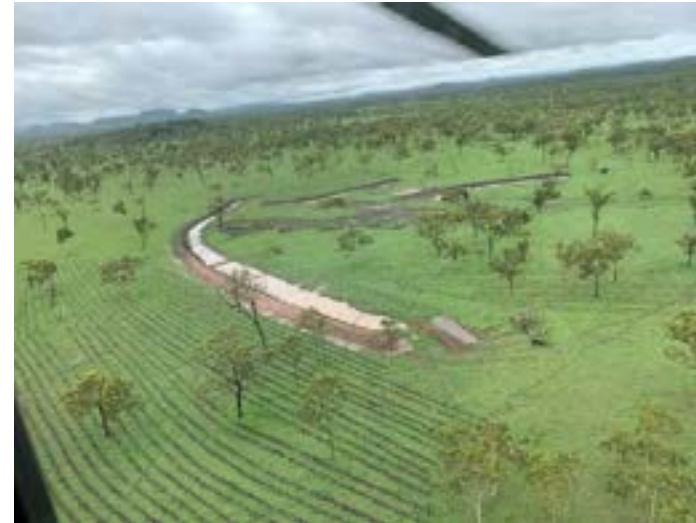
**Figure 35: Images of the rehabilitation site at the Strathbogie Treatment gully taken during the 2019/20 wet season (Photos: Fruition Environmental)..**

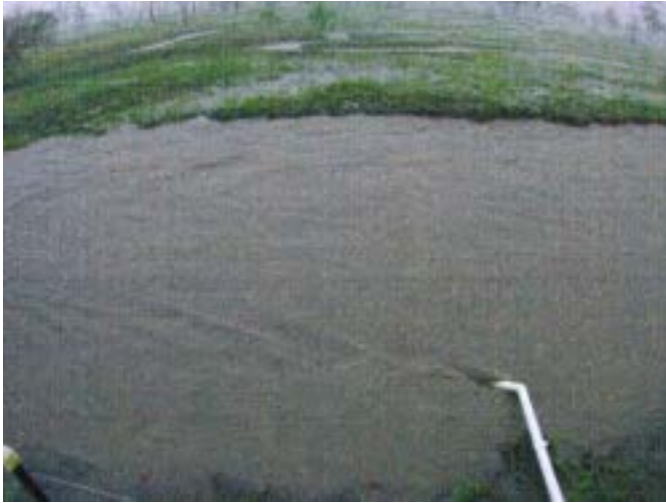
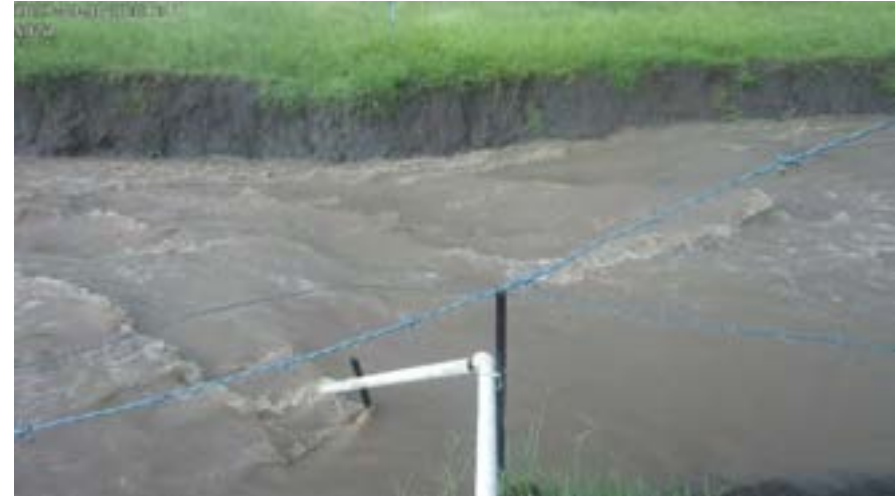
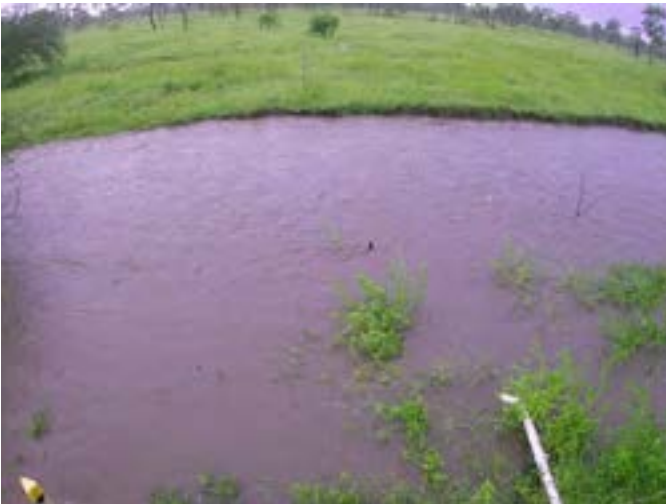
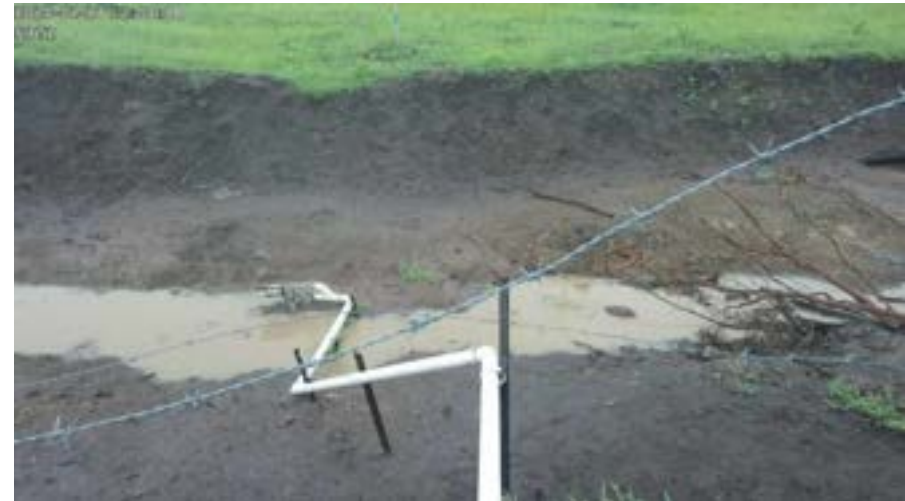
(A) Control site peak event in 2018/19

(B) Treatment site peak event in 2018/19

(C) Control site peak event in 2019/20

(D) Treatment site peak event in 2019/20

**Figure 43: The site web cam captured peak flow events at both the control and treatment sites during the 2018/19 wet season prior to the rehabilitation, and during the peak event in the 2019/20 wet season, which is the first year after rehabilitation.**

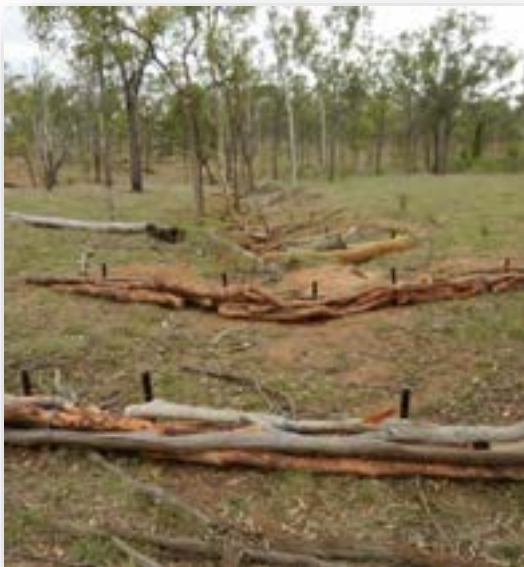
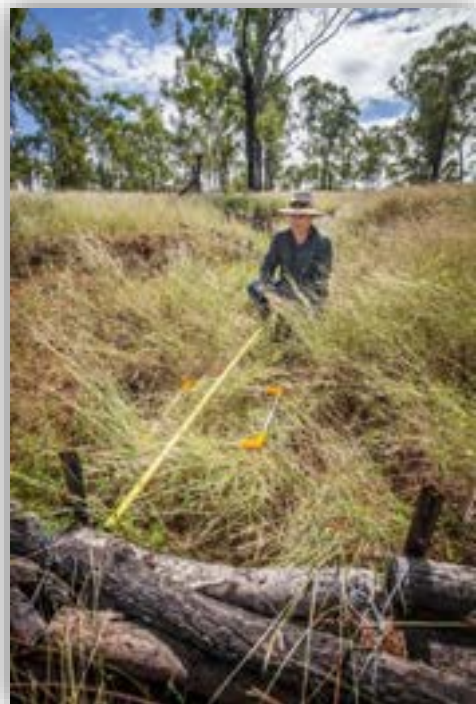
**Figure 44: (A) Example of the stick traps installed at Minnievale station and (B) measurements of the vegetation cover and biomass behind the stick traps at this site in April 2019.**

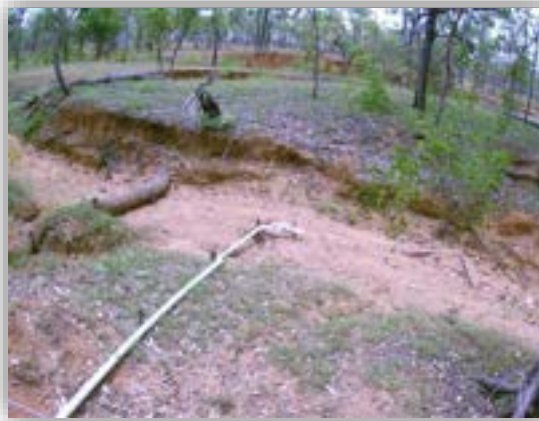
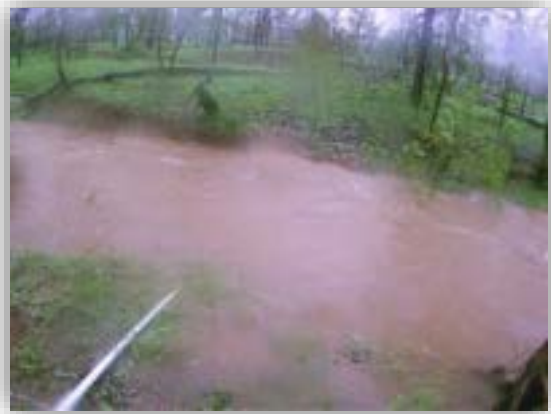
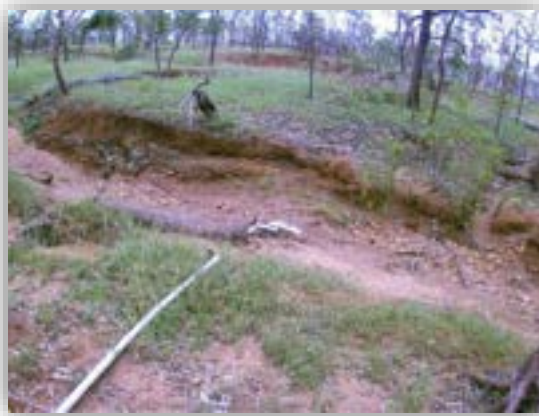
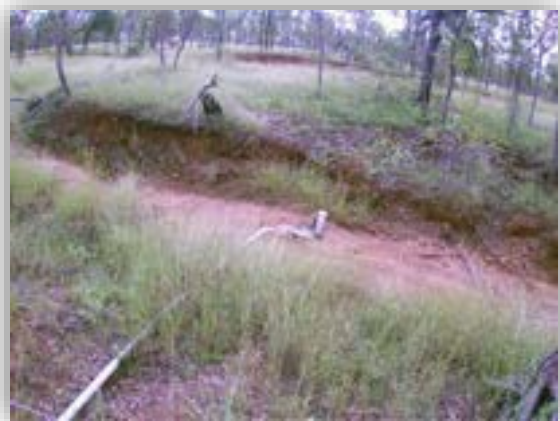
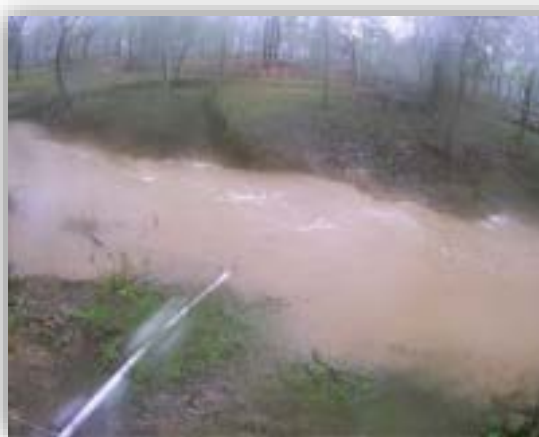
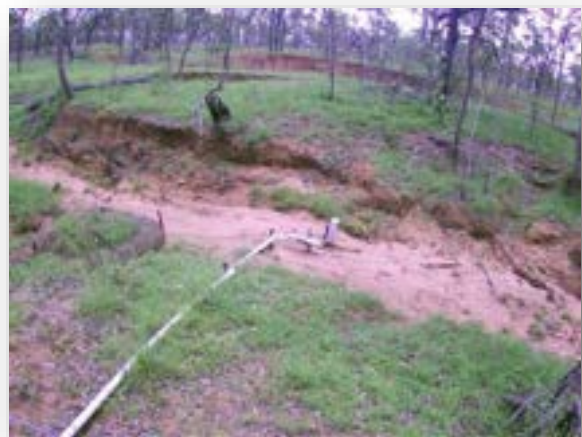
**Figure 46: Treatment gully at MinnieVale in (A) 2016 (B) during an event in 2017 (C) in April 2017 and (D) at the end of reporting period in April 2018 (E) during an event in Dec 2018 and (F) after the event in 2019.**

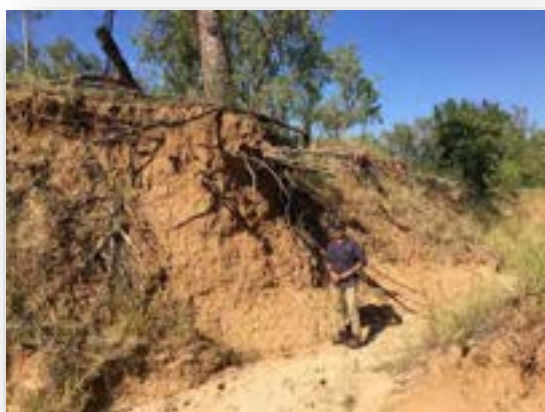
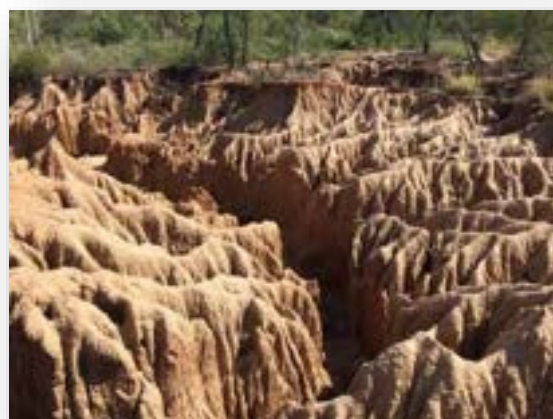
**Figure 53: (A) Single channel gully at the Mt Wickham site and (B) highly sodic soil resulting in Badlands or alluvial gully formation on the upper surfaces of the Mt Wickham site.**

Mt Wickham was added to the study site in 2018. This site is a combination of linear and alluvial gully formations on highly sodic soils that drain into Sandalwood Creek and then into the Bowen River (Figure 53).

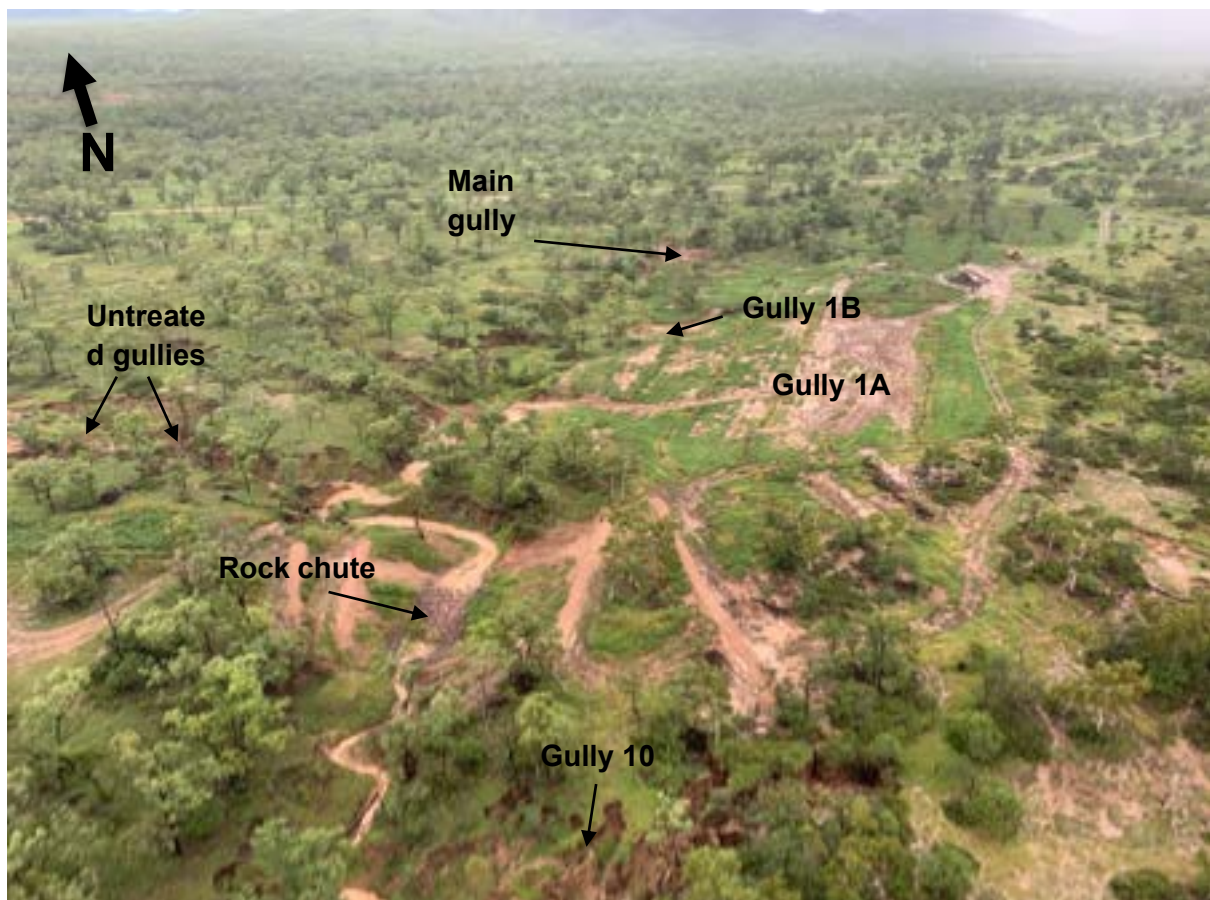
Figure 55: Image taken during sample collection for the January/February rainfall event (Photo credit: Damon Telfer). Note the area under the gully 1A text with little vegetation as a result of works to repair holes and tunnel erosion following the heavy rainfall in July (Source: NQ Dry Tropics)

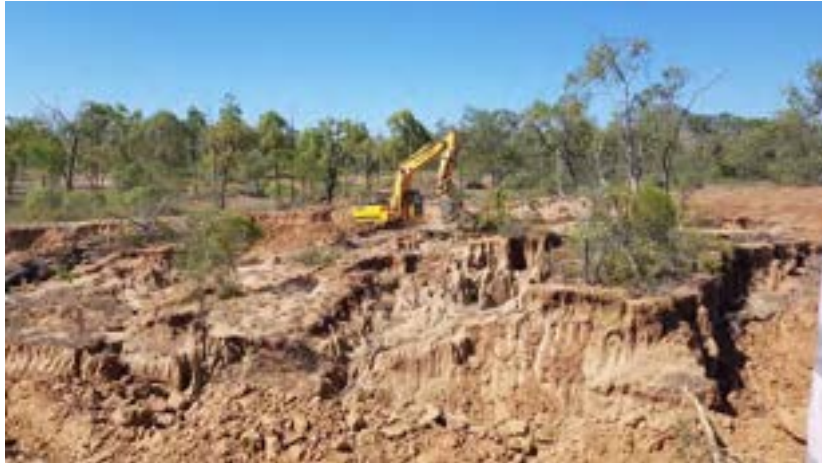
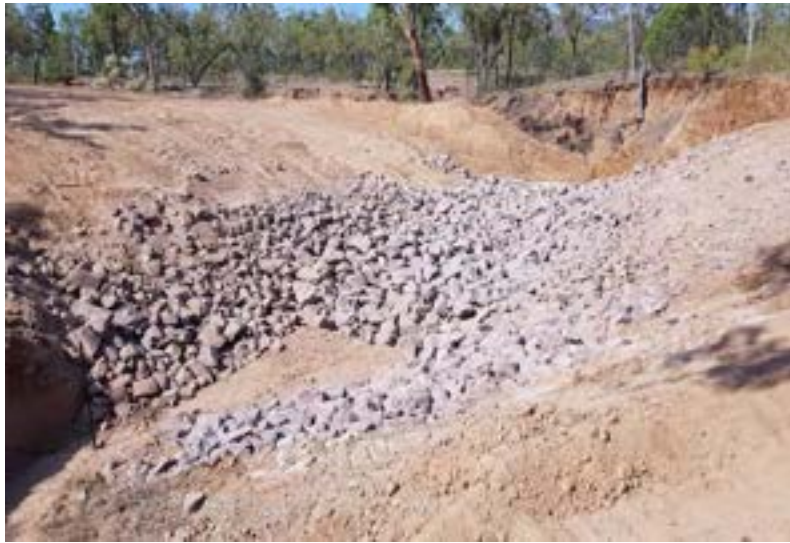
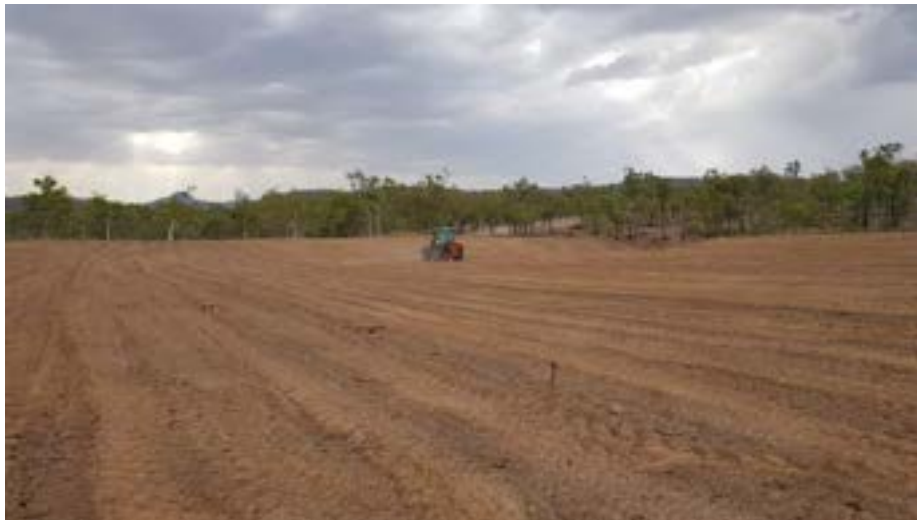
**Figure 56: (A) Gully 1A during excavation, looking across the gully towards Blue Valley Road (B) Rock chute 5 looking upstream in the main gully; (C) Gully 1A being ripped with harrows. Looking towards the outlet (Source: NQ Dry Tropics).**

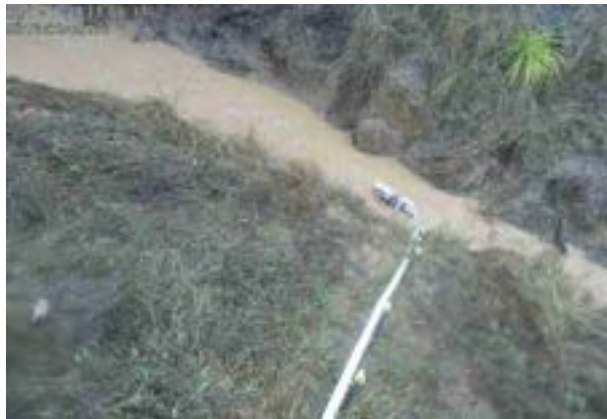
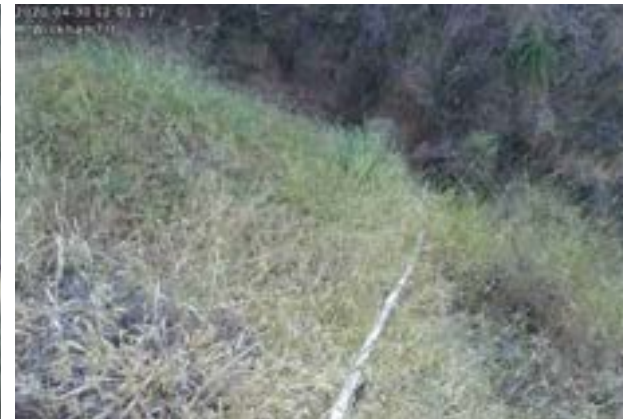
**Figure 58: Mt Wickham Control gully (A) before (B) during an event in Jan 2020 and (C) April 2020. Mt Wickham Treatment gully (A) before (B) during and event in Jan 2020 and (C) April 2020.**

The water quality monitoring equipment was installed on 21<sup>st</sup> February 2018, and the pre-treatment pasture and biomass surveys were initiated in August 2018. The rehabilitation of the treatment site commenced on the 22<sup>nd</sup> of October 2018 following the site plan completed by Verterra and Alluvium consulting services (Figure 54). The rehabilitation plan involved a combination of grade control rock chutes, re-contouring of the extensively eroded gully surface (Figure 53B; Figure 56), soil amelioration using a range of chemical treatments and revegetation using a range of pasture and legume species (see Appendix C). Phase II of the on-ground works were undertaken at the beginning of the dry season in 2019, but they are not part of this evaluation. Images of the control and treatment water quality monitoring equipment before, during and after events in the 2019/20 wet season are shown in Figure 58.

Despite the significant improvements in vegetation at the treatment site relative to the control, the low rainfall in 2019/20 meant that much of the vegetation (at both treatment and control sites) was drought affected by April 2020. Much of the Rhodes grass had disappeared, and there was an increase in legumes (*Desmanthus*) which had grown and started shading out other grasses. Although the vegetation recovery has been significant at Mt Wickham, it is still a fragile response that is vulnerable to low rainfall conditions and grazing.

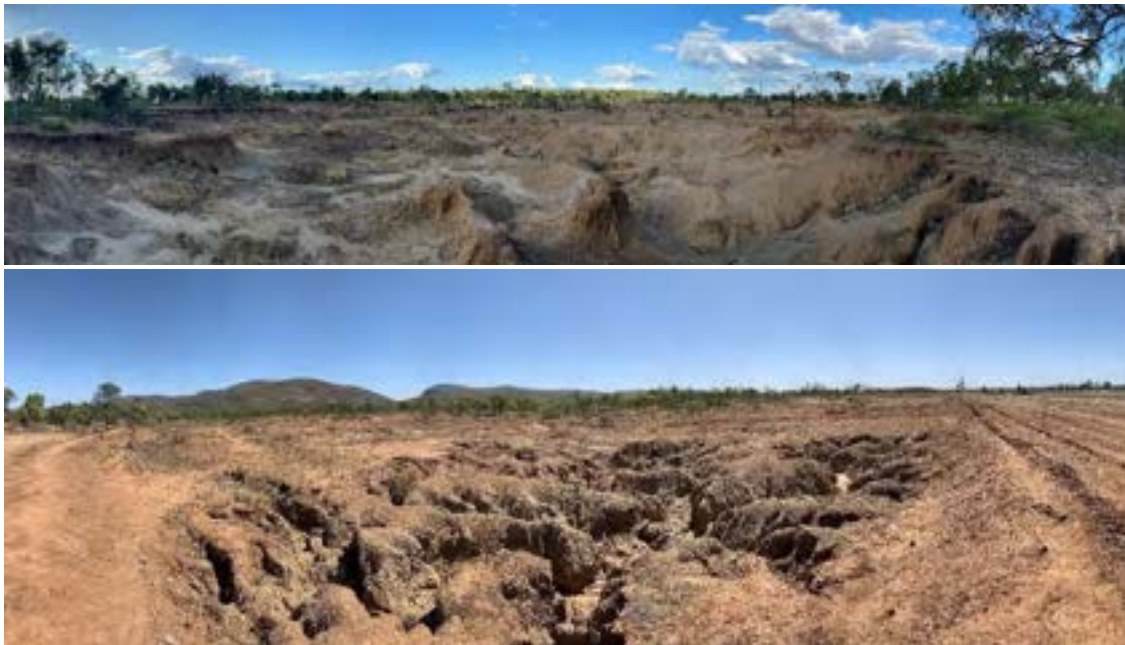
**Figure 64: Glen Bowen control (above) and treatment (below) sites prior to rehabilitation**

The location of the water quality monitoring sites, land condition and terrain analysis surveys are shown on Figure 66. The water quality monitoring equipment was installed in early November 2019, and the terrain, pasture and biomass surveys were conducted in early Dec for the pre-wet analysis and April 2020 for the post-wet analysis. Noting that there was no pre-wet vegetation survey conducted on the treatment gully as rehabilitation had already been initiated before the field data could be collected. However, it is safe to assume that the land condition and cover metrics at the treatment gully were equivalent or similar to the control gully prior to rehabilitation (see Figure 64 and Figure 66).

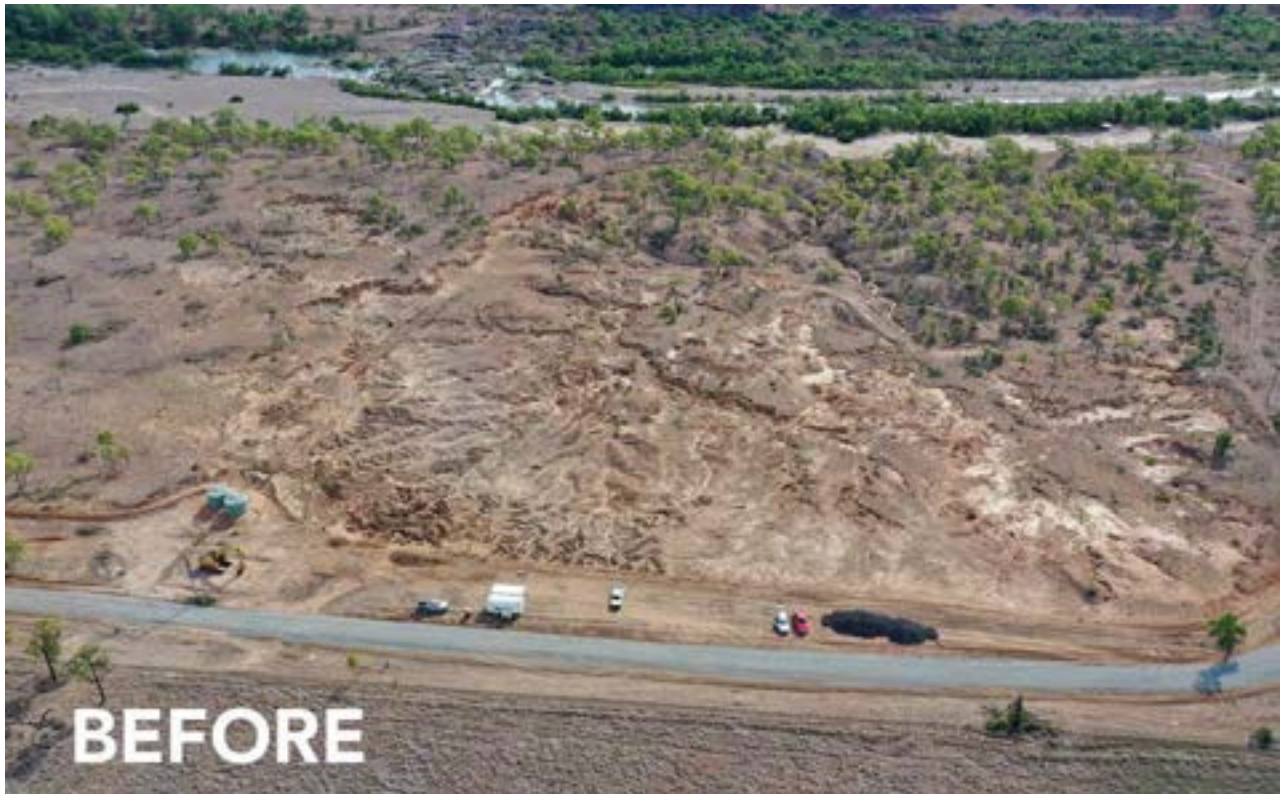
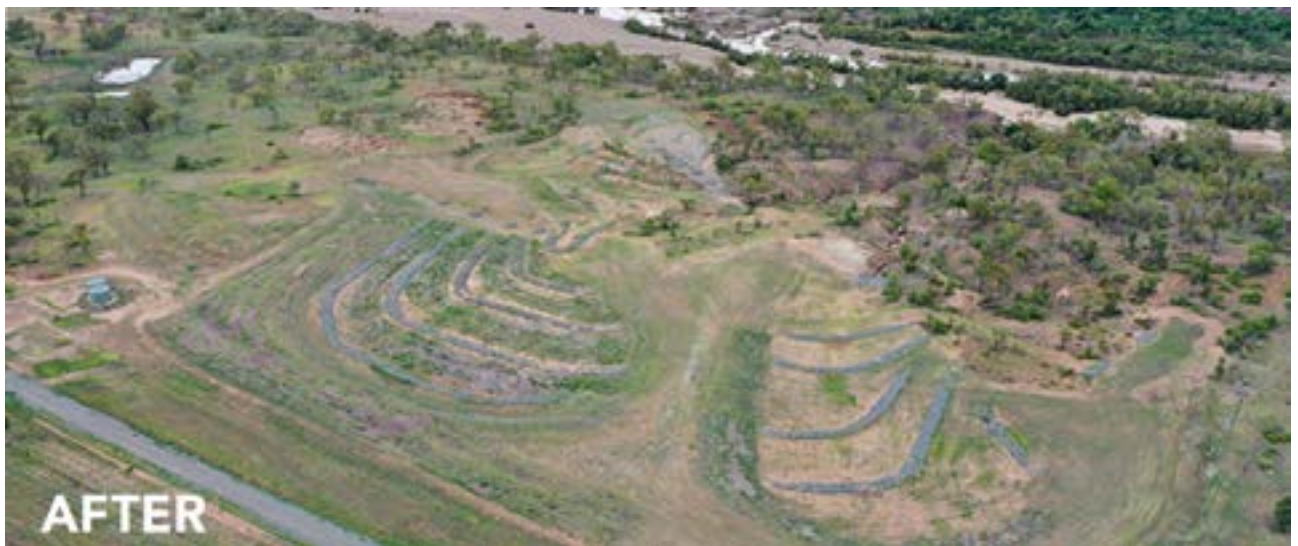
Figure 67: Before and after images of the Glen Bowen Treatment gully (Image source: NQ Dry Tropics)

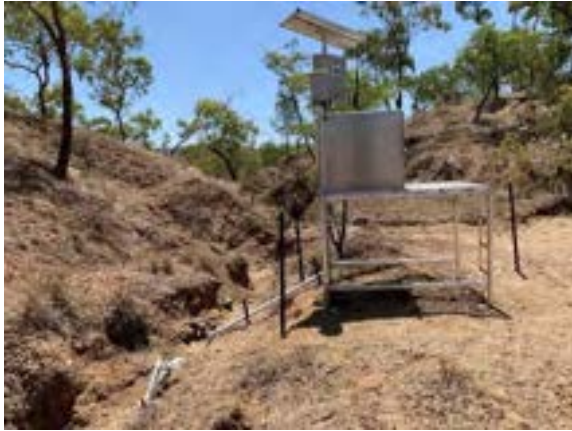
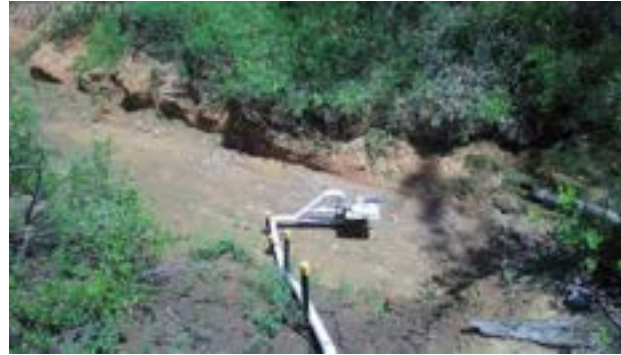
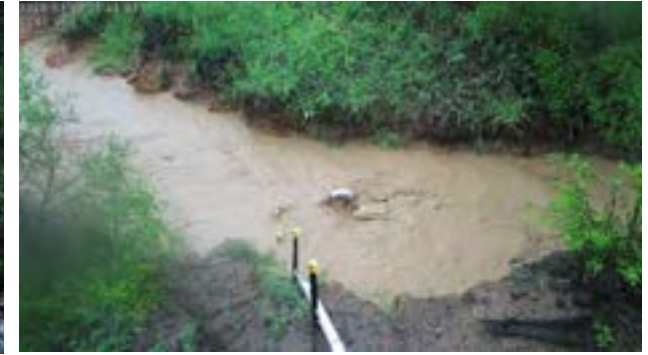
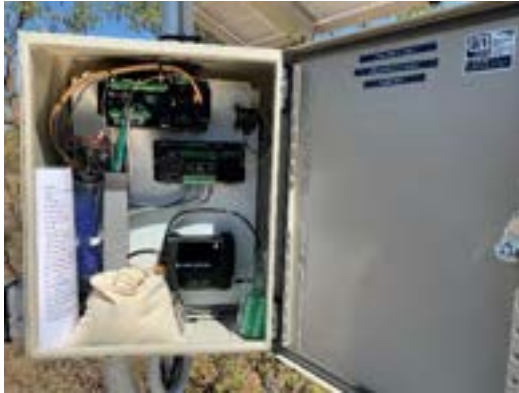
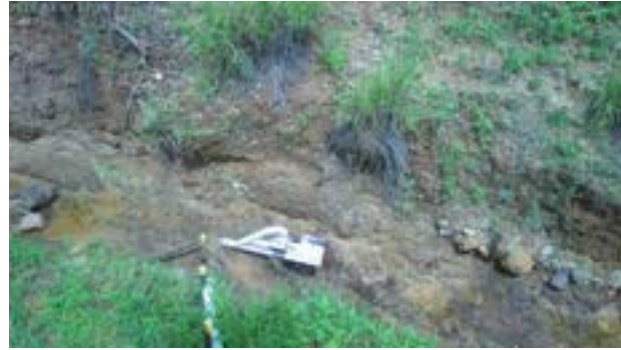
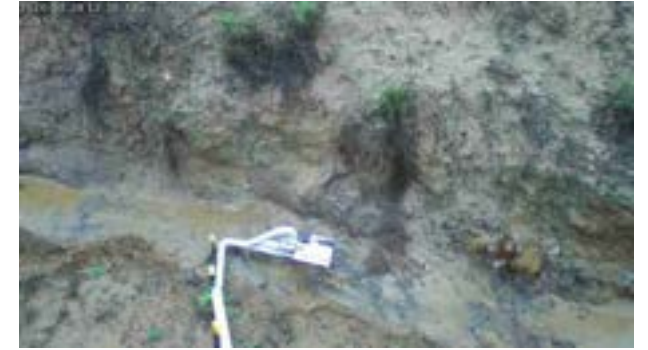
**Figure 68: Glen Bowen water quality monitoring station set up (A, D). The instrumentation setup is the same at both treatment and control sites (B) the control site sensor cluster on the bed of the gully and (C) the control site sensors during an event that was just above the event threshold for sample collection. (E) The treatment gully sensor and (F) is following a small runoff event at the treatment gully site. Note the difference in the colour of water between the control (C) and treatment sites (F).**

The location of the instrumentation was based on the pre-purchased cable length of 10 m for all instruments, the ability to safely install the instrumentation during earthworks, and to locate it in an area that would not undergo considerable backwater flow from the Bowen River in large events. The stream monitoring instrumentation at the treatment site captures about 2/3rds of the treated gully area. The bed of the treatment gully at the location of the monitoring station has reached bedrock or an older coarse sub-stratum (see Figure 68E). The bed of the control gully is predominantly clay and sand (Figure 68F).

Unlike the Mt Wickham site, no 'before' treatment water quality samples were collected prior to the rehabilitation treatment at Glen Bowen. Due to the relatively low rainfall over the 2019/20 wet season, and the impact of the rehabilitation works, no water quality samples were collected at the treatment gully in 2019/20. There were ~17 samples collected at the Glen Bowen control gully during 2019/20 wet season, however, there was insufficient rainfall and runoff to completely submerge the velocity sensors enough for measurement (Figure 68C) and therefore no discharge or loads calculations were possible at this site in 2019/20.

There was some flow recorded at the control site (see Figure 68C), and although some depth data was collected (Figure 62), this was not sufficient to submerge the velocity sensors

appropriately and no velocity data were collected at this site. Therefore, it was not appropriate to calculate discharge and loads for the 2019/20 wet season. The treatment site, which has a large catchment area, should have had the same amount or more runoff than the control site. However, other than very small flow (see Figure 68F), no runoff data or samples were collected from the treatment site.

Importantly, there is an obvious difference in the colour of water between the control (Figure 68C) and treatment sites (Figure 68F) during the only runoff event of the season. This suggests that the rehabilitation works have considerably reduced the runoff at this site, and subsequently they have also reduced the amount of soil being transported from the treatment gully into the Bowen River.

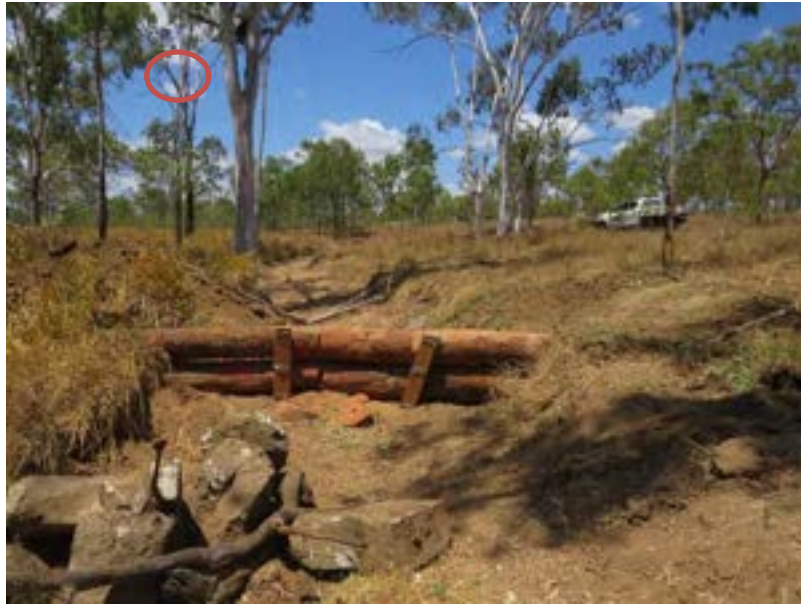
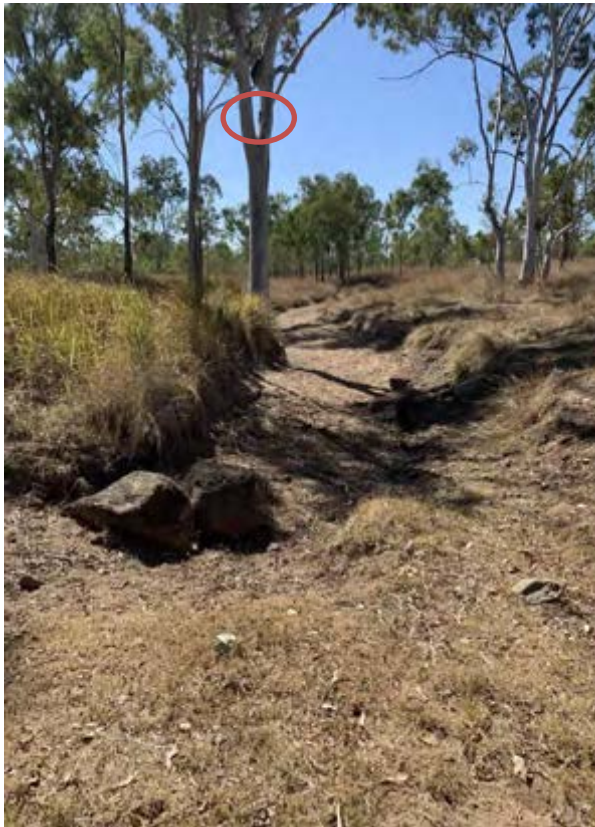
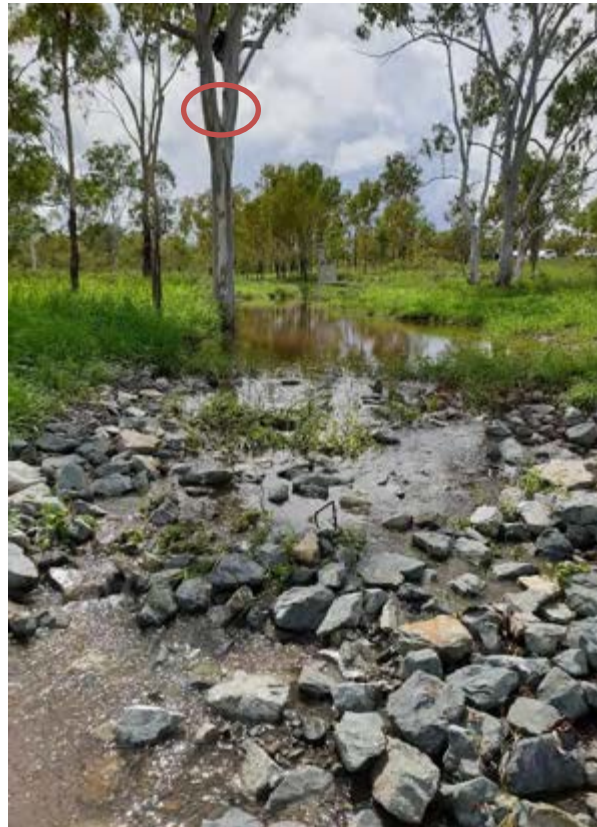
**Figure 77: Mt Pleasant (A) During (B) before and (C) after rehabilitation at the treatment site (MP1). Photo (C) is after ~100 mm of rain in late February 2020. The CSIRO water quality monitoring station can be seen in the background of photo (C). (Image Source: NQ Dry Tropics)**

The rehabilitation works on Mt Pleasant were designed by the Mulloon Institute and included a series of log and rock weirs to slow down the water and create a backwater or ponding environment within the treatment gully (Mulloon Consulting, 2019). The specific location of the rehabilitation structures are shown in Figure 76, and a series of before and after photos from site #1 and #2 are shown in Figure 77 and Figure 78.
