# **Quantifying the effectiveness of gully rehabilitation on water quality: results from demonstration sites in the Burdekin catchment**

Rebecca Bartley, Aaron Hawdon, Anne Henderson, Brett Abbott,  
Scott Wilkinson, Nick Goodwin, Kahlytah Ahwang

Supported by the Australian Government's National Environmental Science Program  
Project 5.9 Gully remediation effectiveness  
and the Landholders Driving Change Program (LRP17 - 003 and LME17- 009)

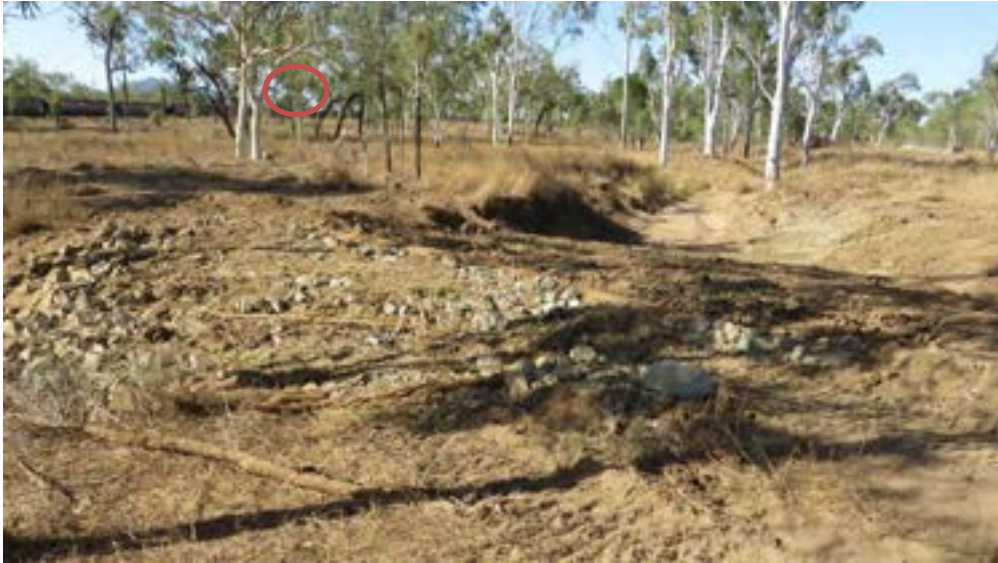
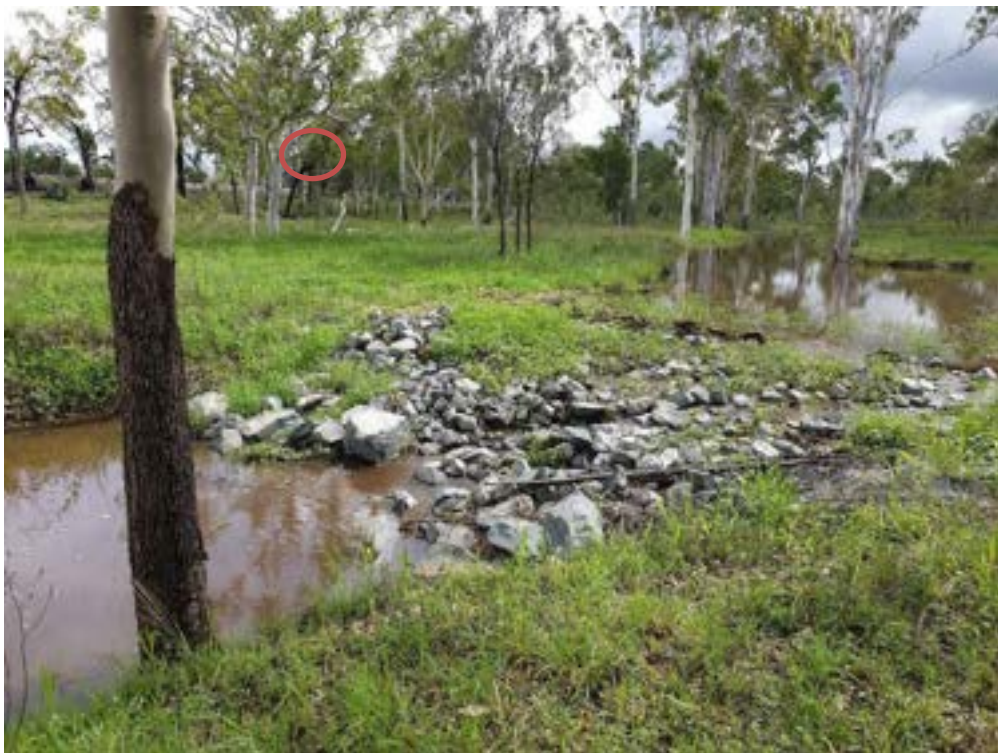
**Figure 78: Mt Pleasant treatment site (MP2) (A) immediately after remediation but prior to rainfall and (B) after ~100 mm of rain in late February 2020 (Image Source: NQ Dry Tropics).**

The rehabilitation works on Mt Pleasant were designed by the Mulloon Institute and included a series of log and rock weirs to slow down the water and create a backwater or ponding environment within the treatment gully (Mulloon Consulting, 2019). The specific location of the rehabilitation structures are shown in Figure 76, and a series of before and after photos from site #1 and #2 are shown in Figure 77 and Figure 78.

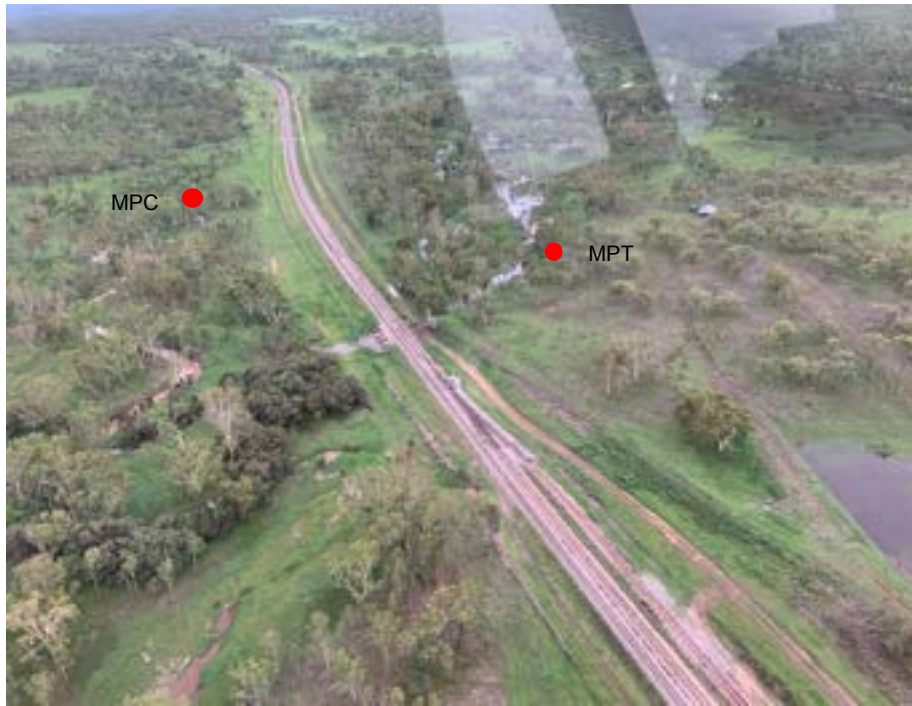
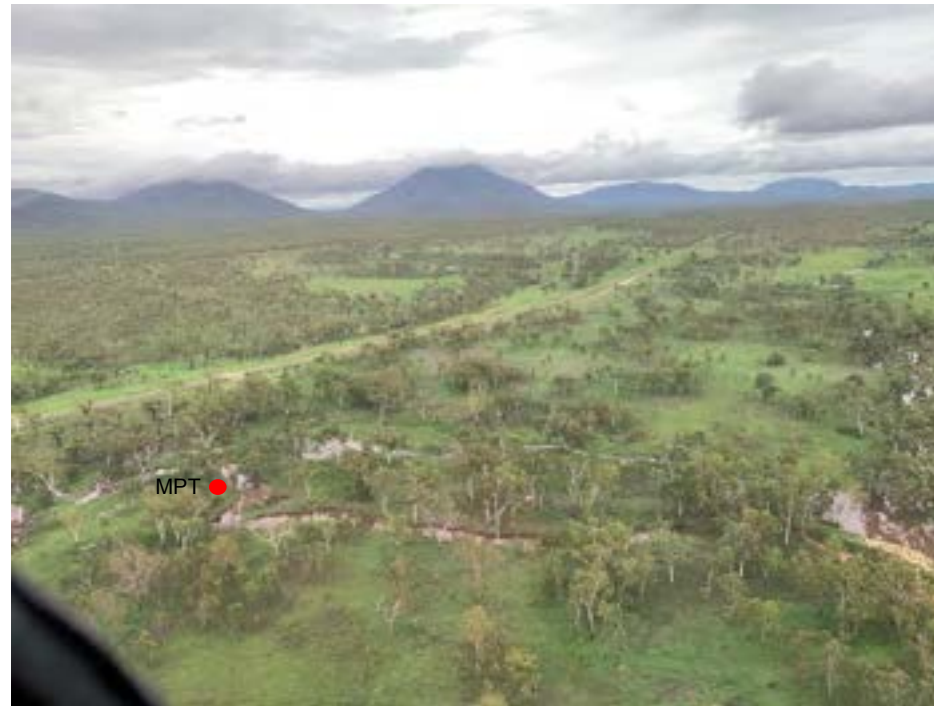
**Figure 79: (A) aerial photo from helicopter of the control gully (left) and the treatment gully on the right of the image; (B) the treatment gully backing up behind the rehabilitation structures (Photo credit: Fruition Environmental). Red dots show the approximate location of the water quality monitoring equipment at Mt Pleasant (Image Source: Fruition Environmental).**

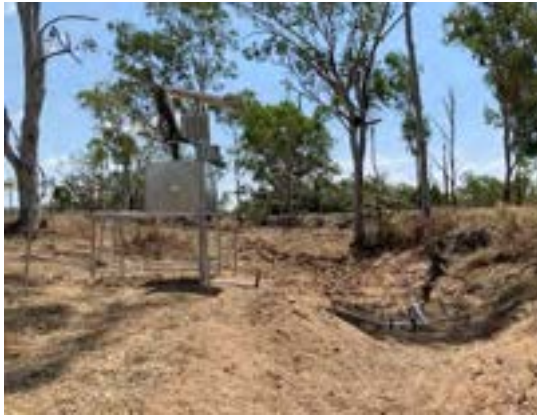
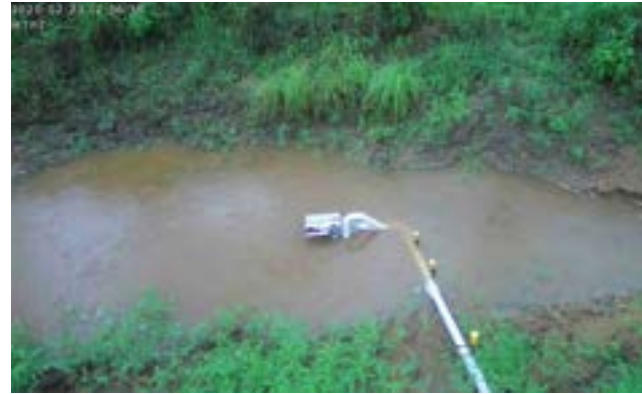
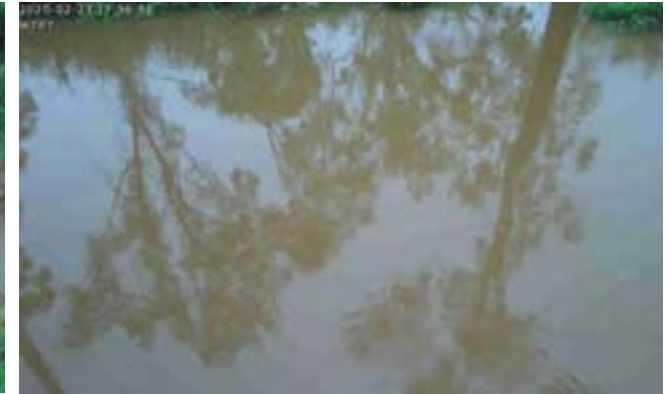
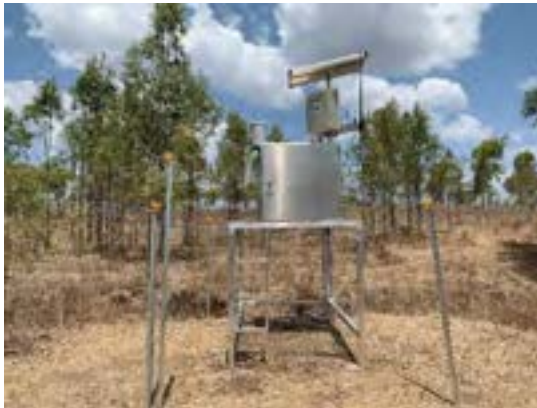
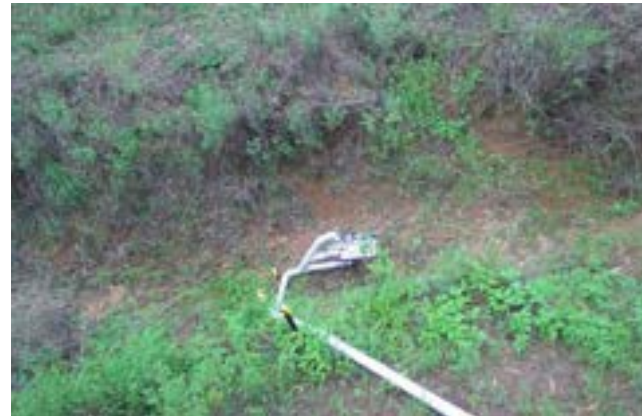
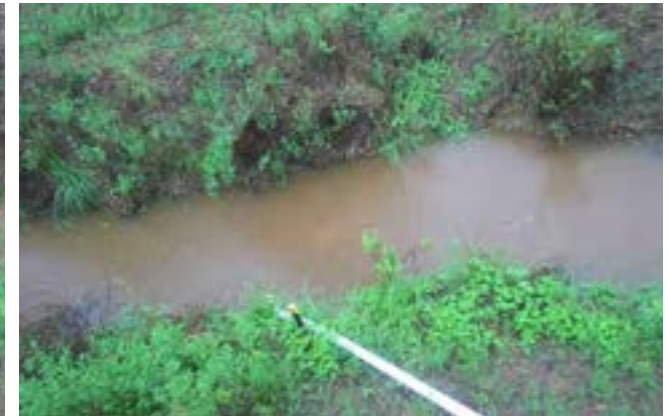
**Figure 80: Mt Pleasant Treatment gully site setup (A and D). The same system was set up at the control site. The treatment site (B) at the beginning of an event; and (C) during an event. The Control site (E) before an event and (F) during an event.**

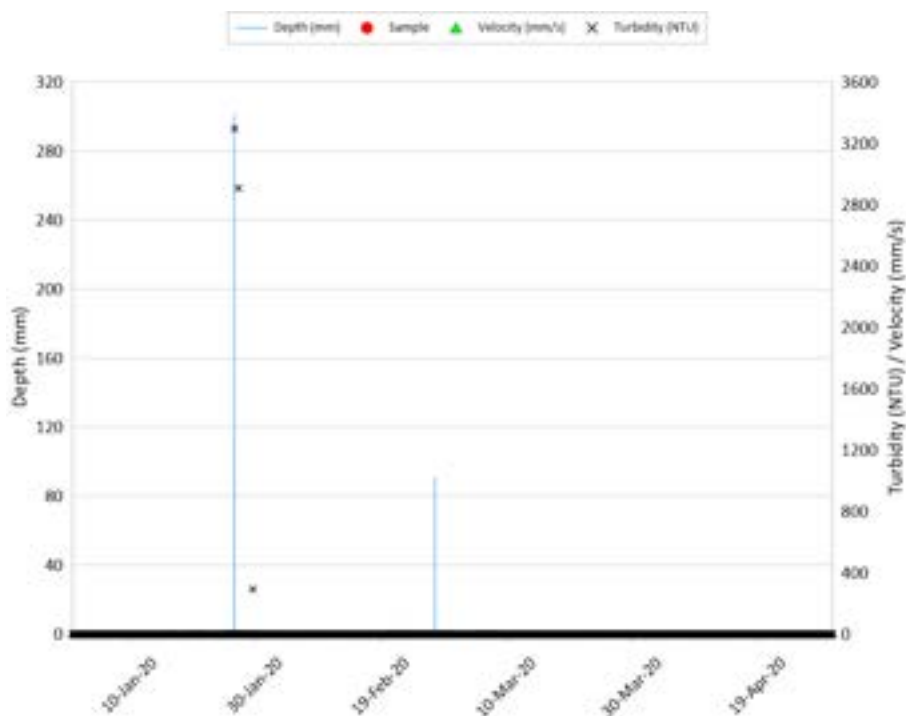
Figure 87: Virginia Park Control gully runoff, turbidity, velocity and sample points on the hydrograph.  
Event threshold = 300 mm.

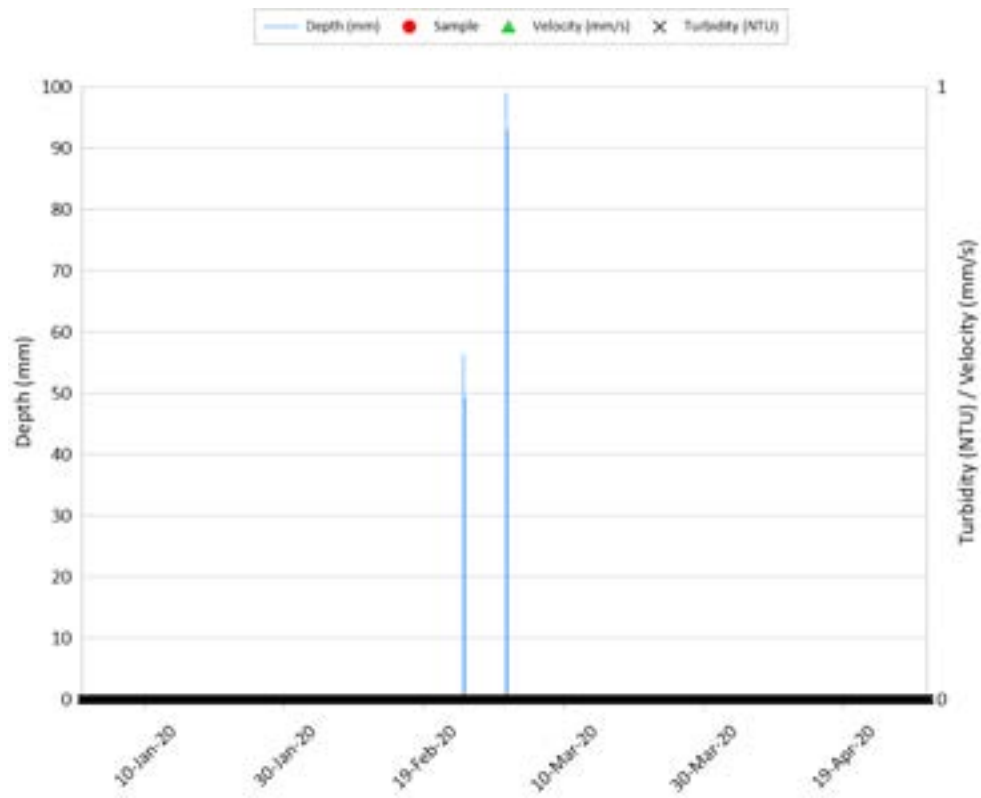
Figure 90: Strathbogie Treatment (SBT2) gully runoff, turbidity and sample points on the hydrograph. Event threshold = 120 mm.
