Highway Overpass Evaluation of Effectiveness: Kuranda Range Road Upgrade Project

Miriam Goosem, Robyn Wilson, Nigel Weston and Martin Cohen

School of Earth and Environmental Sciences
James Cook University, Cairns

July 2008

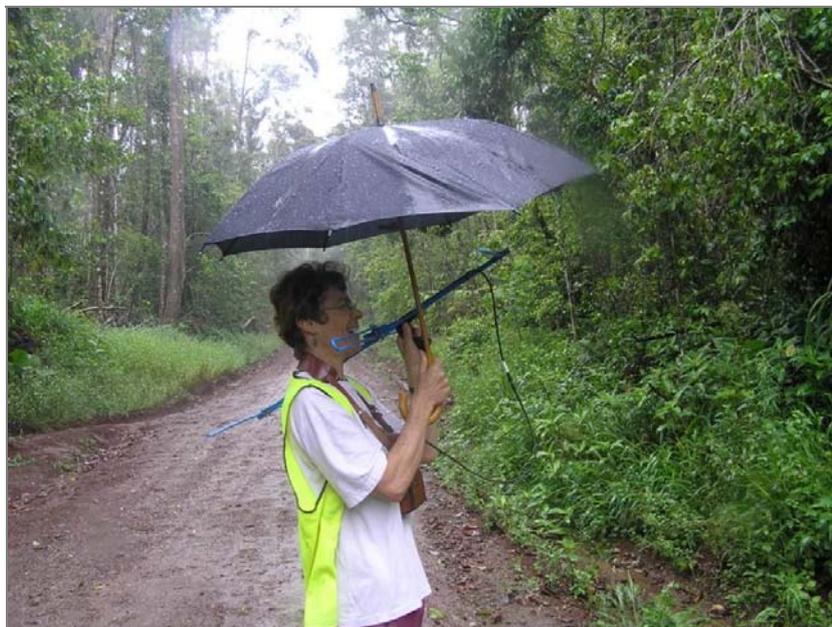
Figure 1.6 Daytime radio-tracking for possum den sites. Photo courtesy of Miriam Goosem.

Possum movements were monitored one or two nights a week using a Telonics hand-held radio-receiver and a three element Yagi antenna (Titley Electronics Inc., Australia). A maximum of two fixes were taken in a night with all observations at least 2 hr apart to reduce the risk of autocorrelation (Swihart and Slade 1985). When located the date, time, position (side of road, distance from road into forest, distance along road from a permanent marker) and group size was recorded and an attempt was made to sight the animal. Radio-collared animals were also tracked in the day in order to locate dens, record the side of the road and their proximity to the highway and overpasses.

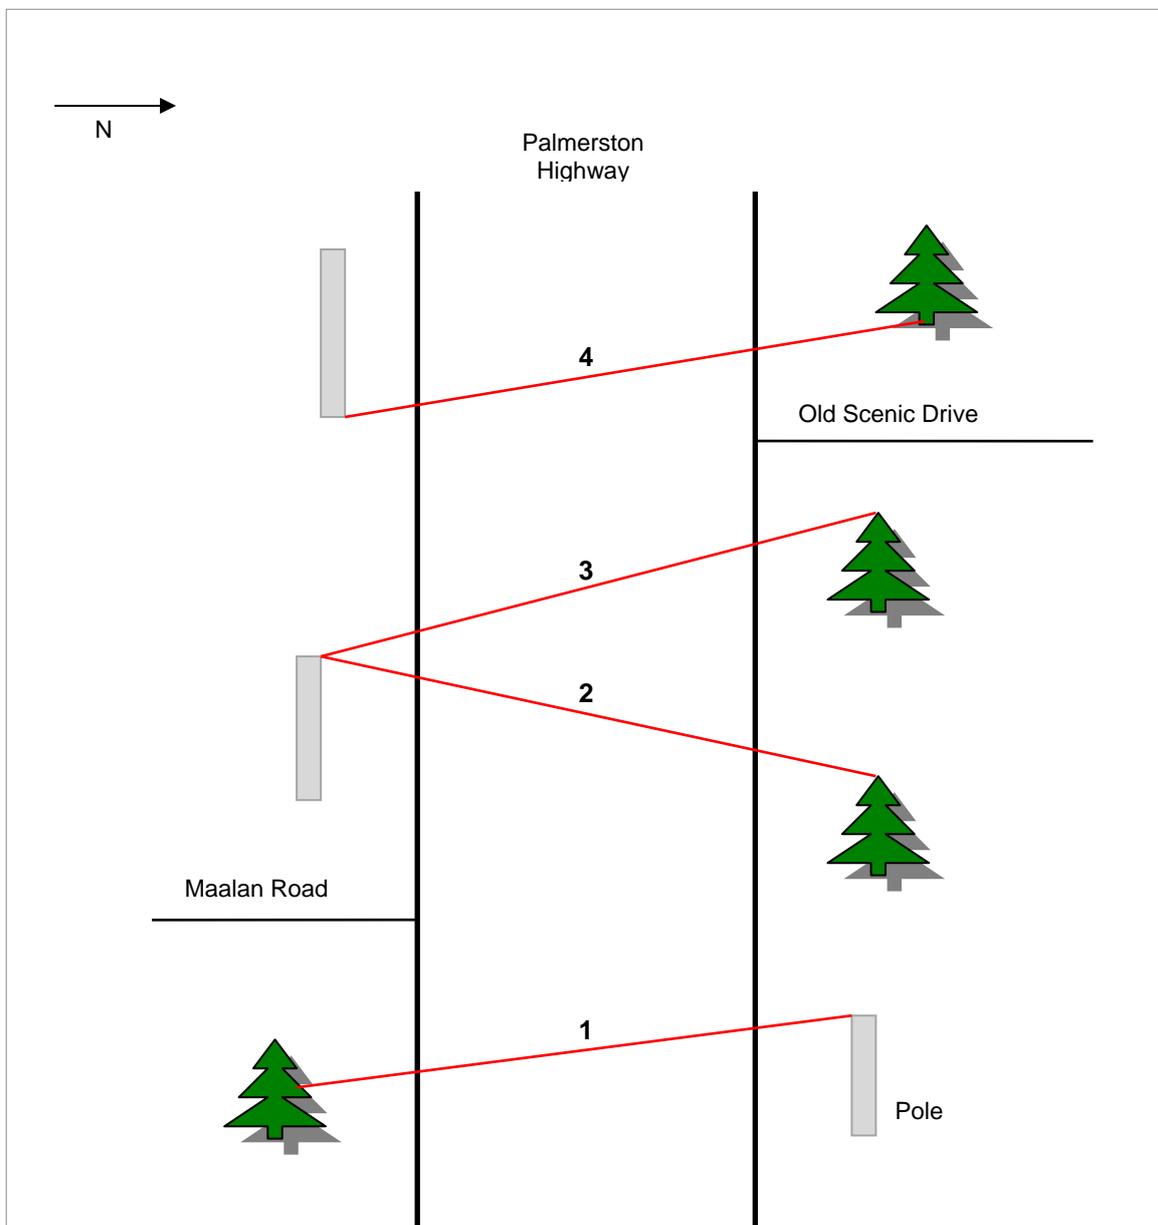
Figure 1.7 Location of the overpasses along the Palmerston Highway. Key: 1, 3, 4 = rope ladders; 2 = rope tunnel.

Three rope ladders and one rope tunnel (range: 34-44 m long, Figures 1.7-1.10) were installed over the Palmerston Highway on the 11 November 2005 (Figure 1.4). Each was attached to a telegraph pole on one side of the highway and a substantial tree on the other (Figures 1.8-1.10). They were erected on a diagonal across the road surface to increase the length of the crossing so it better reflected the gap proposed for the Kuranda Range Road upgrade.

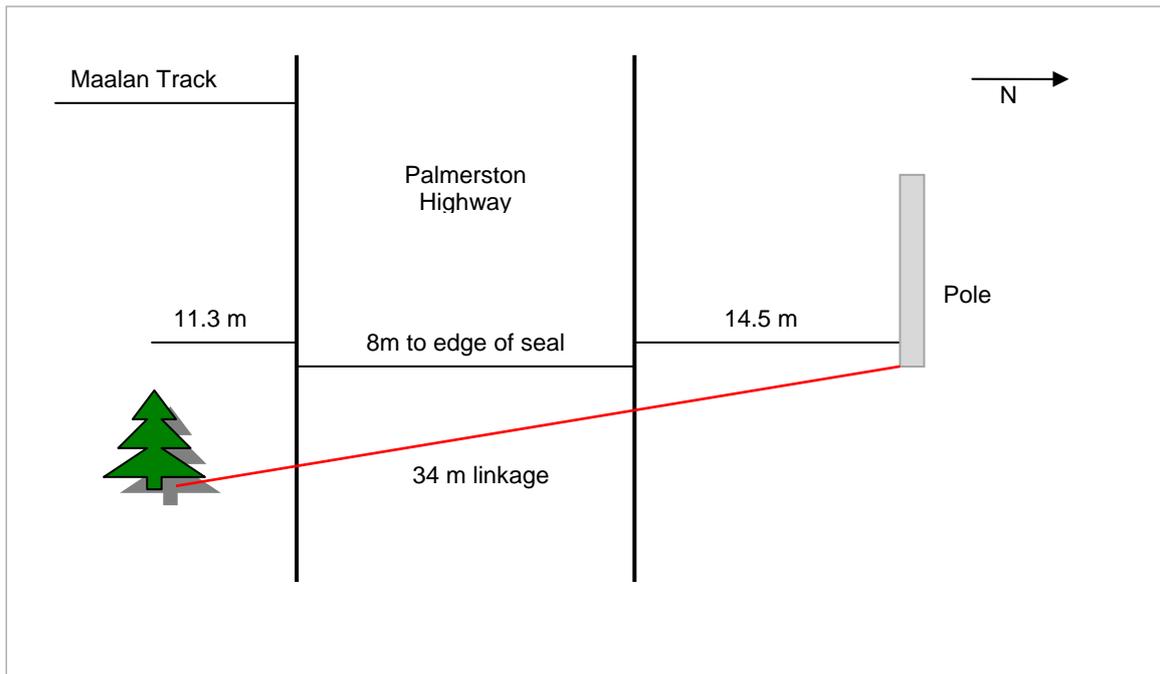
Figure 1.8 Overpass dimensions and means of attachment – Linkage 1.

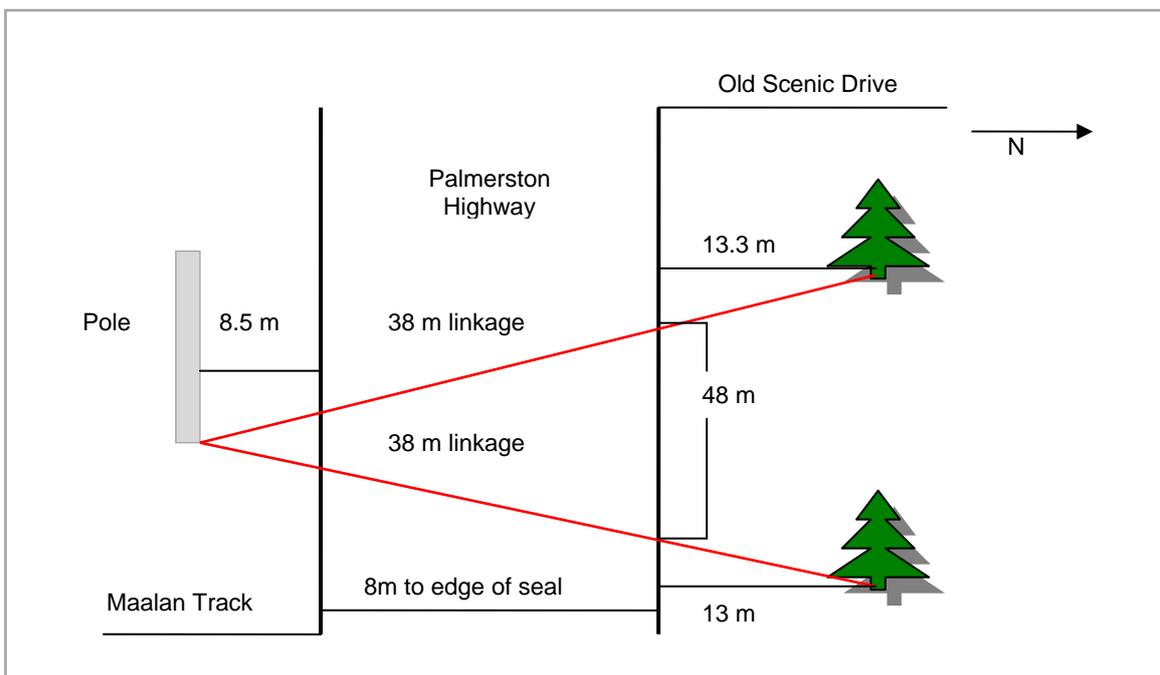
Figure 1.9 Overpass dimensions and means of attachment – Linkages 2 and 3, between Maalan Road and Old Scenic Drive.

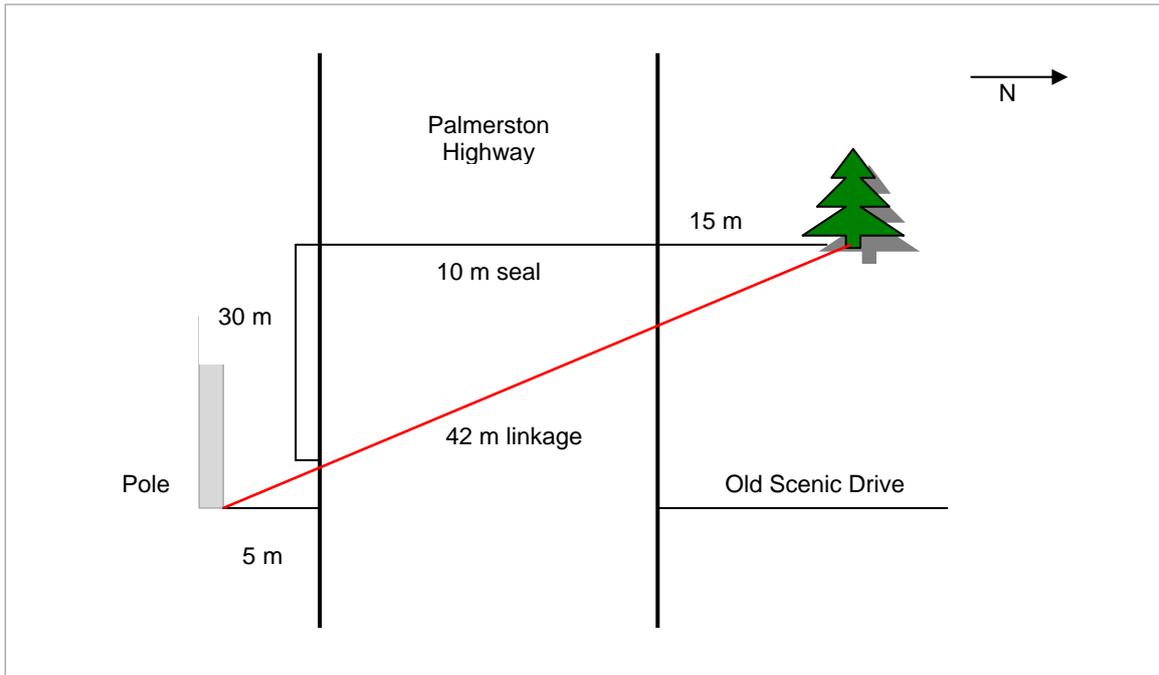
Figure 1.10 Overpass dimensions and means of attachment – Linkage 4, Millaa Millaa side of Old Scenic Drive.

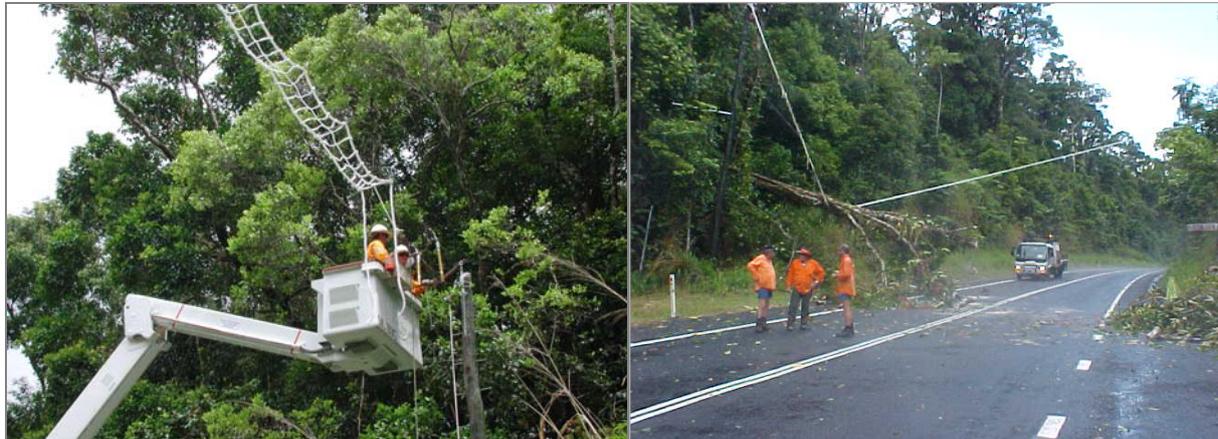
Figure 1.11 (Left) Attaching the rope ladder to telegraph pole, and (right) the rope ladder one month after installation after a tree collapsed on top of it. Photos courtesy of Robyn Wilson.

A tree collapsed through one of the overpasses a month after installation (Figure 1.11) but this overpass was replaced in the following week. All overpasses remained intact following the passage of Cyclone *Larry* through the area (Figure 1.12). An information sign to inform drivers of the purpose of the overpasses was erected at the approach to them in November 2006 (Figure 1.13).

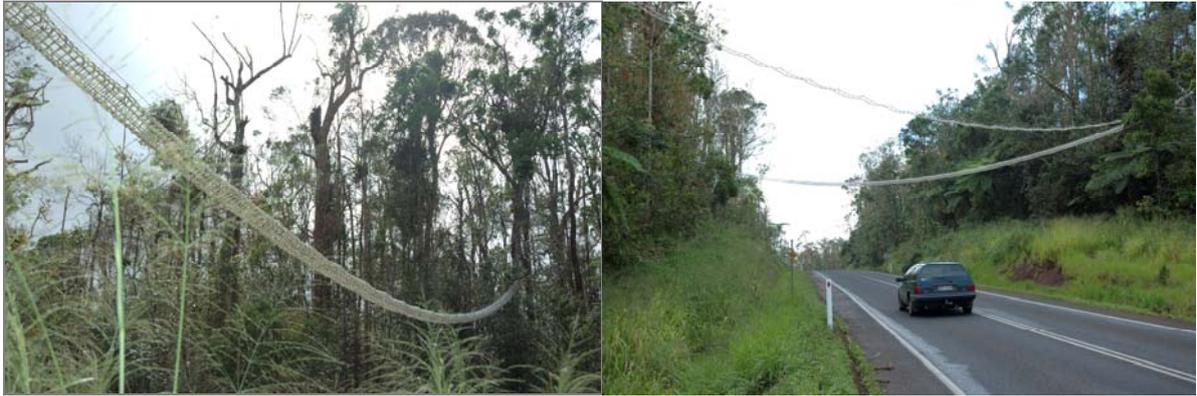
Figure 1.12 (*Left*) rainforest destruction, and (*right*) the rope tunnel two months after Cyclone Larry. Note the width of the canopy gap over the road. Photos courtesy of Robyn Wilson.

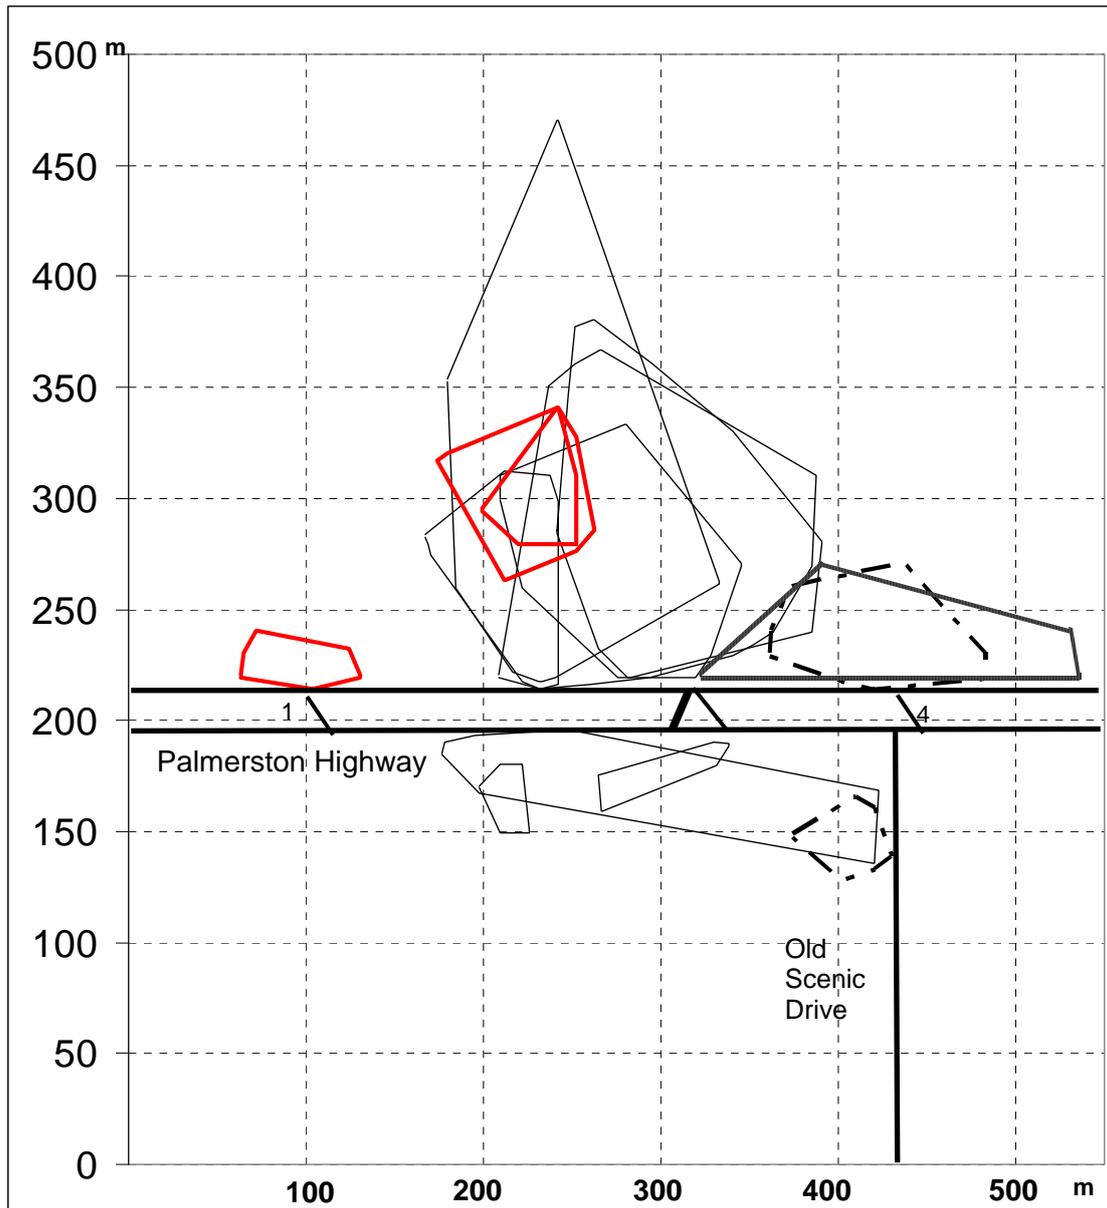
Figure 1.14 Home range (95% Convex Polygon) of *P. herbertensis* and *H. lemuroides*.

Key: Black thin line = *P. herbertensis*; Red = *H. lemuroides*; Black broken lines = movements of two *P. herbertensis* that crossed the Palmerston Highway. The larger dashed line was the range prior to the possum crossing the highway. Insufficient data was recorded for the second possum prior to its crossing to plot its movements. Lines across the highway are the location of overpasses; the thickest line is the tunnel-type overpass, while the thinner lines are ladder-type overpasses.

There was considerable overlap in the home range of male and female Herbert River Ringtails (Figure 1.14). However, it was rare to sight two Herbert River Ringtail Possums in the same tree. No Herbert River Ringtail Possums were observed coming to ground to cross between trees.

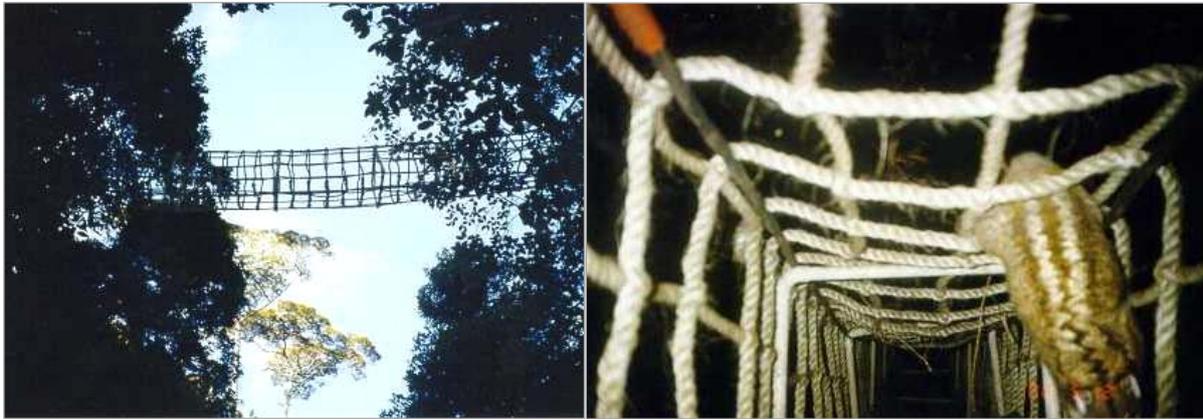
Figure 2.1 (Left) Initial rope tunnel design by Rupert Russell of the Queensland Environmental Protection Agency, installed across a forestry road in the Lamb Range area, with (right) a Green Ringtail possum making use of it. Photos courtesy of Nigel Weston.

The design of the initial rope tunnel from Mr Rupert Russell of the QEPA was modified by Thiess Pty Ltd (Bax 2006) after advice from the Rainforest CRC. Modifications allowed a similar construction to be placed over a wide divided four-lane highway at Karuah, near Newcastle in New South Wales (Figure 2.3), whilst taking safety issues of such a long span into account. The Thiess design was in turn modified by Mr David Rivett and Mr Nigel Weston for the final rope tunnel erected over the Palmerston Highway.

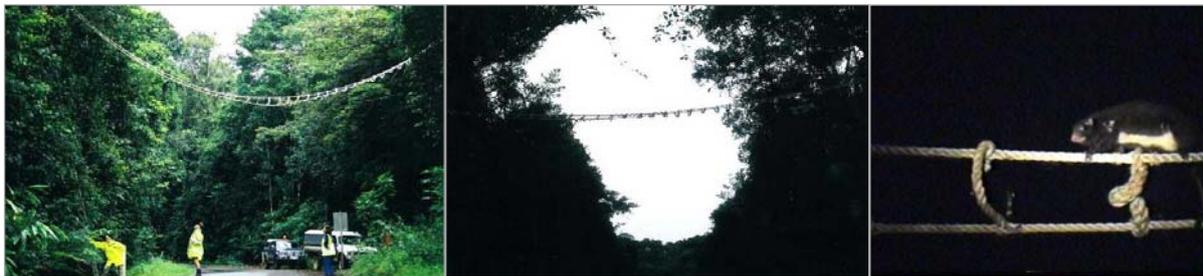
Figure 2.2 (Left and centre) Rope ladder erected over the Old Palmerston Highway, and (right) being used by a Herbert River Ringtail possum.

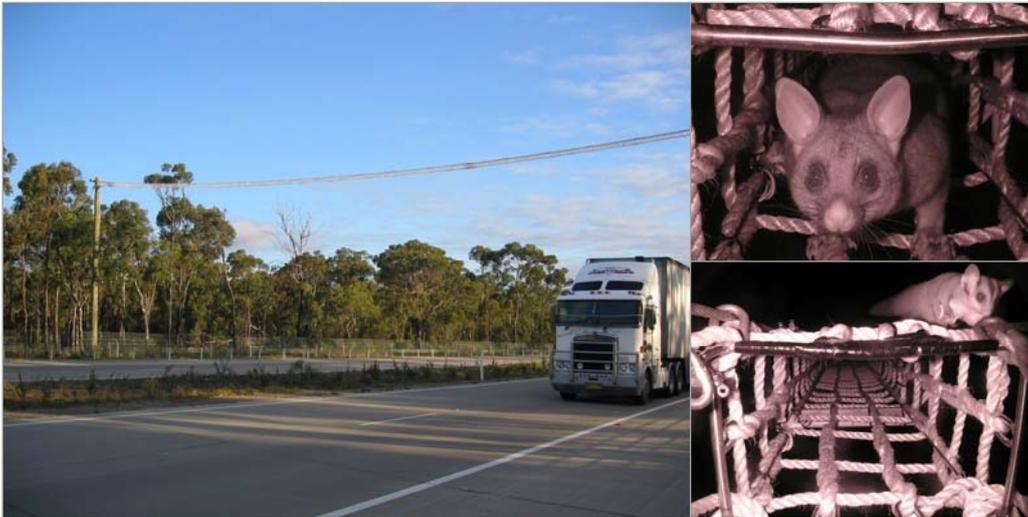
Figure 2.3 (Left) The long rope tunnel constructed by Thiess Pty Ltd over the divided four-lane highway at Karuah, near Newcastle, NSW, with (above right) brushtail possum and (below right) squirrel glider making use of it. Photos courtesy of Bob Bax.

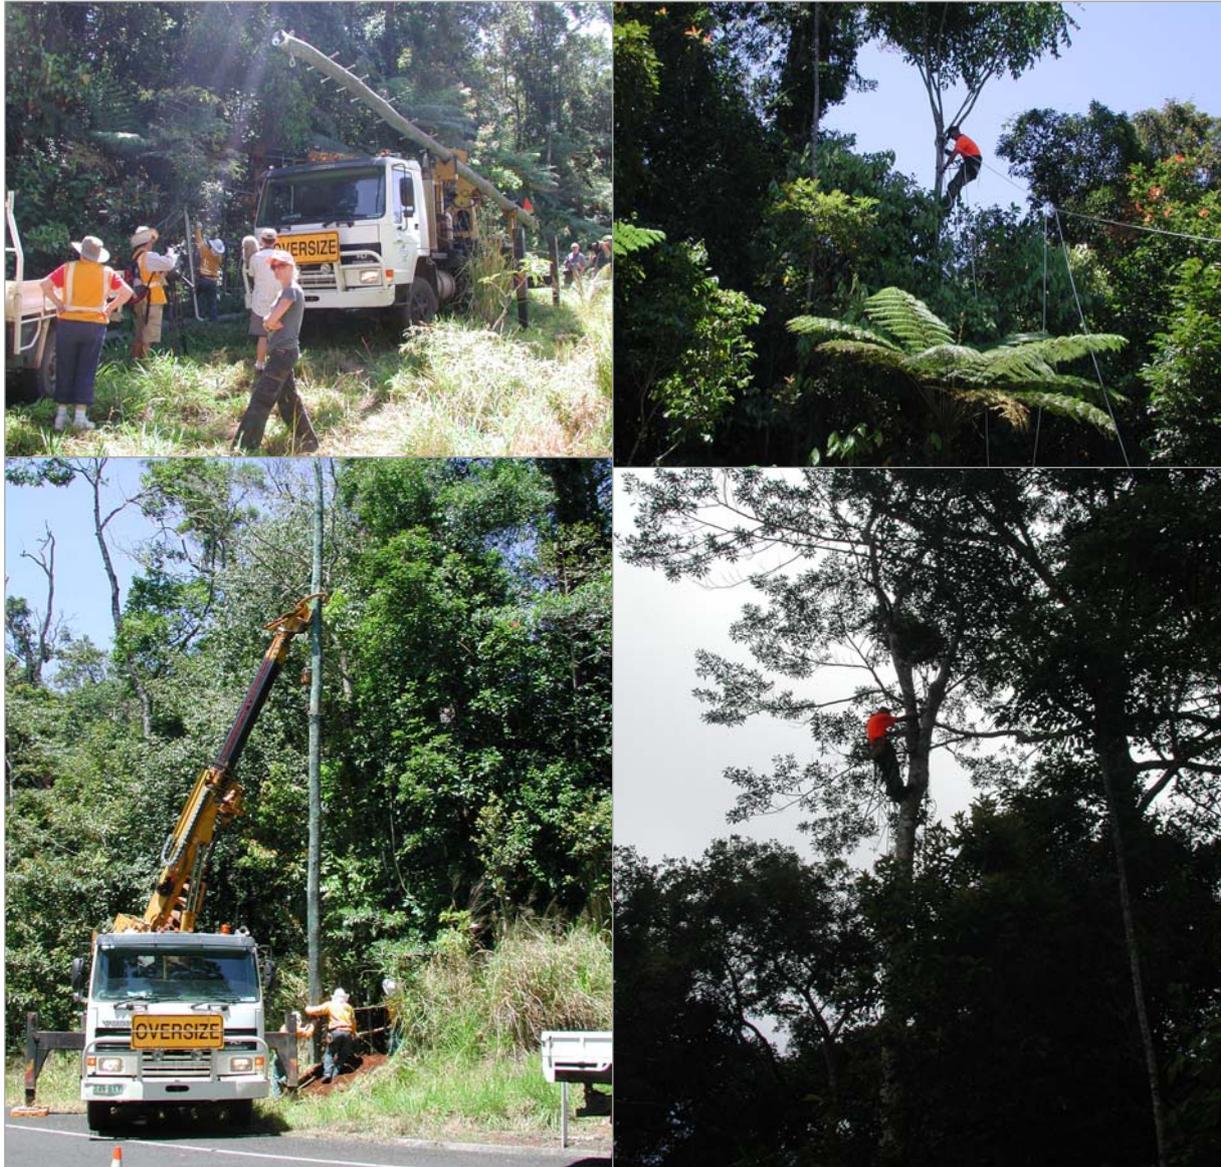
Figure 2.4 Canopy bridges were installed between an electricity pole on one side of the road and a large, solid, healthy tree on the other side. Photos courtesy of Birgit Kuehn.

The final design comprised two stainless steel cables strung between an electricity pole on one side of the road and a large, solid, healthy tree on the other (Figure 2.4). The poles were braced back to footings in the ground by cables. The canopy bridges were attached to trees using bolted wooden supports, created in Mr David Rivett's home workshop with the assistance of Mr Nigel Weston. Wooden supports were attached by tree climbers to avoid tree damage (Figures 2.5, 2.6). The rope tunnel was spliced from 22mm diameter marine grade 'silver rope' by Gulf Net Menders Chandlery, Cairns (Figure 2.7). Finer diameter rope was used for the cross-members to reduce weight (Figure 2.8). The tunnel included stainless steel frames every metre (Figure 2.8) to which D-shackles were attached which then slid along the cables for erection (Figure 2.9). The Ergon Energy cherry picker was then used to thread the tunnel into position from the pole to the tree (Figure 2.10). Chains and turnbuckles attached to the pole eyelets or wooden support eyelets were used for tightening the cable (Figure 2.11).

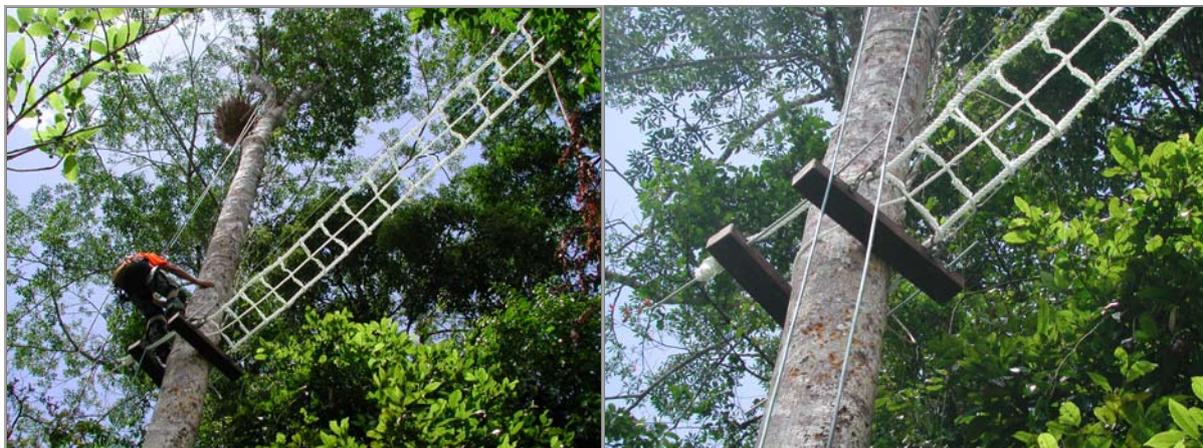
Figure 2.5 Canopy bridges were attached to trees using wooden supports to prevent damage to the tree. Photos courtesy of Birgit Kuehn.

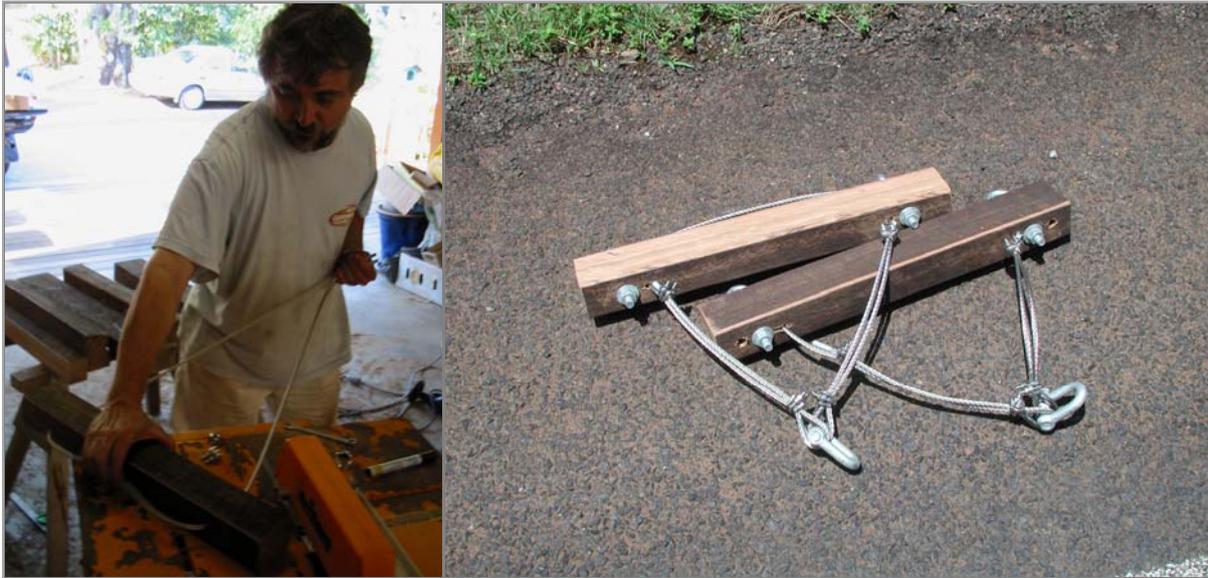
Figure 2.6 Wooden supports used in attaching the canopy bridges to tree trunks, (*left*) created in the home workshop, and (*right*) the final product. Photos courtesy of Nigel Weston.

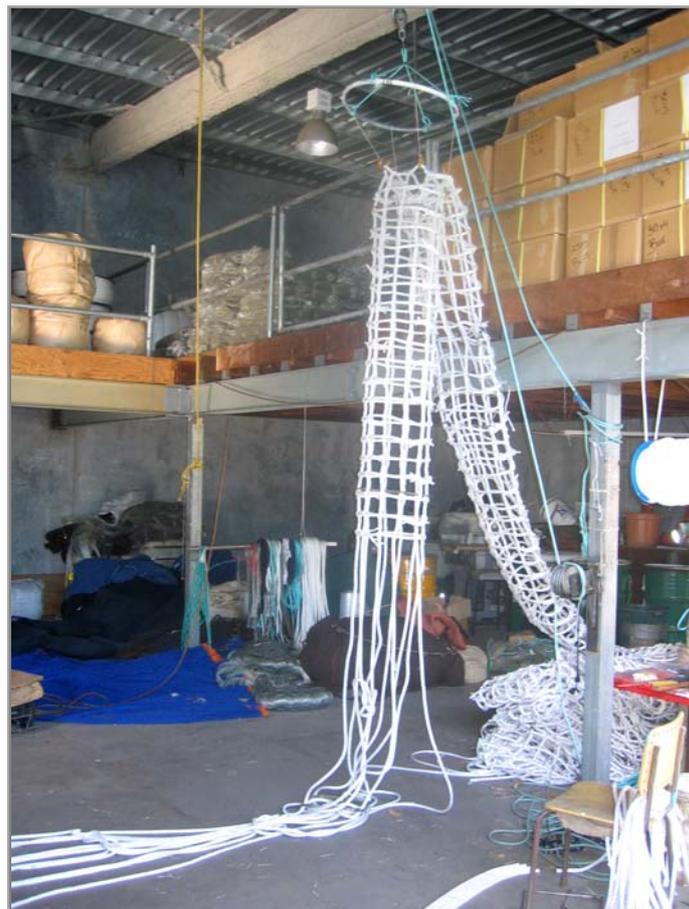
Figure 2.7 Rope tunnel under construction at Gulf Net Menders Pty Ltd. Photo courtesy of Nigel Weston.

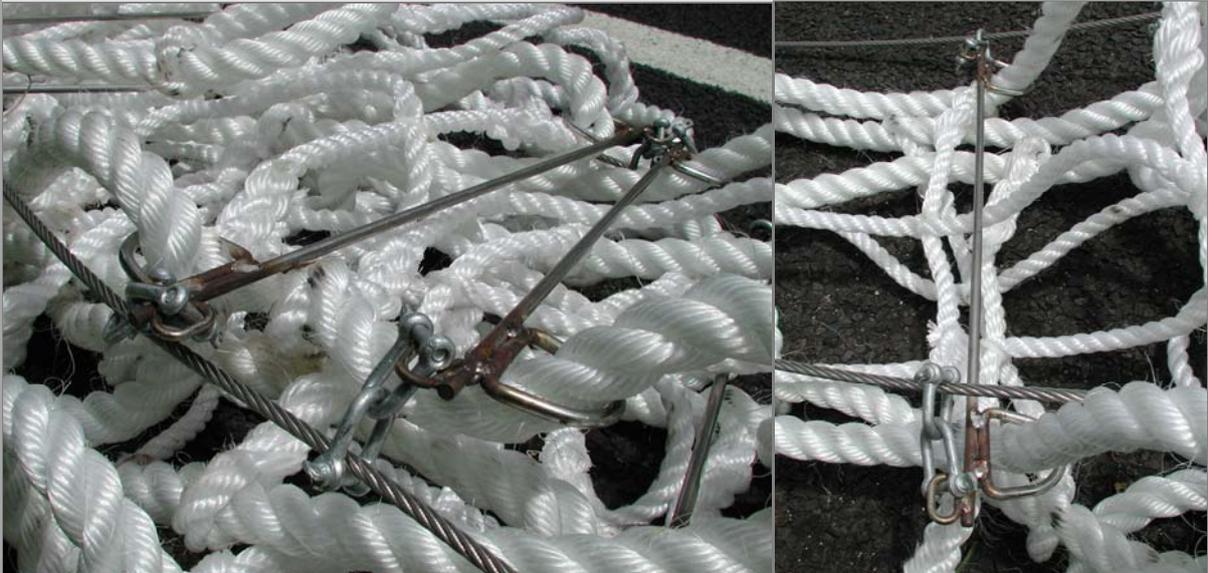
Figure 2.8 Rope tunnel showing (*left*) stainless steel framework and D-shackles attached to the cable, and (*right*) finer rope cross-members. Photos courtesy of Nigel Weston.

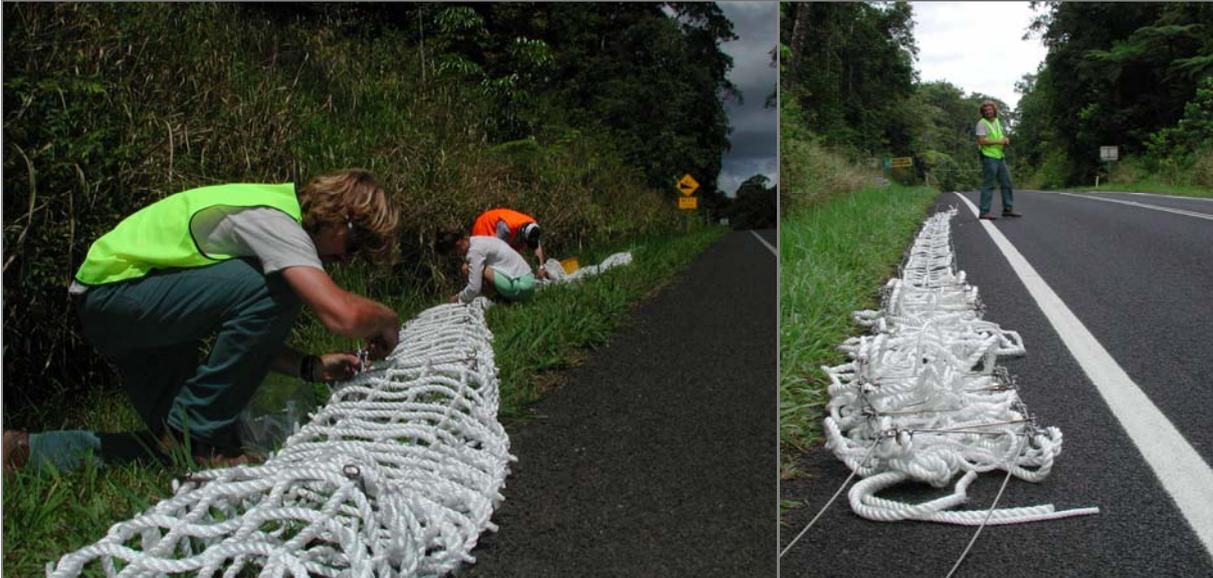
Figure 2.9 Attaching D-shackles and threading the cable for erection. Photos courtesy Birgit Kuehn.

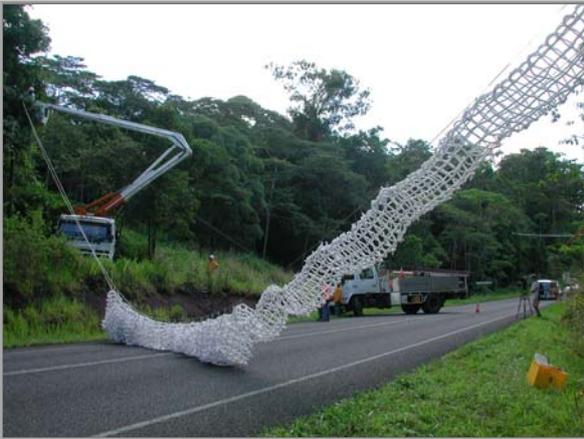
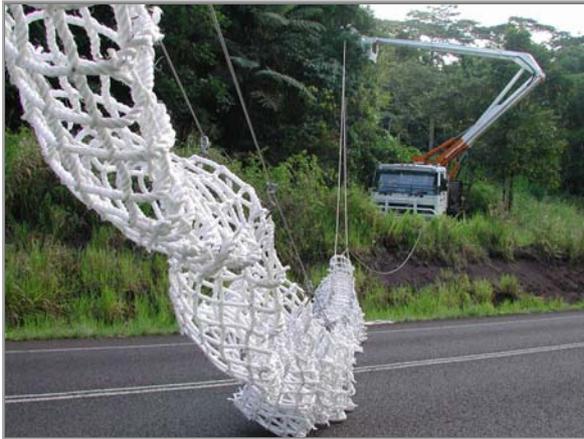
Figure 2.10 Ergon Energy cherry picker used to thread tunnel into position from electricity pole to tree support. Photos courtesy of Birgit Kuehn.

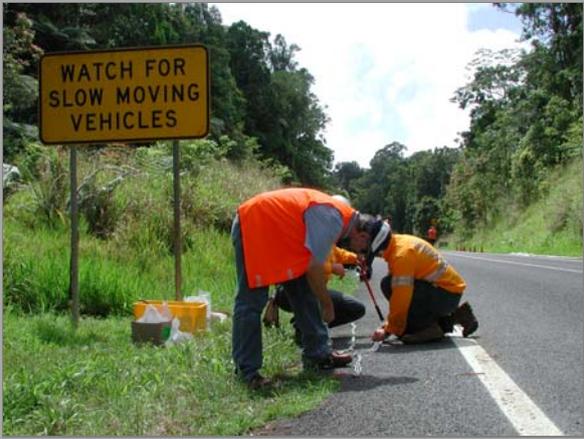
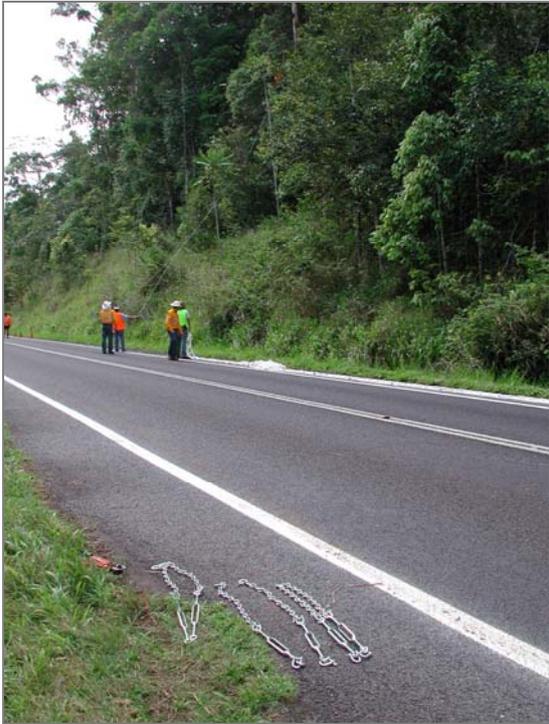
Figure 2.12 Rope ladder design showing finer rope cross-members spliced to 22 mm main length and stainless steel supports and attached to D-shackles threaded onto cable supports. Photos courtesy of Birgit Kuehn.

Rope ladders were based on a similar design, using the 22 mm diameter silver rope with finer silver rope cross members (Figure 2.12). Cable, attachments, supports and erection were as for the rope tunnel construction (see above) (Figure 2.13).

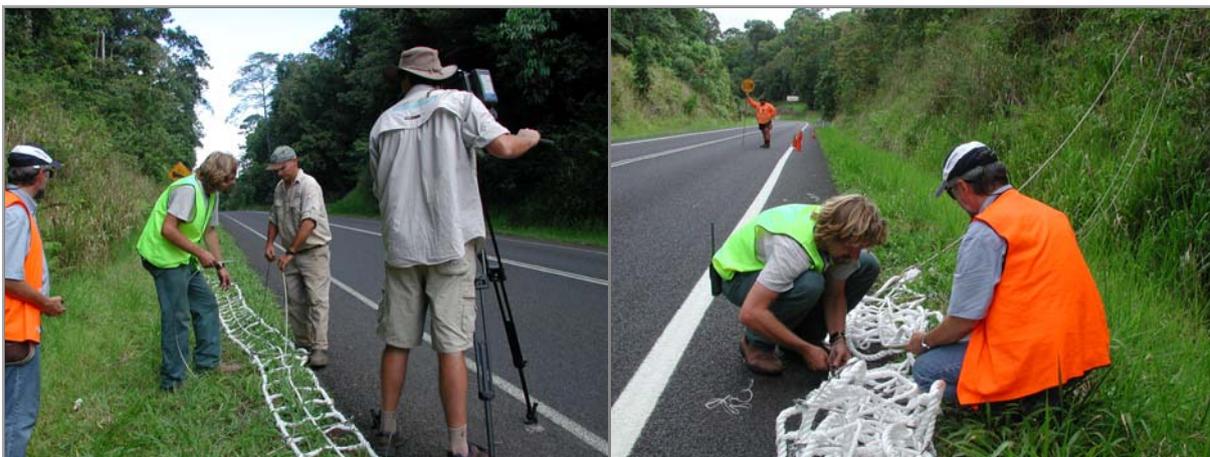
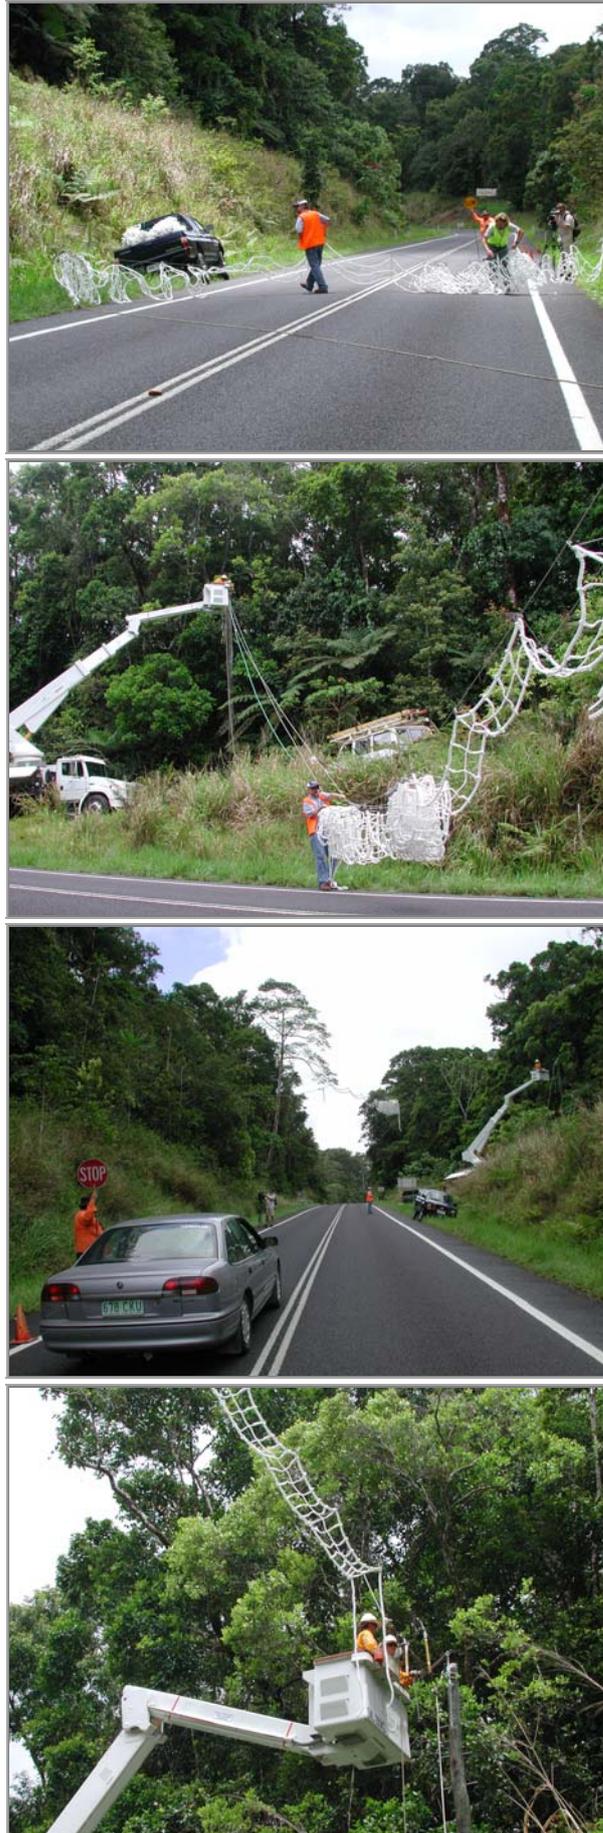
Figure 2.13 Erection of rope ladder canopy bridges. Photos courtesy of Birgit Kuehn.

Figure 2.13 (cont'd) Erection of rope ladder canopy bridges.
Photos courtesy of Birgit Kuehn.

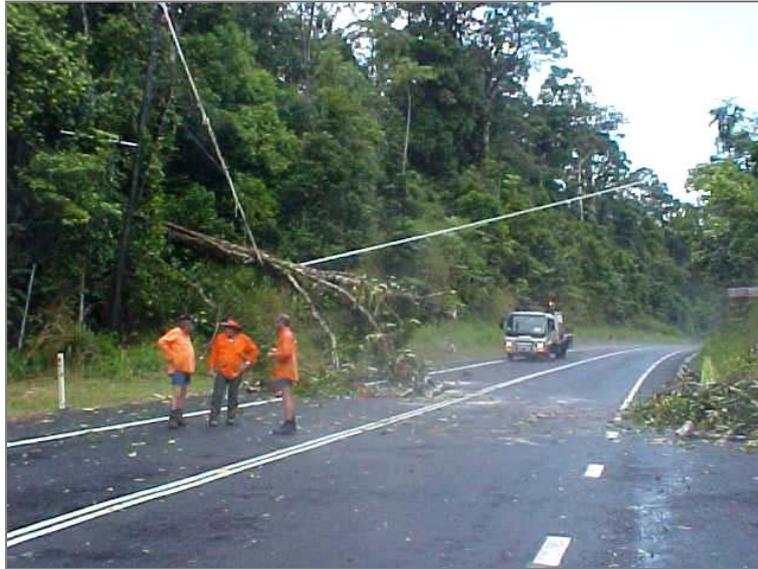
Figure 2.14 Fallen tree supported by rope ladder overpass. Photo courtesy of Robyn Wilson

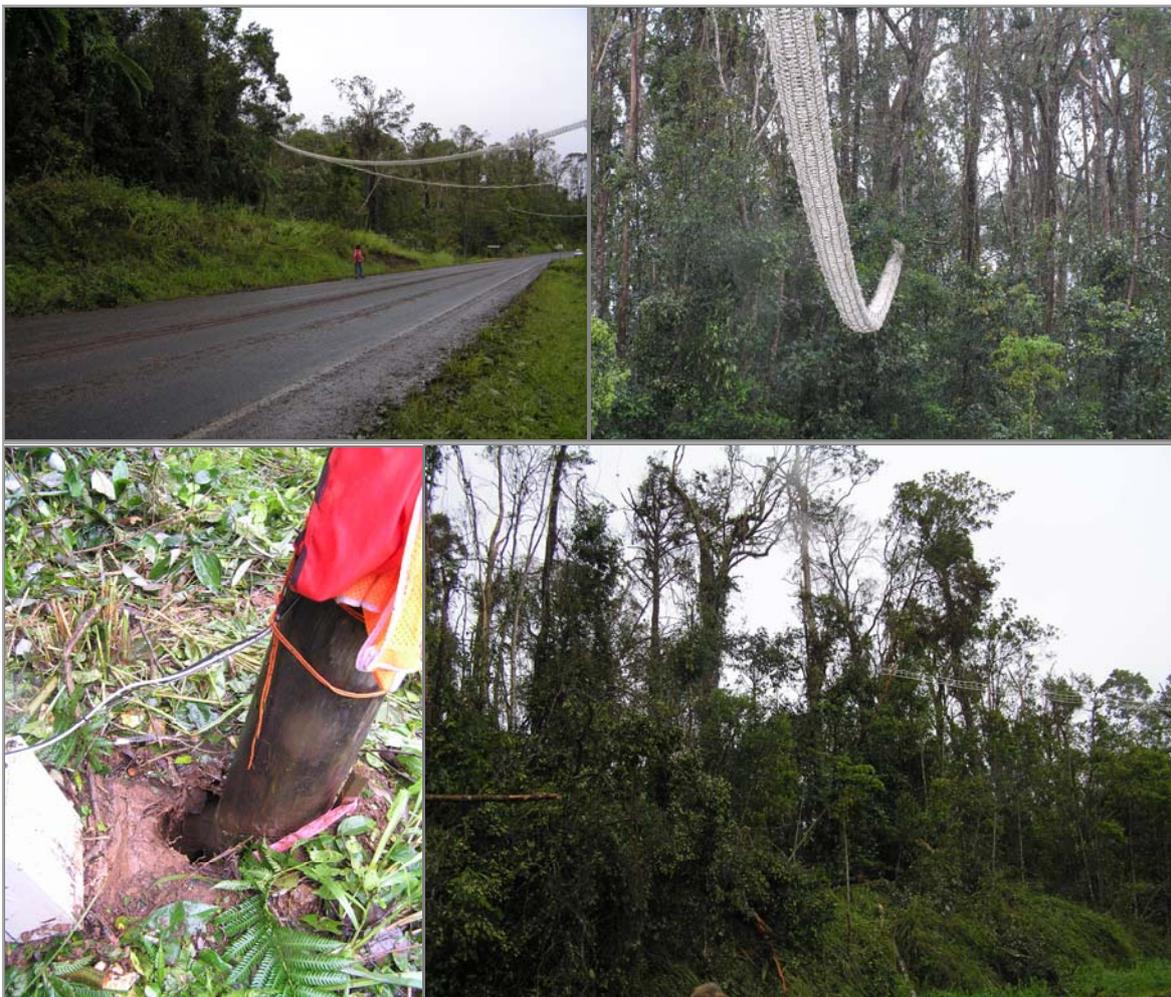
Figure 2.15 Photographs taken three days after category 4 Tropical Cyclone *Larry* passed almost directly over the Palmerston Highway and its canopy bridges. The bridges are still in place although with slight sagging of the rope tunnel, a pole loosened in ground, and damage next to one of the ladders. Photos courtesy of Steve Goosem.

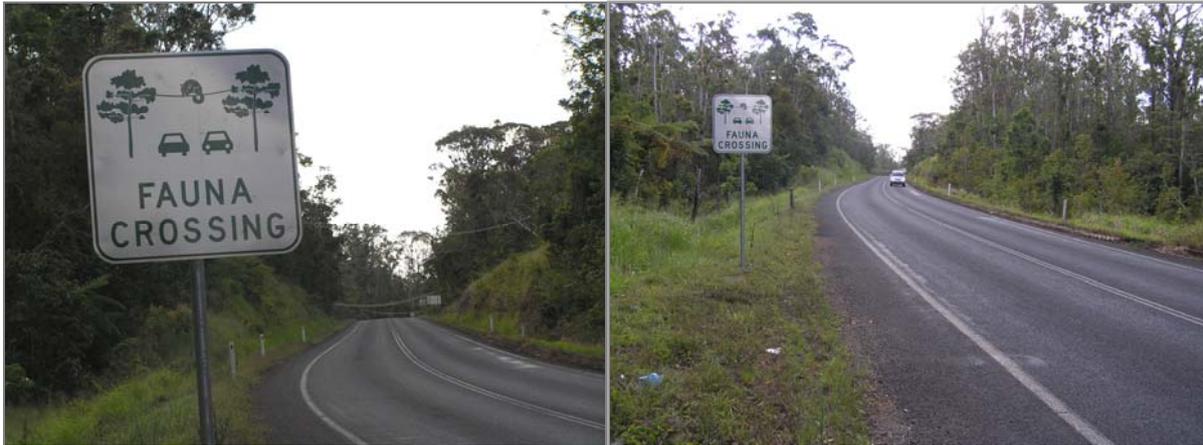
Figure 2.16 QDMR signs informing motorists of the purpose of the canopy bridges. Photos courtesy of Miriam Goosem.

In 2006, QDMR signs specially designed by QDMR were erected at either end of the canopy overpass group to provide information to the public about the reason for the erection of the overpasses (Figure 2.16).

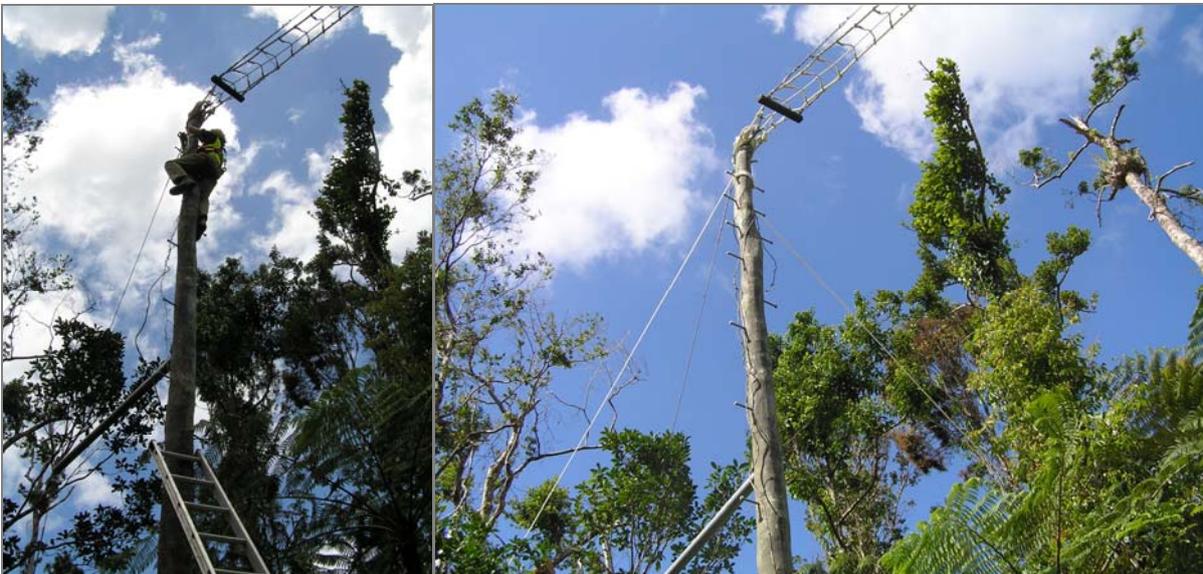
Figure 2.17 Installation of ropes from poles to neighboring trees, where poles were somewhat isolated from adjacent foliage. Photos courtesy of Miriam Goosem.

In November 2006, ropes connecting the two electricity poles that were more isolated from neighbouring trees were installed to encourage possums to access the canopy bridges (Figure 2.17). Further ropes were added to the pole attached to the rope tunnel and rope ladder in November 2007.

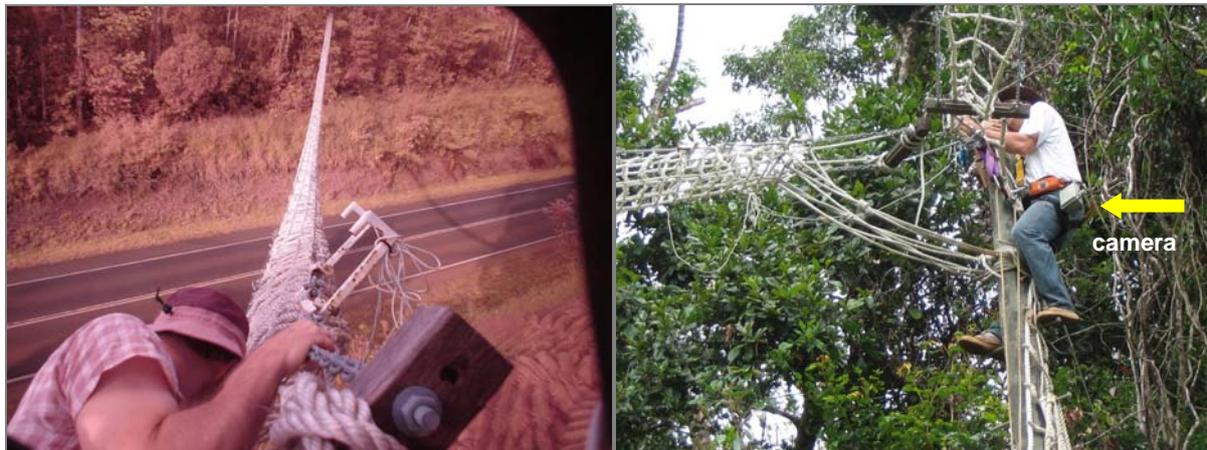
Figure 3.1 (Left) Installation of infrared-beam sensors on the rope tunnel canopy bridge, and (right) climbing the pole to the rope tunnel – note the camera housing ready to install, attached to the climber's hip. Photos courtesy of M. Cohen and J. Cooper.

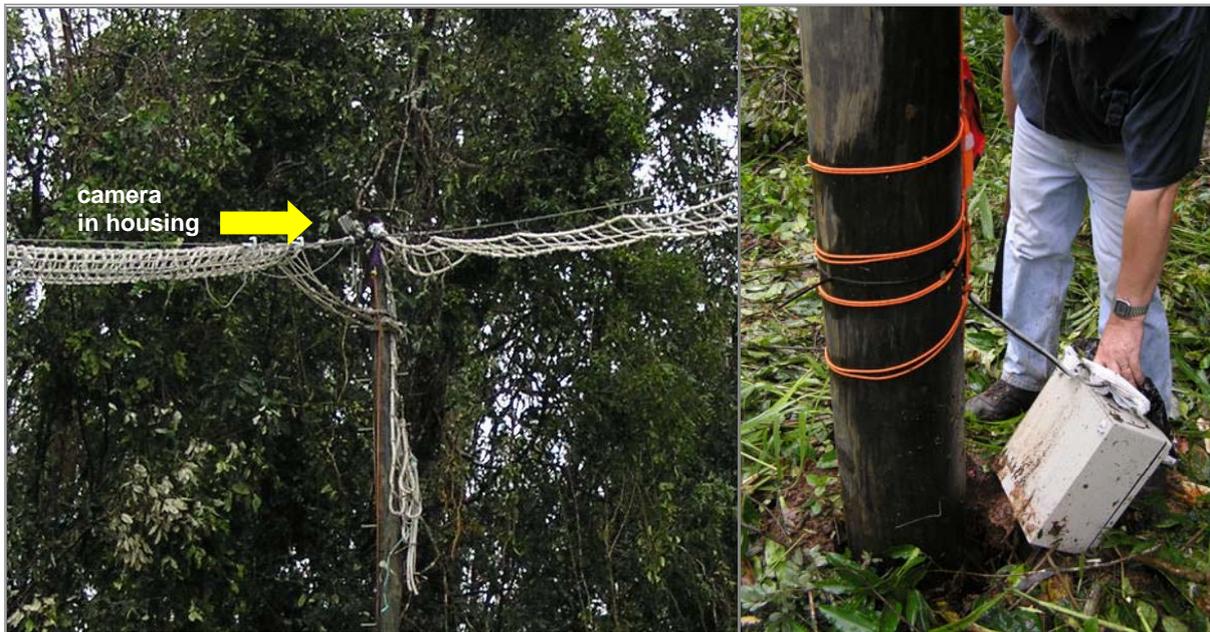
Figure 3.2 (*Left*) Inconspicuous camera in position facing along the rope tunnel, and (*right*) the control box for downloading images and battery with cable leading down from camera. Photos courtesy of Steve Goosem and Miriam Goosem.

At each weekly visit, the images were downloaded and the battery changed. Due to malfunctions caused by water entering the cable and box system after Cyclone *Larry*, for many months it was necessary to climb the pole, and replace the camera memory card. At the same time the camera was checked and cleaned and the sensor adjusted.
