Highway Overpass Evaluation of Effectiveness: Kuranda Range Road Upgrade Project

Miriam Goosem, Robyn Wilson, Nigel Weston and Martin Cohen

School of Earth and Environmental Sciences
James Cook University, Cairns

July 2008

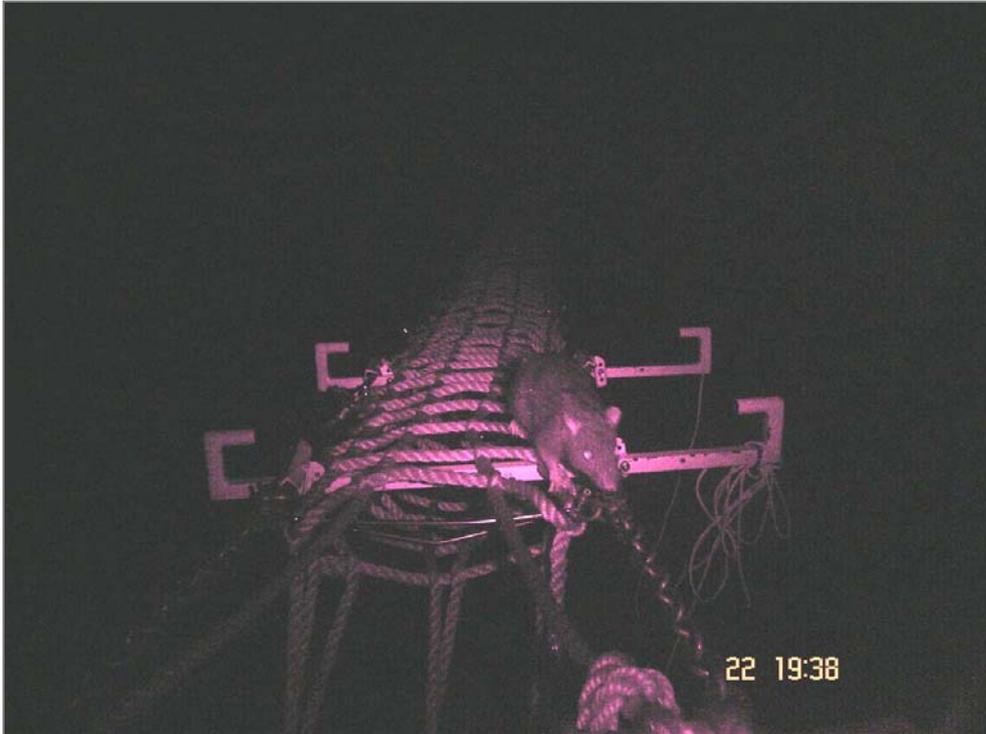
Figure 3.3 Giant White-tailed rat on canopy bridge, 22 April 2006.

Table 3.2 shows the faunal activity on the rope tunnel canopy bridge where the camera has been installed. The first evidence of faunal activity on the canopy bridges was when a Giant White-tailed rat, *Uromys caudimaculatus*, was photographed crossing the bridge and returning on 22 April 2006 (Figure 3.3). In July 2006, possum scats were seen underneath the tunnel bridge.

Date	Species	Time crossed	No. of images	Time returned	No. of images
22.04.06	Giant White-tailed Rat	7:38 pm	4	7:42 pm	3
17.08.06	Herbert River Ringtail Possum (sub-adult)	12.23 am	7	1.47 am	1
20.08.06	Herbert River Ringtail Possum (sub-adult)	9.23 pm	8	11.15pm	1
01.09.06	Herbert River Ringtail Possum (sub-adult)	10.27 pm	4	11.44 pm	1
19.04.07	Green Ringtail Possum	11.21 pm	4	11.40 pm	1
21.05.07	Green Ringtail Possum	2.15 am	3	2.51 am	1
25.05.07	Lewin's Honeyeater	10.50 am	1

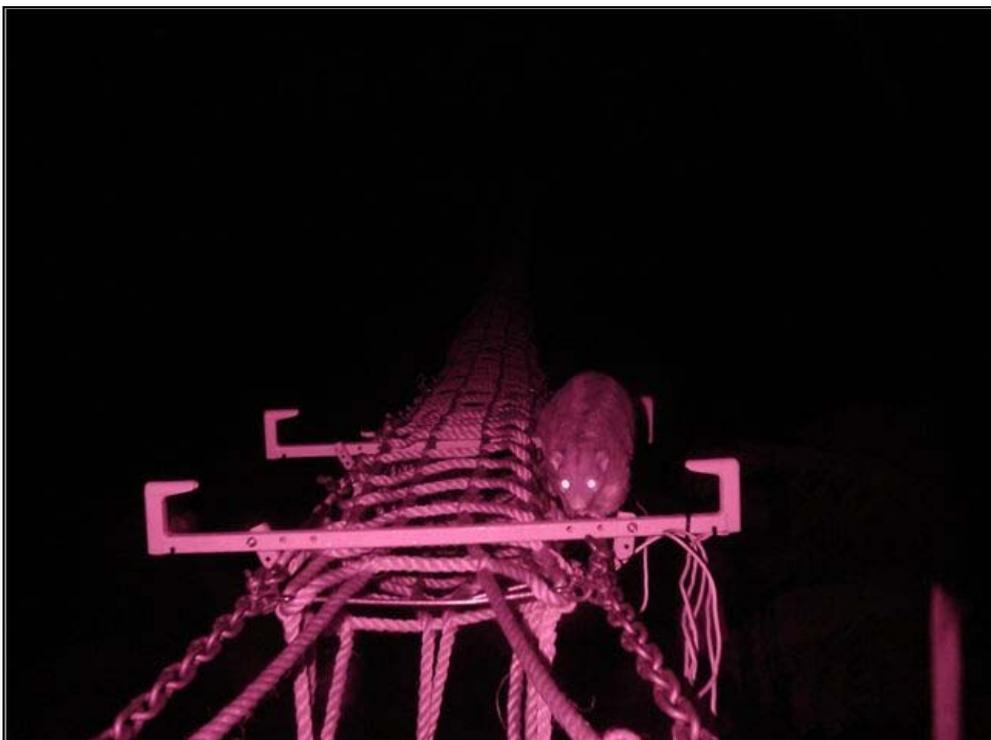
Figure 3.6 Green Ringtail possum on canopy bridge, 21 May 2007 (2.15 am).

Immediately after repair and reconditioning, a Green Ringtail Possum was photographed crossing the canopy bridge on 19 April 2007 at 11.21 pm, returning across the bridge twenty minutes later (Figure 3.5). A Green Ringtail Possum was also seen on 21 May 2007 at 2.15 am (Figure 3.6), returning across the bridge 35 minutes later (Figure 3.7). We believe this is most likely to be the same individual. Since then, no further activity has been recorded.

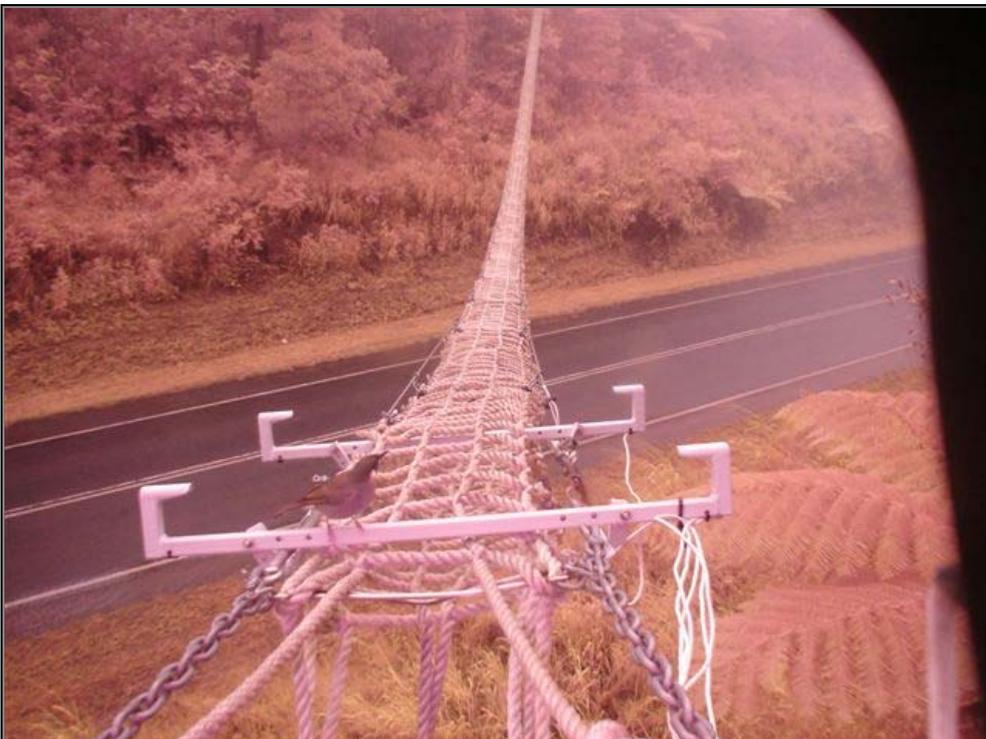
Figure 3.8 Lewin's Honeyeater on canopy bridge in daylight, 25 May 2007.

The system is sensitive enough to detect a small bird on the bridge during daylight hours (Figure 3.8).
