# **Southern Great Barrier Reef Coastal Habitat Archive and Monitoring Program: Mangrove Management Plan Volume 2**

## **Volume 2**

Norman C Duke<sup>1</sup>, Jock Mackenzie<sup>1</sup>, Ric Fennessy<sup>2</sup>, Riley Cormier<sup>3</sup> & John Kovacs<sup>3</sup>

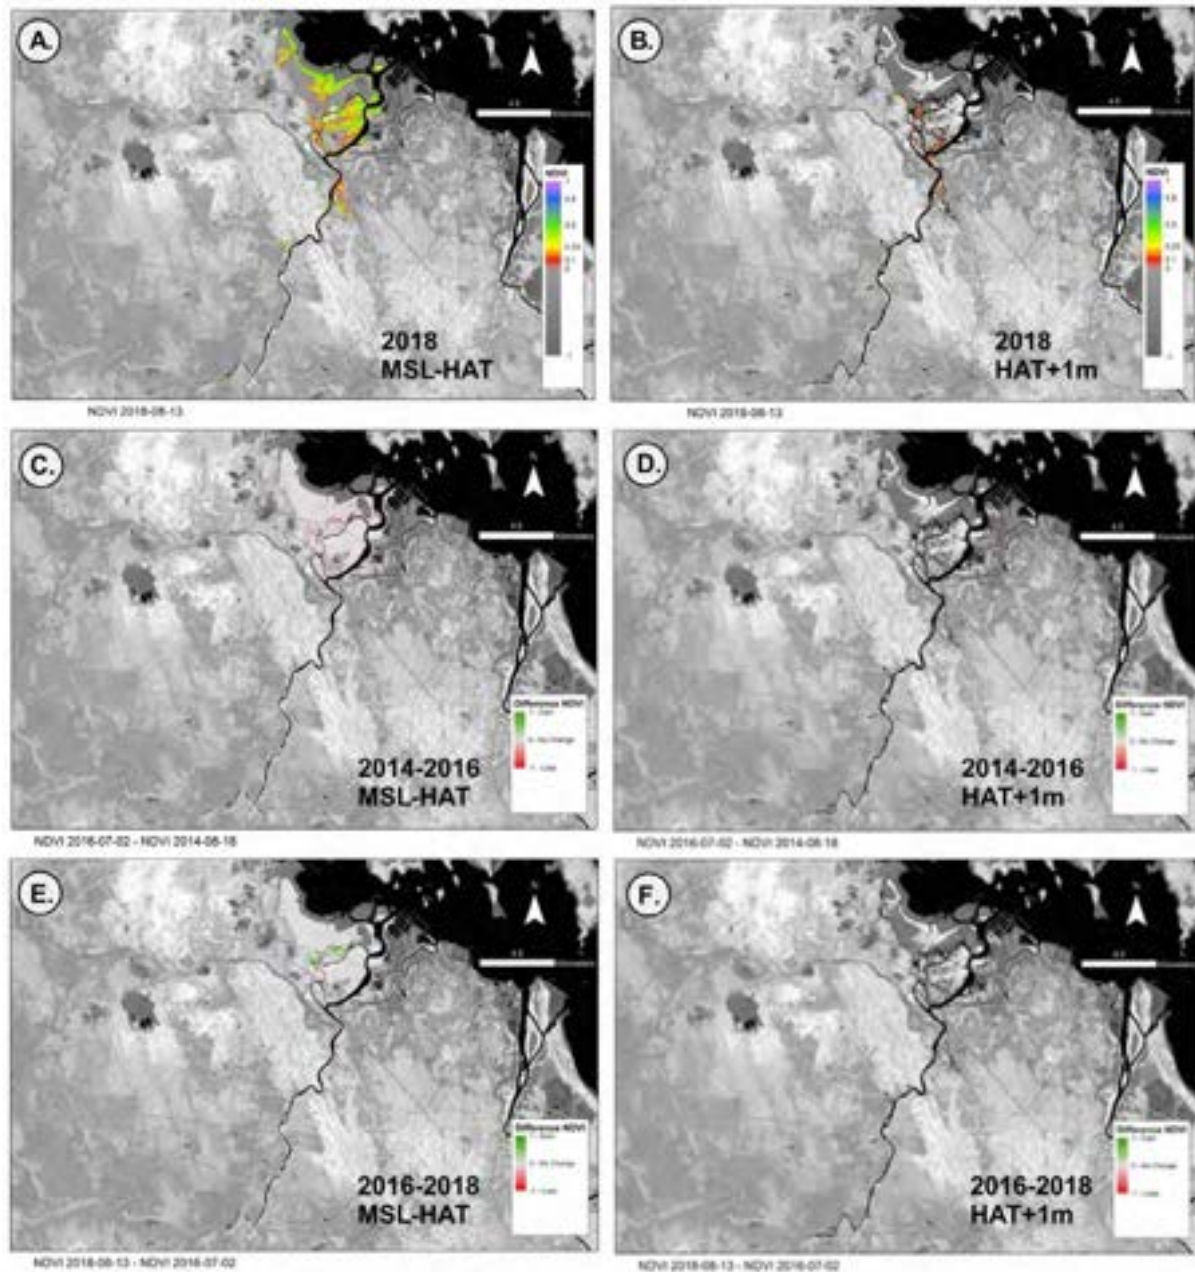
**Figure 11: Satellite images of the Calliope River estuarine areas showing NDVI measures of vegetation condition for tidal wetlands (MSL-HAT) and supra tidal zone (HAT +1m) for 2018 (A & B), and two change detection periods 2014-2016 (C & D) and 2016-2018 (E & F).**

A first evaluation of the condition of vegetation cover was made using vegetation indices (like NDVI) from satellite imagery (Fig. 11). The indices for specific dates represent measures of sub-lethal status at the time (A & B in 2018 – for tidal wetlands and supra tidal areas, respectively). Colours towards the red end of the scale showed vegetation in relatively poor condition while that at the green-blue end is indicated they were healthier. In the 2018 views, tidal wetlands and supra tidal vegetation were in poorer condition upstream than for stands towards the mouth.

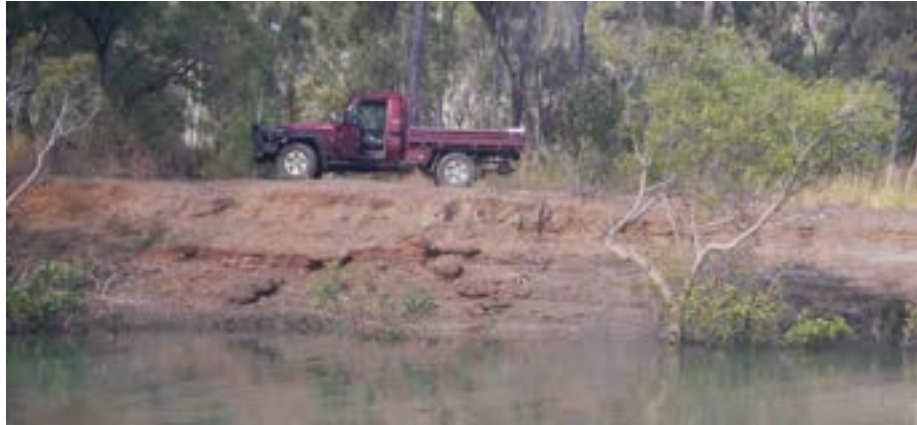
#### **Direct Damage - Vehicle Access (Fig. 14)**

People access tracks were observed in many places along the estuary. Some were official and well-constructed, but there were many others consisting of little more than a cleared track through mangroves to the waters' edge. Further to these instances, there were many places also where vehicle access onto saltpan-saltmarsh areas had resulted in track runnels, damage to saltmarsh vegetation and unnatural ponding across expansive areas also littered with abandoned rusting vehicles. The damage to soil and vegetation integrity is widespread and extensive.

Figure 14: Vehicle access to the river bank is taken for granted without account of the damage to shoreline sediments and buffering vegetation.

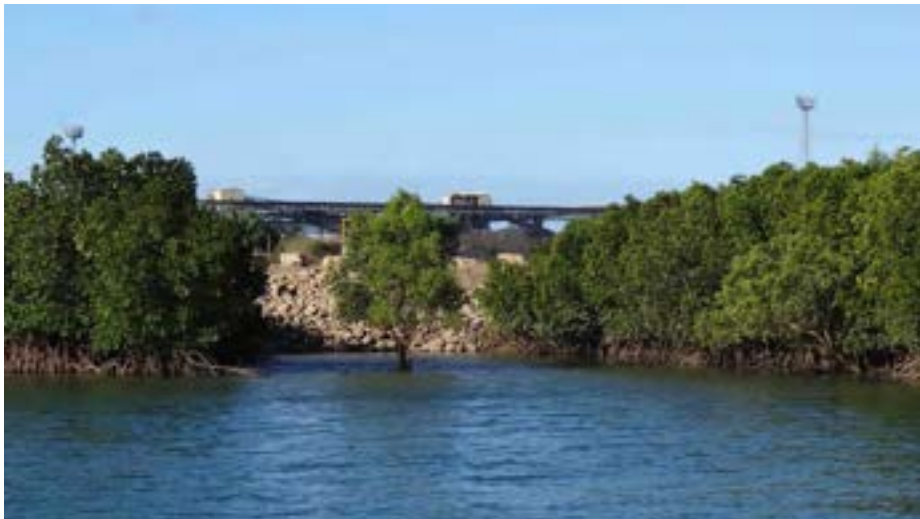
#### **Altered Hydrology - Restricted Flow (Fig. 15)**

Also notable during the field surveys was the number of constructions affecting the natural flows of tides and river runoff. These have sometimes quite noticeable consequences with either sometimes dramatic effects like severe erosion, or sites of massive sediment deposits. These might arise after a particularly extreme flow event or storm, but they also occur during relatively benign weather conditions after some significant change has been made to the natural runoff. Some examples observed along the estuary include ponded pastures, fish farm ponds, road and bridge verges, drain paths, and encroachment and land fill across tidal flats, and construction of bund walls and roads without adequate drainage.

Figure 15: Landfill with bund wall blocks a natural drainage tributary altering the hydrology of the estuary.

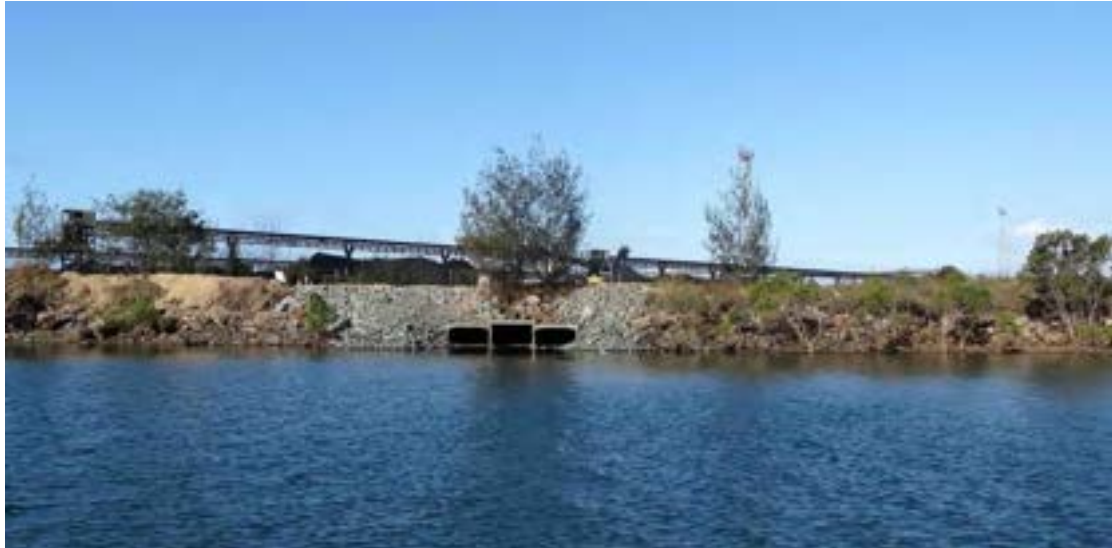
The presence of green algae covering exposed mud flats fronting mangroves is considered an indicator of excess nutrients in surrounding waters. These occurrences were mainly associated with outflow drains in the lower estuary.

Figure 17: Drains along the landfill reclaimed areas are a feature downstream.

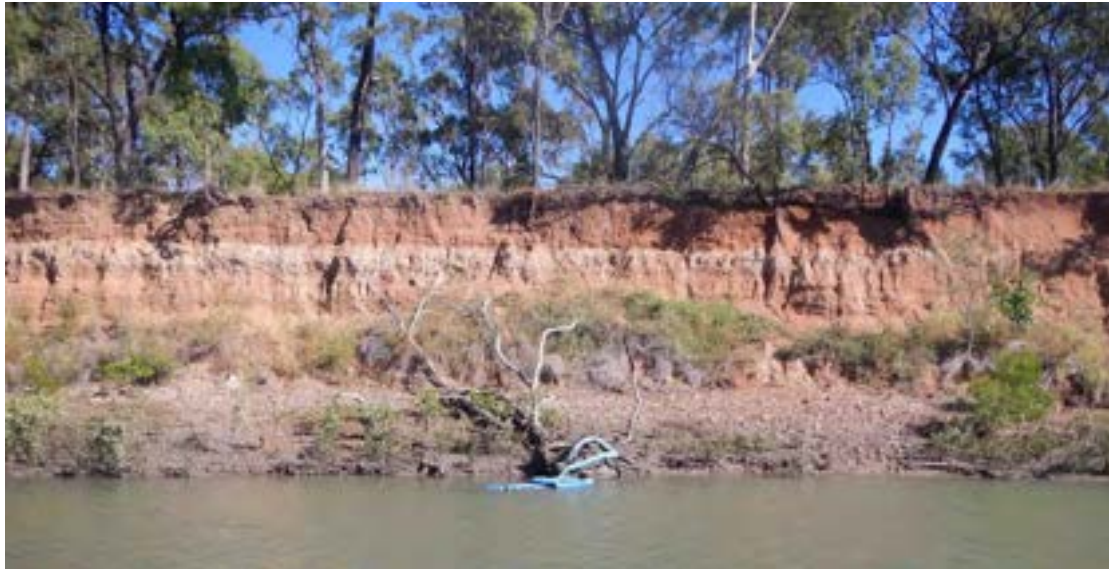
### **Bank Erosion (Fig. 19)**

Bank erosion refers to the collapse of river banks. The frequency of its occurrence largely determines whether this is natural or not. For instance, where there is a corresponding amount of depositional gain (=expanding bank) as a direct counter process, used to quantify the net result of overall erosion or deposition of banks throughout the system. In this case, the erosion appears to be greatly exceeding deposition. Bank erosion is accelerated in areas lacking riparian vegetation, the presence of fires damaging vegetation, vehicles damaging vegetation, and changes to hydrologies, including rising sea levels.

**Figure 19: Bank erosion is seemingly unabated where vegetation present is unable to stop the loss of land and tidal wetland areas. Note also the industrial litter along the edge.**

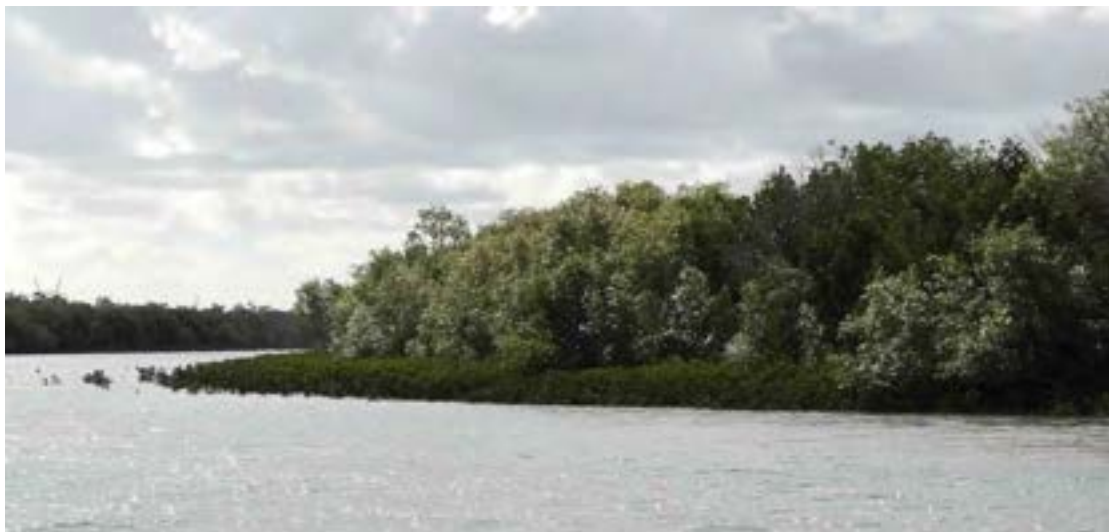
### **Depositional Gain (Fig. 21)**

Depositional gain as noted is often seen as the counter process to bank erosion along estuarine shorelines. It can also occur when sediments accumulate in estuarine systems for other reasons like catchment vegetation clearing, tilled agriculture in the catchment, installation of weirs and dams blocking the normal tidal and river flow hydrologies. It is useful to consider all the likely influences before making conclusions about the dominant cause. The depositional gain indicator is the occurrence of young seedlings in front of established frontal mangrove trees. The age of the young stand is indicative also of when new sediment levels on the mud bank exceed mean sea level making the site available for natural mangrove colonisation. As such, depositional gain is driven by sediment supply.

**Figure 21: Depositional gain with young seedlings taking advantage of the recently accreted mud bank.**

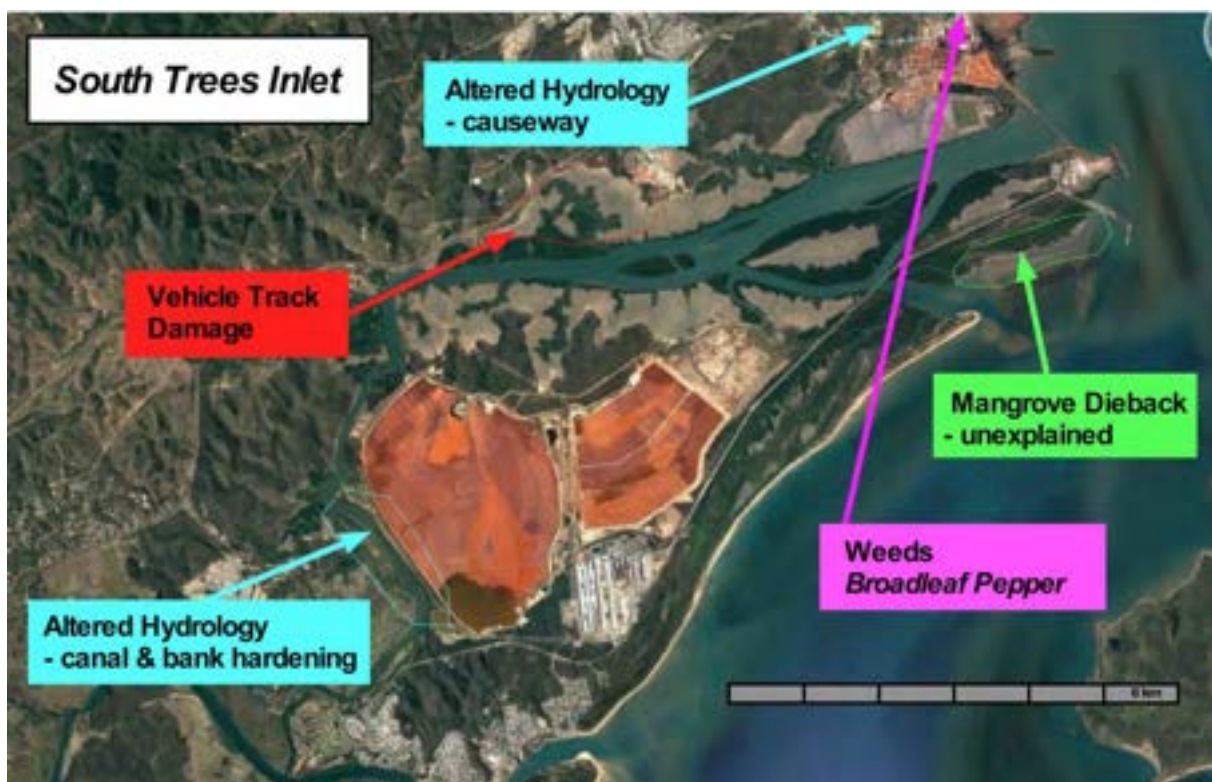
Key issues flagged at 2016 and 2017 community workshops included altered hydrology, weed infestations and vehicle access damage (see Fig. 30).

Figure 30: Digitised outcomes of the workshop community-based participatory mapping of South Trees Inlet tidal wetland management issues.

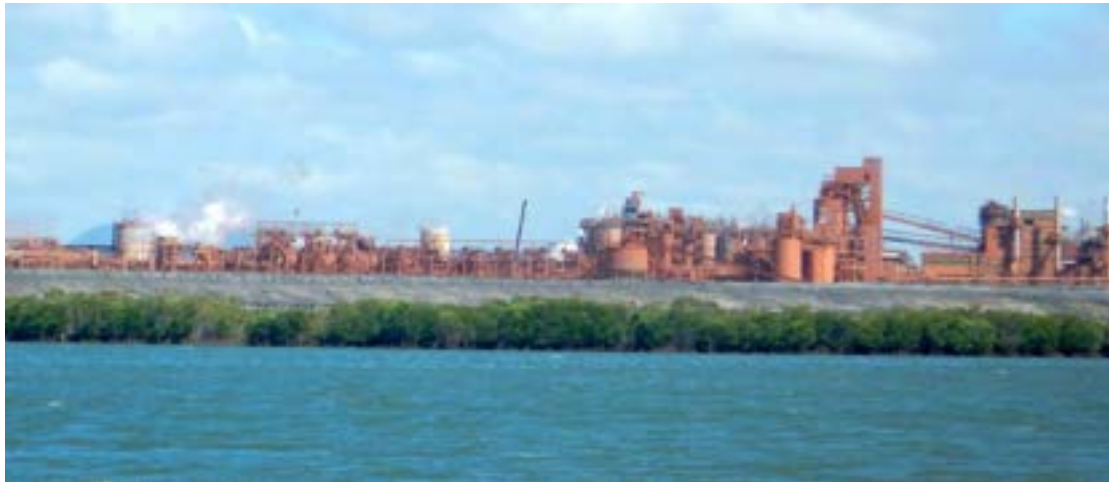
Extensive construction works have affected the hydrology of this estuarine system. This situation has amplified the risks to the overall health of this largely estuarine system. This affects its resilience and capacity to recover and repair itself after being damaged by large-

scale catastrophic events, like severe flooding, cyclonic winds or sea level rise. Direct losses were observed mostly towards the mouth of the estuary, But, this also includes issues like cutting of riparian vegetation, installation of boat ramps, construction of bridges, and verge hardening with rock walls, constructed shorelines and landfill replacement of tidal wetlands. This driver was the one most highly rated as detrimental to the condition of the South Trees Inlet estuary.

**Figure 31: Landfill sites fronted by remnant mangroves dominate the lower downstream estuarine areas.**

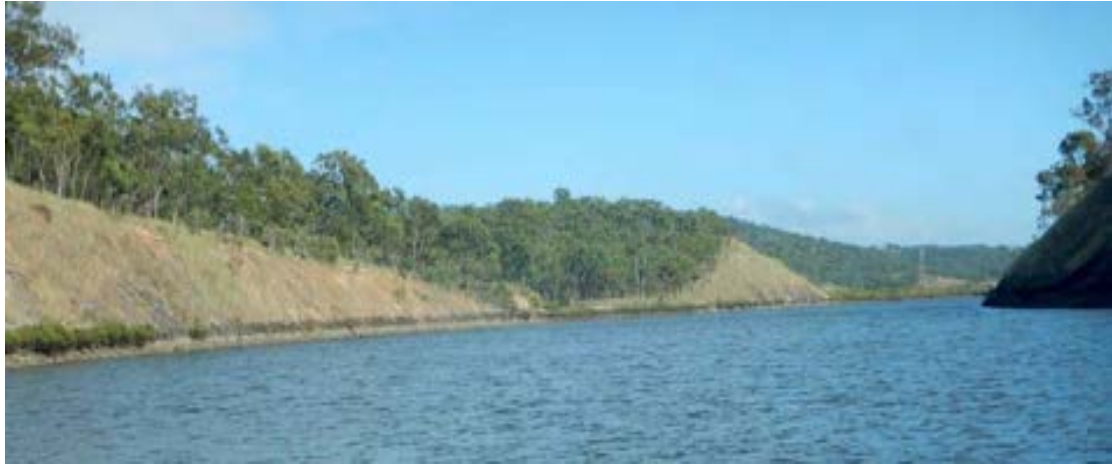
Structures like bund walls, breakwaters and constructed drains were all observed along the estuary. The observation was also made that native wildlife (birds, fish, marine vegetation, mangroves) were greatly reduced in diversity and numbers in areas surrounded by hardened structural walls.

**Figure 35: Channel modification has been undertaken on a massive scale in the channel connecting the inlet with Boyne estuaries.**

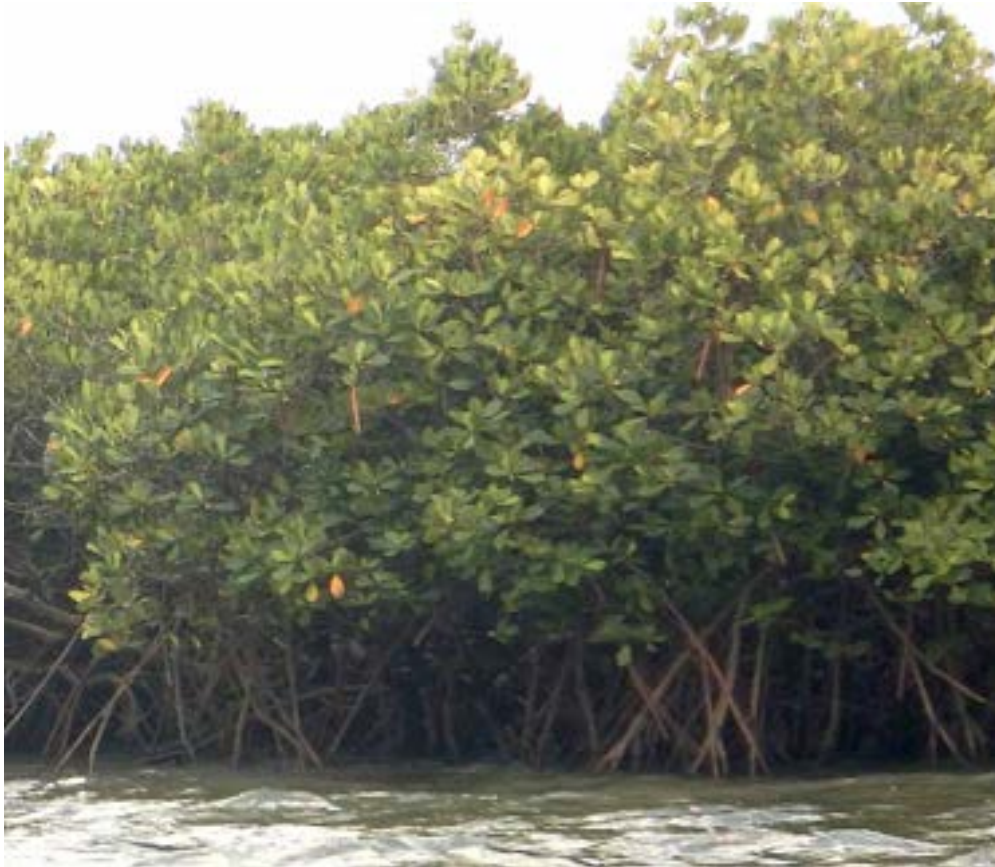
There were a number of survey observations listing the presence of possible pollutant sources at places along the estuary. One was the presence of red dust covering foliage of mangrove trees near the mouth adjacent to the bridge at the mouth. Another observation was of the presence of green algae on exposed mud flats fronting mangroves. This was considered an indicator of excess nutrients in surrounding waters. These occurrences were possibly associated with outflow drains in the lower estuary.

**Figure 36: Trees bearing pollutant-related, albino propagules are commonly seen during the fruiting season.**

- maintain environmental freshwater flows to the estuary
- minimise dust levels reaching mangroves and other native vegetation
- Increase public awareness regarding the importance of tidal wetlands.
- maintain regular monitoring of the health and condition of riparian and tidal wetland vegetation surrounding the estuary
- maintain regular monitoring of the areas damaged by severe storms

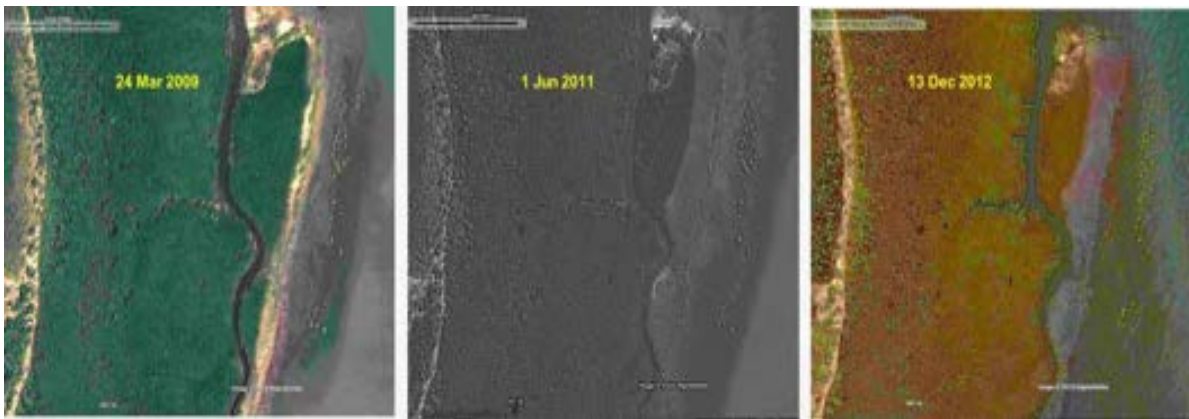
Figure 37: Occurrence of large mangrove dieback patch on South Trees Island.

A large patch of mangrove dieback was noted along the eastern side of South Trees Island at the south-eastern mouth of the estuary. The imagery available confirms this occurred around 2010. The cause is not known but it appears to be the result of storm damage contributing to shoreline erosion. A field investigation is needed to resolve this question.

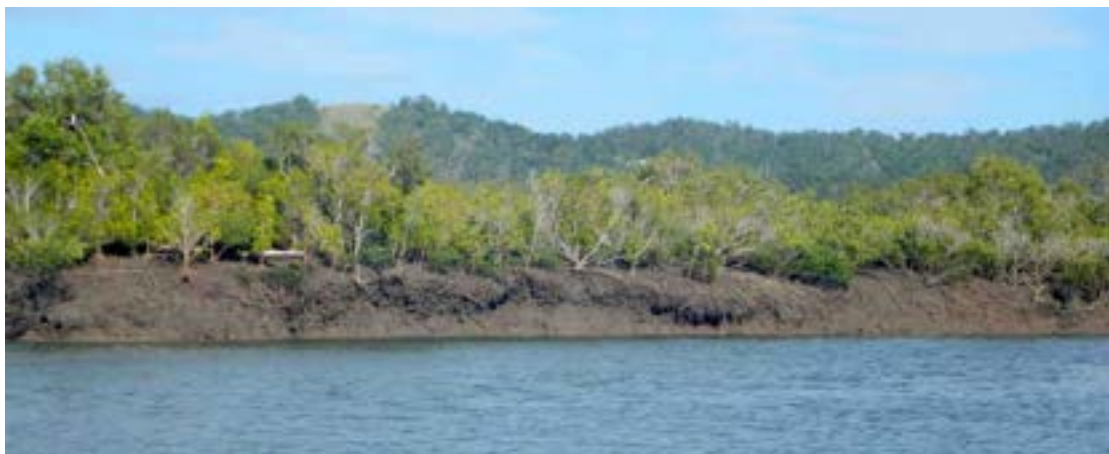
Figure 38: Bank erosion and slumping is not too common in the estuary.

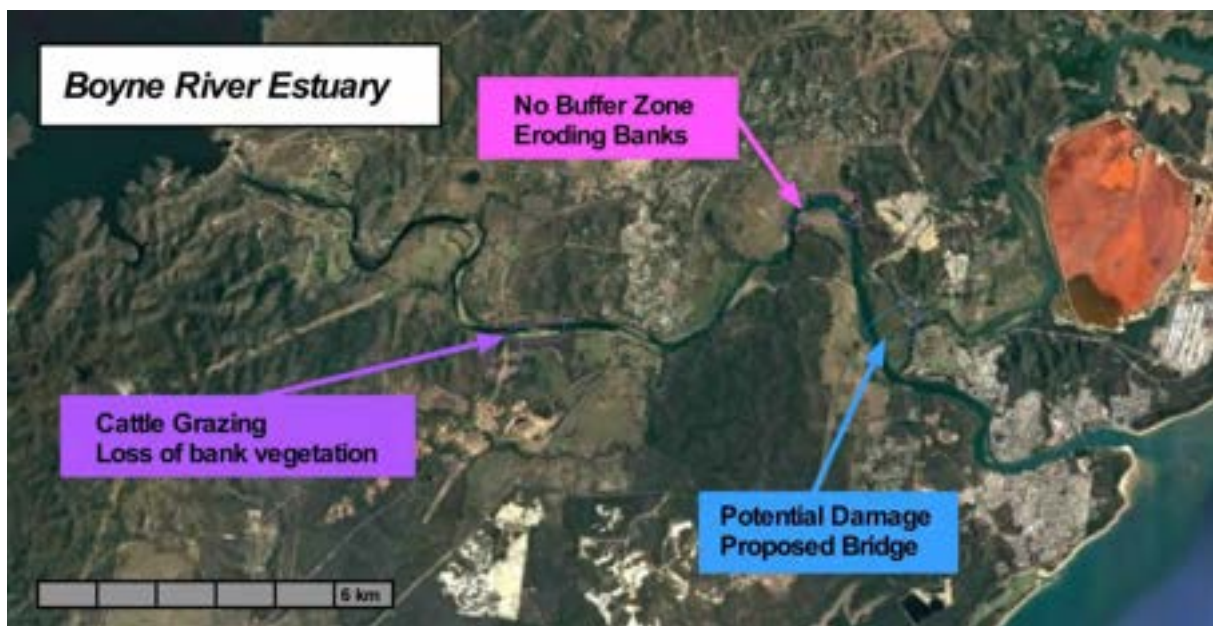
Key issues flagged at 2016 and 2017 community workshops included cattle grazing, lack of buffer zones, and a proposed new bridge (see Fig. 46).

Figure 46: Digitised outcomes of the workshop community-based participatory mapping of Boyne River tidal wetland management issues.

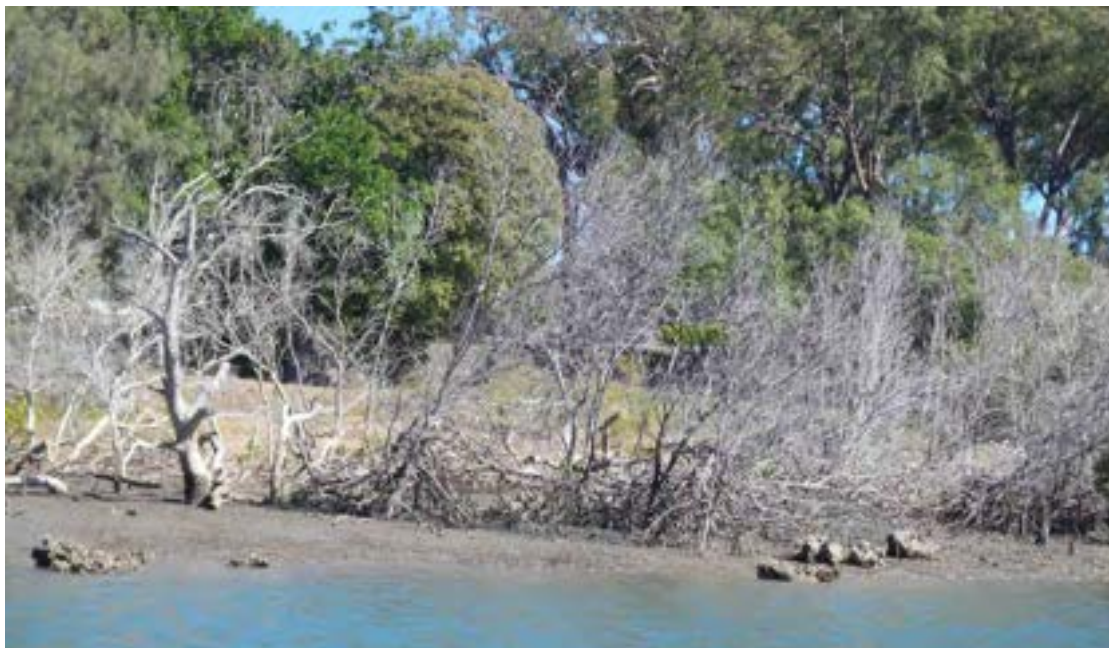
There were only a few field observations listing the presence of possible pollutant sources at places along the estuary. These mostly listed the presence of green algae covering exposed mud flats fronting mangroves. This is considered an indicator of excess nutrients in surrounding waters.

Figure 51: Exposed mud flats often have green surfaces where algae flourishes with the extra light and nutrients.

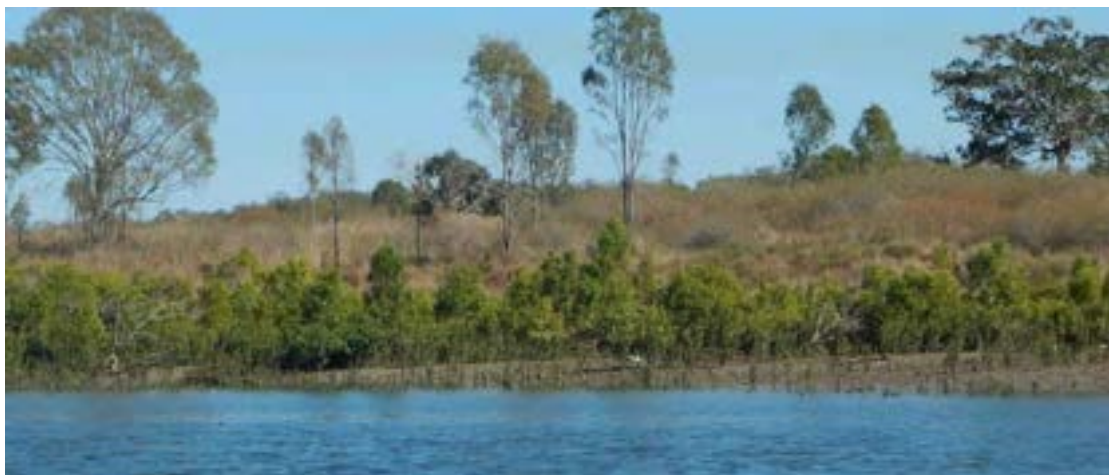
**Figure 52: It may not be depositional gain, but there are patches of young plants growing on exposed banks in many places representing flood damage recovery. They only need a few years before they become more secure and less vulnerable.**

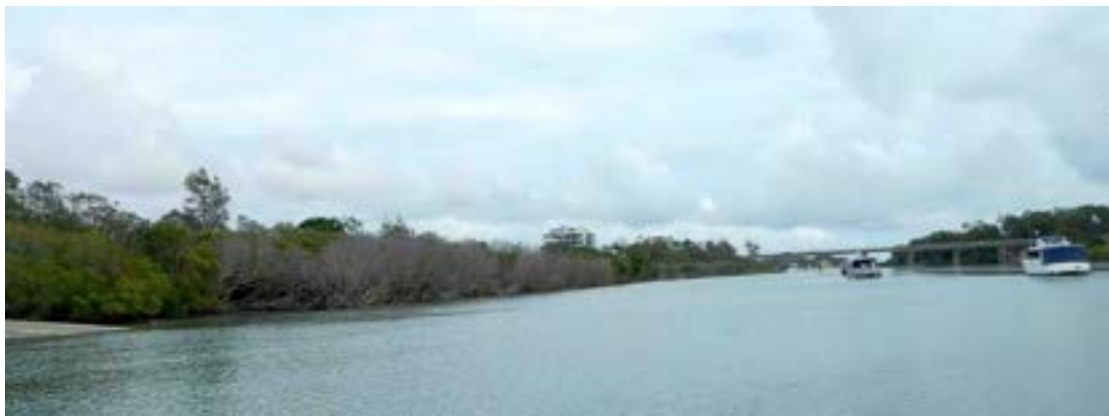
Flood damage was notable along most of the Boyne estuary. The indicators observed were dead trees, standing and lying angled downstream and often covered in silt and occasionally either undermined or with roots buried under sediments. Flood damage recorded in the Boyne system dominates the overall condition of this heavily impacted estuary. More than half (57%) of fringing mangroves along the Boyne were severely impacted by flooding in 2013. Some of these areas have not since recovered.

**Figure 53: Flood damage dominates most mangrove stands fringing the estuary.**

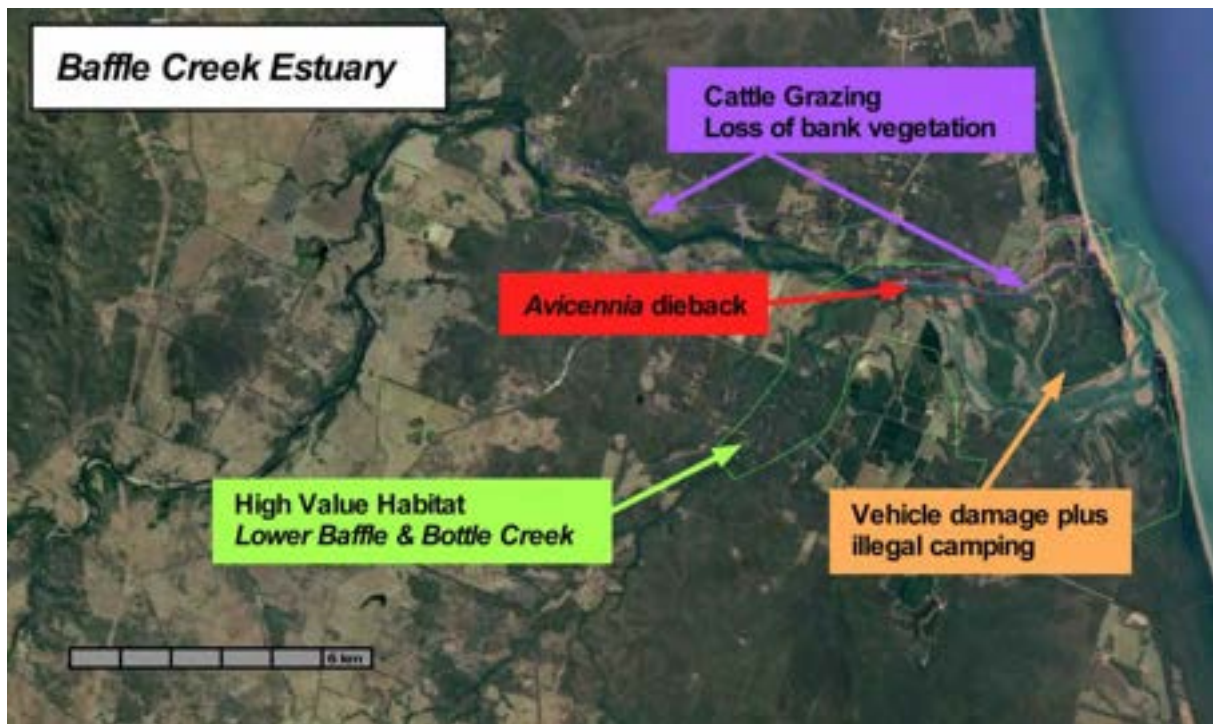
Key issues flagged at 2016 and 2017 community workshops included cattle grazing, vehicle access damage and dieback of *Avicennia* mangroves (see Fig. 61).

Figure 61: Digitised outcomes of the workshop community-based participatory mapping of Baffle Creek tidal wetland management issues.

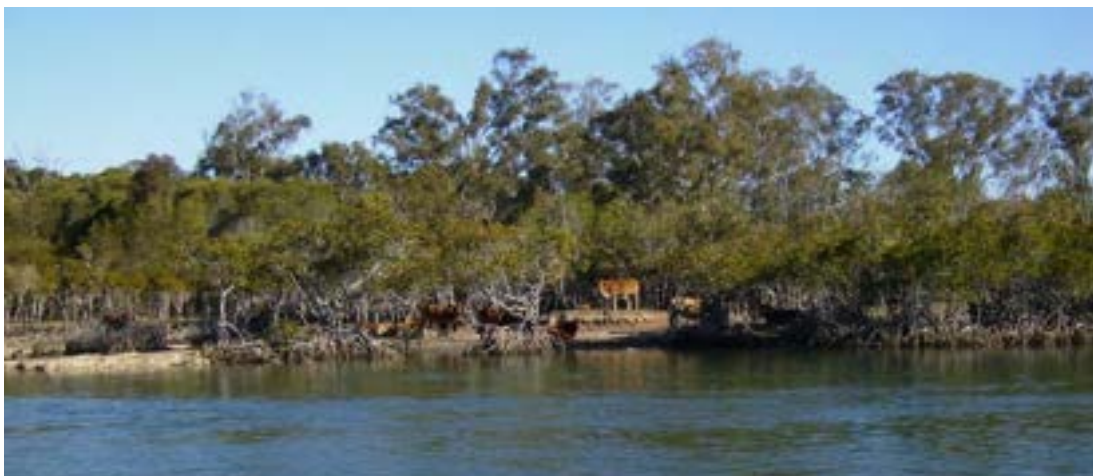
- Cattle grazing in the intertidal zone (Fig. 63).
- Litter and erosion control
- Agricultural intensification
- Increased urbanization
- Increased water extraction and proposed water storage
- Catchment modification

Figure 63: Cattle amongst the mangroves in the mid estuary.

Baffle Creek estuary has high conservation value. However, these values are threatened by both direct and indirect anthropogenic drivers of change present within and adjacent to the estuary. The primary direct threat to the estuary environment is cattle. Heavy grazing of saltmarsh and mangroves has significantly reduced the resilience of these habitats to natural pressures such as drought and frost. Cattle trampling disturbs tidal wetland sediments, leading to increased erosion, raised turbidity and hence lowered water quality both within the estuary and extending to the nearby southern Great Barrier Reef. Cattle dung in the tidal zone is also likely to contribute to nutrient import into the estuary during high tides, contributing epiphytic algae growth on seagrass. Whilst some efforts have been undertaken to restrict cattle grazing in declared conservation zones, more effort must be made to limit cattle grazing in intertidal

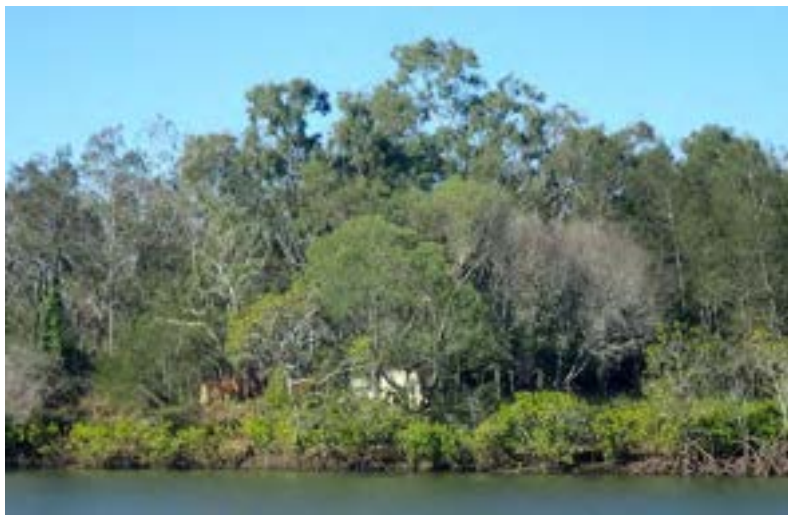
#### **Direct Damage - Cattle Grazing (Fig. 65).**

Cattle grazing was observed in most accessible mangrove areas and all saltmarsh areas within Baffle Creek. The impact of grazing is severe and ongoing. Trampling of saltmarsh areas has greatly reduced vegetation cover and *Sporobolus* saline grasslands are heavily grazed with vegetation height being only a few millimetres. Sediment disturbance is likely to have resulted in saltmarsh surface erosion during flooding. Grazing of mangrove margins following flooding limits mangrove recovery and exacerbates erosion risk during extreme flood events. Cattle grazing therefore limits ecosystem resilience to natural climate events

It has previously been reported that stocking rates along the Baffle Creek estuary are high leading to reduced ground cover and impacts to freshwater and marine wetland ecosystems. Heavy stocking rates are likely to contribute to elevated sediment inputs to the estuary during high-rainfall events contributing to the extensive levels of sediment deposition within the estuary and offshore transport to the southern GBR.

**Figure 65: Cattle grazing mangrove margins threatens mangrove flood recovery and increases erosion risk.**

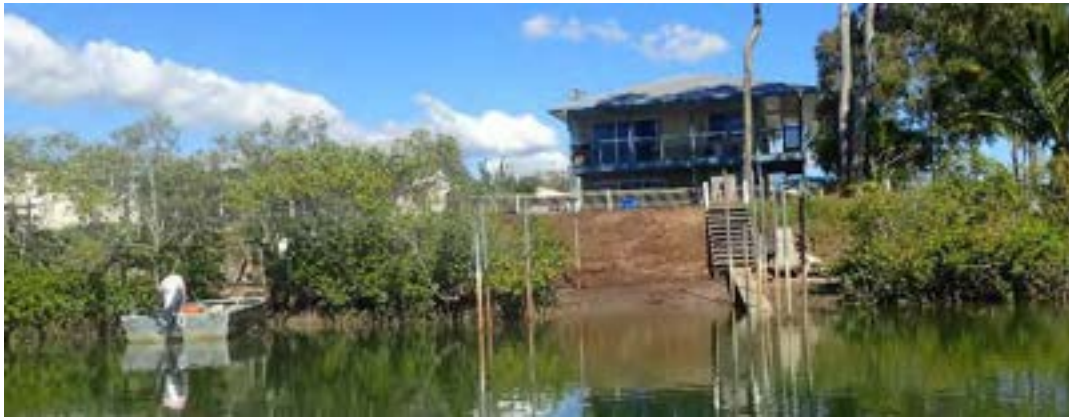
#### **Direct Damage – Cutting/Clearing (Fig. 66).**

Mangrove trimming and clearing of mangroves for shoreline access is apparent along much of the lower and mid estuary. Following flooding, opportunistic mangrove removal and seedling removal appears to be occurring adjacent to settlements and campsites. There appears to be an increasing number of uncontrolled access points along the river. Direct damage to mangroves following flood events limits mangrove recovery leading to reduced shoreline

mangrove cover. Habitat fragmentation for shoreline access decreases habitat resilience to flood events and limits fish habitat values. Uncontrolled access points are also sites of sediment erosion leading to increased sediment loads in the estuary. Preventing mangrove establishment following flood events is likely to lead to an overall loss of shoreline mangrove habitat. There is at least one instance of an abandoned vessel resulting in direct mangrove damage

Figure 66: Recent mangrove removal for shoreline access

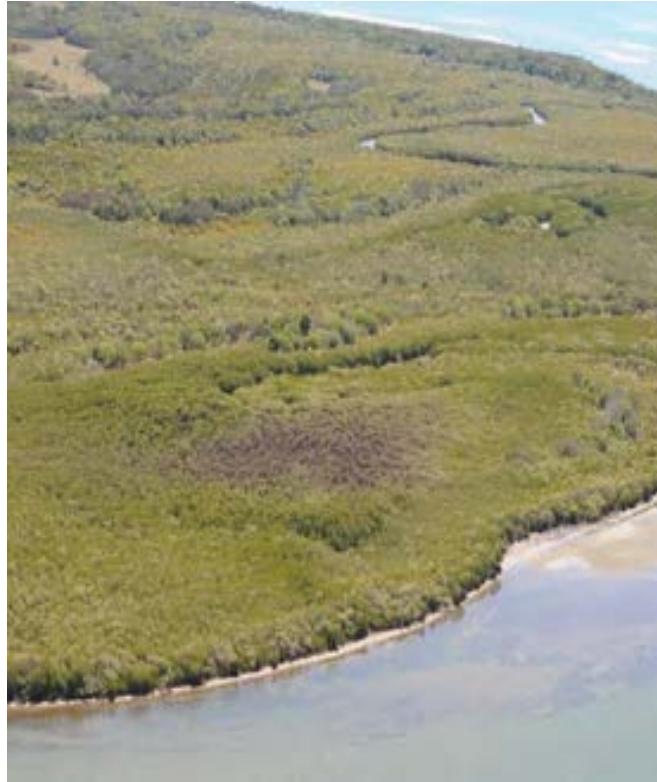
#### **Wildlife Displacement – Bats (Fig. 67).**

A large colony of flying foxes have colonised a tall mangrove stand ~800m<sup>2</sup> in an area on the north bank near the estuary mouth. Bat populations have increasingly been taking up residency in mangroves as a result of habitat destruction elsewhere. Bats can cause significant damage to mangroves by causing foliar leaf loss and increasing sediment anoxia with droppings. Species not able to withstand physical damage, such as those in the *Rhizophoraceae* family will die if the colony persists over an extended period. The colony in Baffle Creek is within a mixed *Avicennia/Rhizophora* community and will therefore likely cause a change in species composition within that area. The bat colony has been present in this location for over 10 years and appears to be increasing in size.

**Figure 67: Flying fox colony, Baffle Creek.**

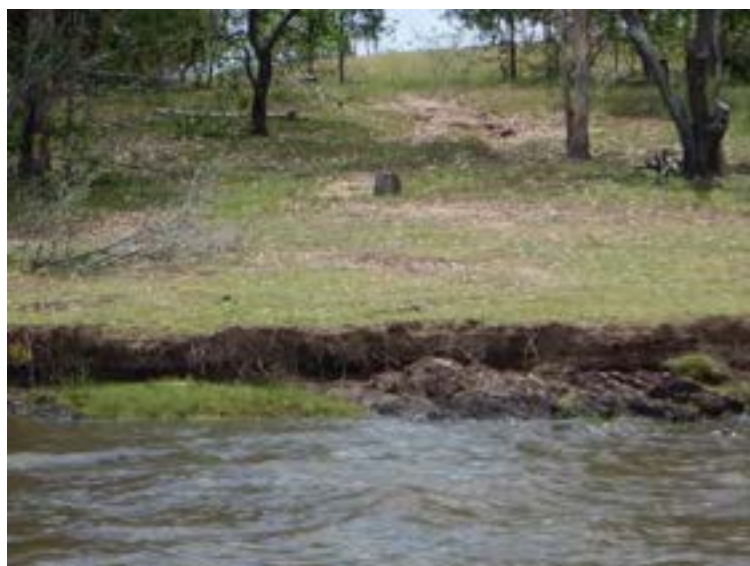
**Bank Erosion** (Fig. 68).

Riparian vegetation removal and cattle grazing along estuary banks has contributed to bank destabilisation in the estuary resulting in bank erosion during flood events. Narrow mangrove margins in the upper estuary are not sufficient to prevent this erosion and shoreline retreat contributes to a loss of mangrove habitat. Estuary bank erosion is likely a significant contributor to sediment loads from Baffle Creek entering the southern GBR. These estuary banks are particularly vulnerable following severe flood damage to the remnant mangrove margin. Camp sites and uncontrolled access further contribute to shoreline erosion risk. Some areas of recent shoreline erosion are recovering with new mangroves present along the shoreline leading to some level of stabilisation.

**Figure 68: Bank erosion along poorly vegetated and grazed shoreline in Eulilah Creek.**

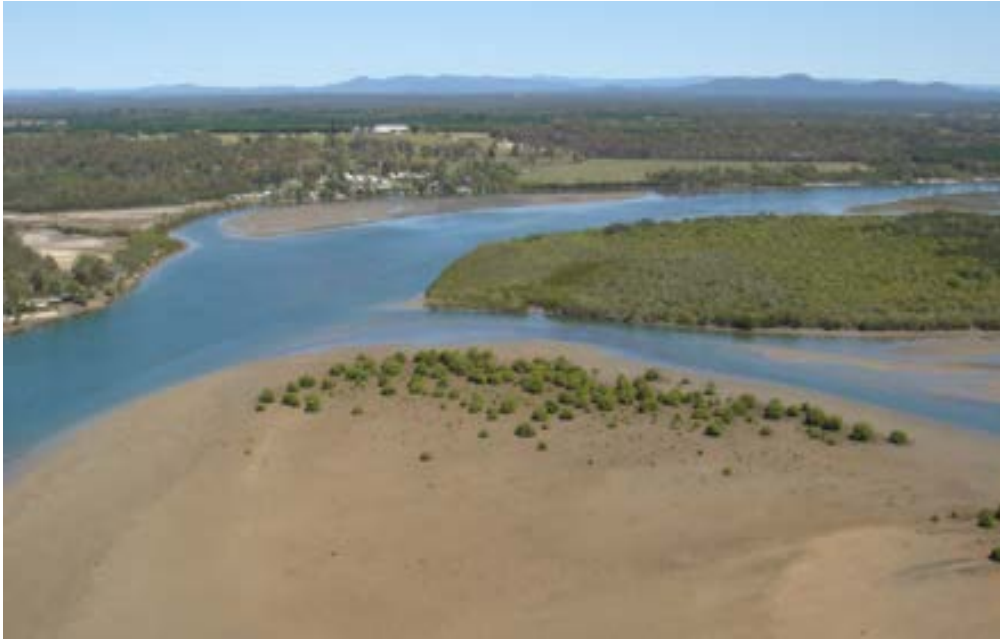
### **Depositional Gain** (Fig. 69).

Islands within the estuary are expanding through sediment deposition and mangrove colonisation. Recently low flows and less frequent flood events have enabled mangrove colonisation and stabilisation of these depositional banks. *Rhizophora* on these banks were aged using the leaf-node scar count method to identify the age of the banks. The oldest trees were recorded as being 10-15 years old, consistent with the recent drying period.

Figure 69: Depositional bank of riverine sediments with mangrove colonisation, Baffle Creek.

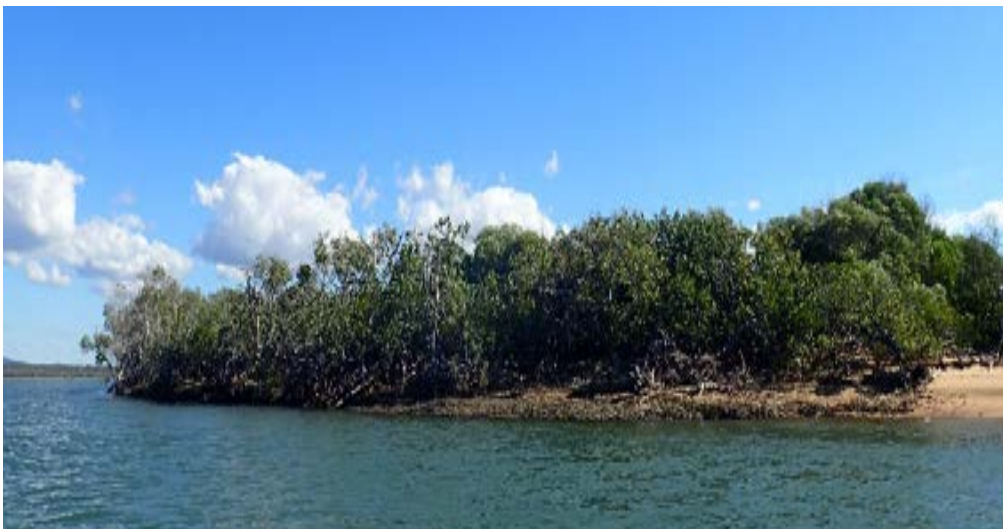
#### **Bank Erosion** (Fig. 70).

The mouth of Baffle Creek is a highly dynamic zone. Severe active erosion is limited to the mouth of the estuary. Oceanic influence appears to be increasing in this zone, potentially exacerbated by recently lower flows and less frequent flood events associated with low rainfall.

Figure 70: Bank erosion in the lower estuary with channel migration into upper-intertidal mangrove forest.

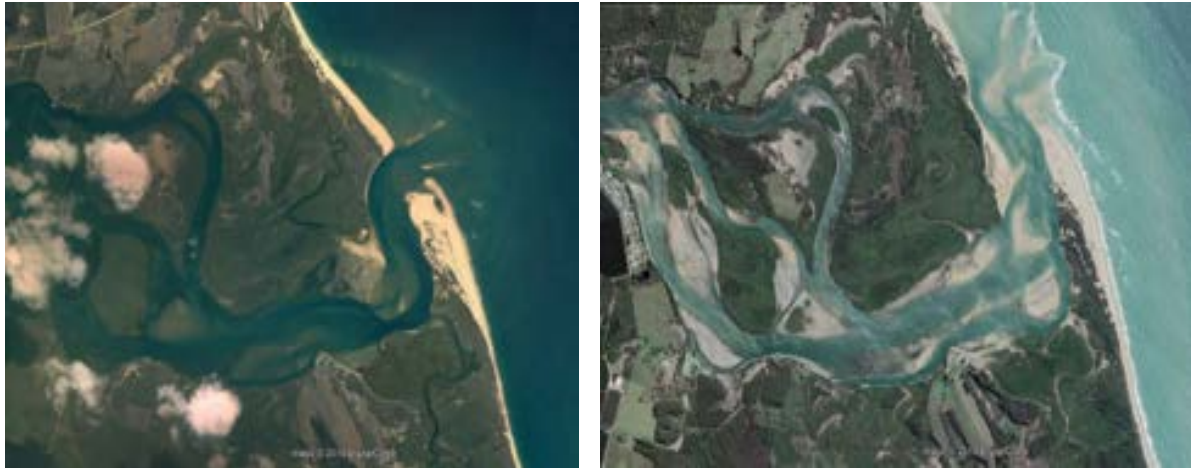
The estuary mouth is rapidly moving (Fig. 71) eroding large areas of mangrove. Further upstream, exposed eroding banks are present opposite depositional islands which have narrowed and shallowed the main channel. Shoreline erosion and associated mangrove loss is likely to increase with rising sea levels.

Figure 71: The mouth of Baffle Creek estuary in 2002 (left) and 2018 (right) showing coastal shoreline retreat and development of depositional islands.

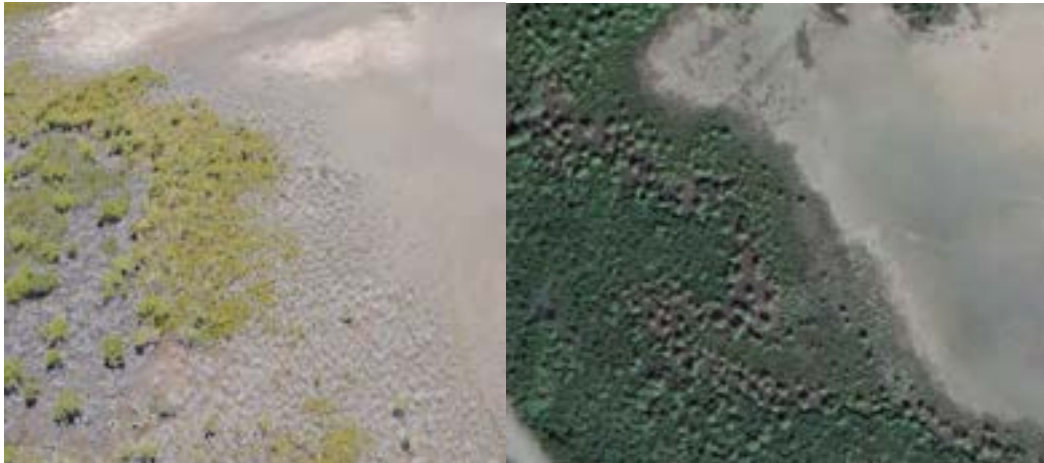
### **Ecotone Shift (Drought) (Fig. 73).**

Past drought conditions greatly affected mid-estuary mangrove communities at the landward fringe and saltmarsh vegetation, causing an increase in unvegetated saltpan area. However, it is very likely that the effects of drought were exacerbated by cattle grazing, trampling and sediment disturbance. Ecotone shift was most evident on and adjacent to Long Island and in Duck Creek, near Winfield. It appears that past observations of negative ecotone shift have since recovered due to higher rainfall conditions and rising sea level over the last decade.

**Figure 73: Drought induced mangrove dieback on the landward fringe, indicative of negative ecotone shift; mangrove to saltpan-saltmarsh in 2008 (left) and the same area showing positive ecotone shift and recovery in 2018 (right; image: Google Earth).**

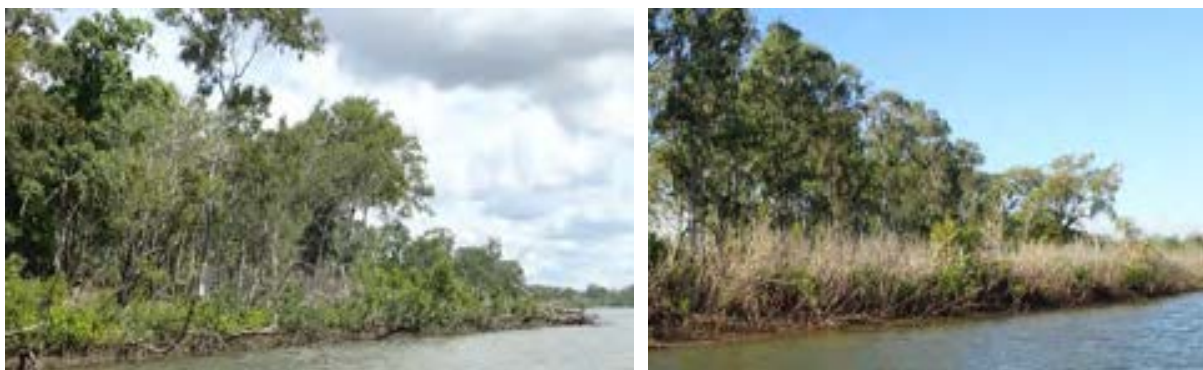
### **Flood Damage (Fig. 74).**

Recent severe flooding has greatly impacted fringing mangroves along Baffle Creek throughout the estuary. Most narrow fringing mangroves in the mid and upper estuary which were inundated by flooding were either physically damaged by floodwaters, experienced extended inundation periods beyond physiological tolerance or had root systems exposed by erosion or smothered with sediment. Large-scale erosion of mangroves has occurred along the northern lower estuary. Flood-related mangrove losses may be offset by the formation of mud deposits in the mid estuary, suitable for mangrove colonisation. There is evidence that some mangrove areas are recovering following flooding.

**Figure 74: Flood impacted mangroves in 2017 showing recovery (left) and limited recovery (right).**

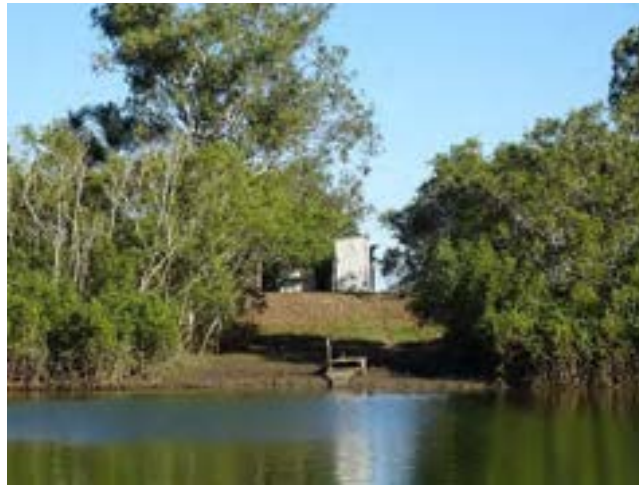
Mangrove habitat fragmentation and removal for shoreline access and river views is occurring along the Kolan estuary and Yandaran Creek. Following recent flooding it appears that mangrove re-colonisation has been prevented in some locations. Habitat fragmentation

reduces mangrove resilience to future flood events, reduces sediment and nutrient trapping capacity and increases sediment export to the southern GBR.

Figure 84: Shoreline habitat fragmentation for shoreline access in the lower-mid estuary.

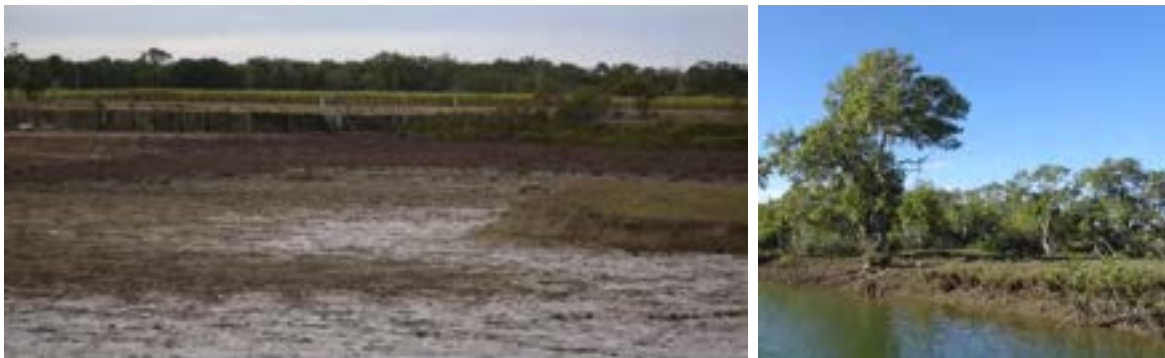
Cattle grazing is impacting tidal wetlands at the Miara boat ramp and along Yandaran Creek. At the Miara boat ramp it is apparent that cattle are grazing on *Avicennia* reducing tree height and also causing sediment instability in adjacent saltmarsh. This area is also affected by altered hydrology and vehicle damage. Along Yandaran Creek, cattle are grazing saltmarsh habitat and *Avicennia* seedlings. In both instances cattle grazing reduces tidal wetland resilience to sea level rise and flood impacts, and disturbs tidal wetland sediments reducing sediment trapping capacity and increasing sediment export to the adjacent southern GBR waters.

Figure 85: *Left*: Damage to saltmarsh resulting from cattle near the Miara boat ramp. Note also the wooden barrier to restrict tidal flow. *Right*: Evidence of cattle grazing and browsing saltmarsh and mangroves along Yandaran Creek.
