# **Southern Great Barrier Reef Coastal Habitat Archive and Monitoring Program: Mangrove Management Plan Volume 2**

## **Volume 2**

Norman C Duke<sup>1</sup>, Jock Mackenzie<sup>1</sup>, Ric Fennessy<sup>2</sup>, Riley Cormier<sup>3</sup> & John Kovacs<sup>3</sup>

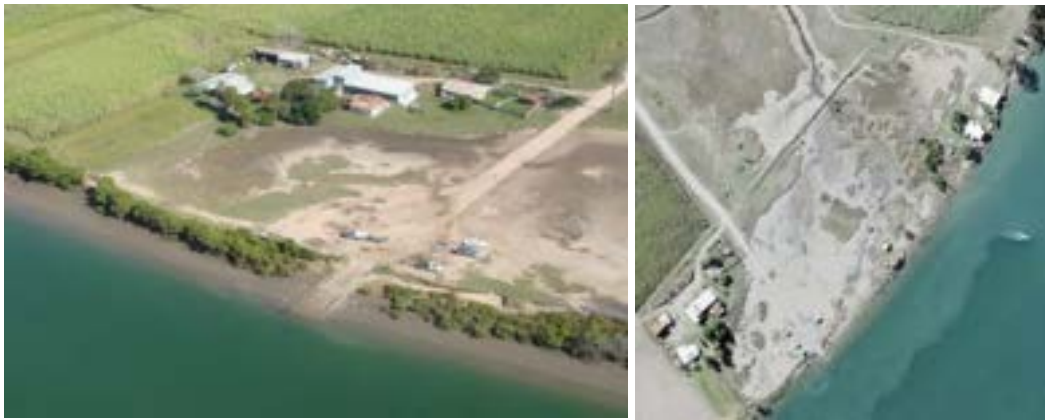
Vehicle damage is evident at the Miara boat ramp where vehicles turn around on adjacent saltmarsh and saline grassland. Vehicle impacts are also present in saltmarsh behind the Miara Caravan Park. These areas are small however damage could easily be prevented if appropriate measures were taken. Given that there is limited remnant saltmarsh habitat in the Kolan estuary and that sub-tropical saltmarsh is an EPBC listed endangered regional

ecosystem, efforts should be undertaken to limit impacts to these areas. Vehicle damage in this area was first reported in 2008 (Mackenzie & Duke, 2011) and more recent observations suggest little has changed in the past 10 years.

Figure 86: Vehicle damage to saltmarsh at the Miara boat ramp in 2008 (Left) and an aerial view of the same location in 2017 showing increased habitat degradation (Right).

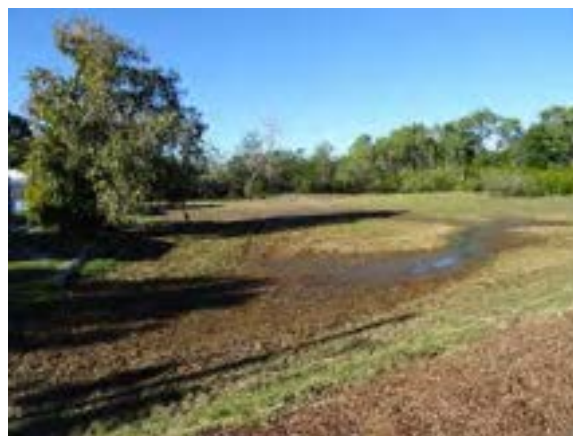
A small area of saltmarsh was observed to be frequently mown behind the Miara Caravan Park. Mowing reduces tidal wetland resilience to sea level rise preventing upland migration of habitat.

Figure 87: Mowing of saltmarsh at Miara Caravan Park.

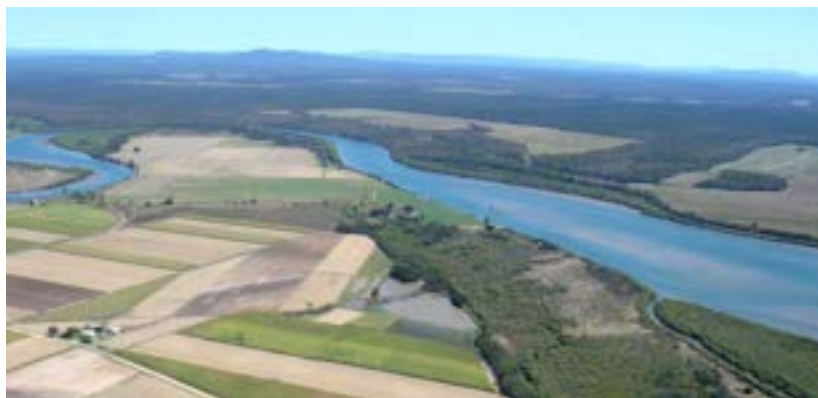
Freshwater impoundment associated with agriculture is contributing to change within the estuary. In areas where water impoundment is present rate of saltmarsh expansion is elevated, suggesting such alterations to hydrology can cause significant changes to plant community structure. In the Kolan estuary it is apparent that the large mangrove to saltmarsh area ratio is maintained by overland and groundwater freshwater inputs. The low canopy density and mangrove retreat occurring during drought conditions suggests that minor changes to hydrological flow in this estuary are likely to have a significant influence on the area of mangrove and saltmarsh.

**Figure 89: Irrigation impoundments restrict freshwater flows to tidal wetland areas and exacerbates drought conditions as can be seen by the dying area (top right).**

There are two areas within the Kolan River where restricted freshwater flow has had an obvious effect on tidal wetlands. These include the area of mangrove near the Miara boat ramp where a wall has been constructed to restrict flow, and in the upstream portion of the Conservation Park where freshwater inputs have been impounded for irrigation.

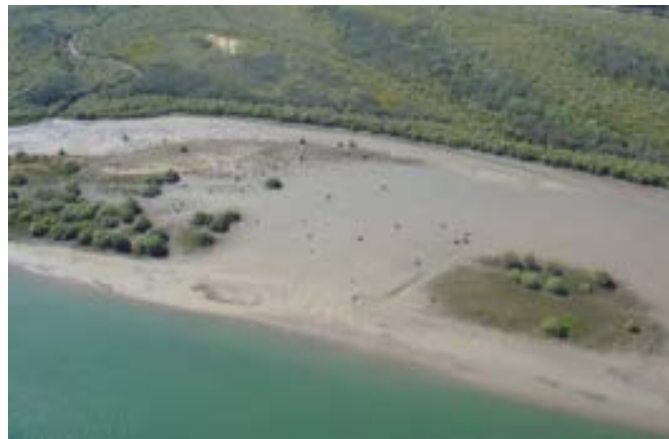
Vegetation removal both within the catchment and adjacent to the estuary has led to increased sediment loads in the Kolan River estuary. During periods of low flow, much of this sediment is deposited within the estuary where it remains as a result of reduced estuarine flushing capacity associated with the construction of the barrage. This sediment has made the estuary shallower, as well as encouraging the formation of accreting banks consisting of deep, nutrient rich anoxic mud. These banks provide perfect habitat for mangrove colonisation, where *Avicennia* and *Aegialitis* are dominant species. It is possible that rapid sediment deposition creates conditions that favour some species and not others. In this instance it is likely that *Avicennia* and *Aegialitis* can quickly become established on downstream depositional banks whereas *Rhizophora* cannot. Plant community structure clearly has the potential to be altered by increased sediment deposition within an estuary. The reduction of *Rhizophora* fringing communities within an estuary greatly influences fish habitat quality as *Rhizophora* stands are structurally more complex than *Avicennia* stands, making *Rhizophora* forests high quality fish habitat.

**Figure 90: Downstream depositional banks colonised by seedlings, signalling future mangrove expansion in this section of the estuary.**

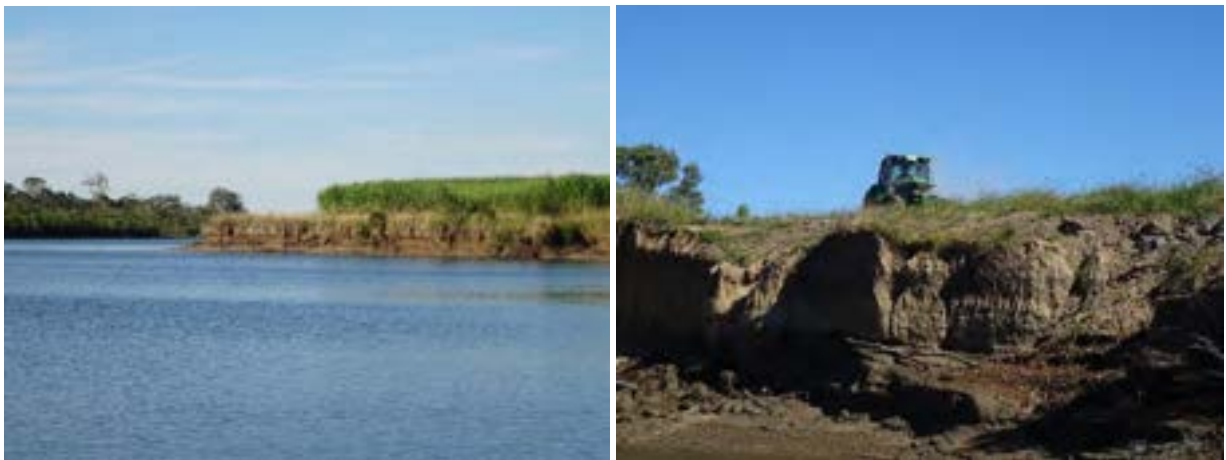
Elevated nutrient and sediment runoff to the estuary may limit the capacity of mangroves to reduce bank erosion during flood events. Elevated nutrient loads and anoxic fine sediment deposits result in mangroves having lower root to shoot ratios making them more vulnerable to erosion and toppling.

Following recent flood events, significant bank erosion has occurred along the estuary near the mouth of Yandaran Creek. An erosion control plan has been designed and is intended to be implemented by Gidarjil Development Corporation with other partners in the near future.

**Figure 91: The absence of a riparian buffer and cropping to estuary margins increases erosion risk and estuary sediment loads.**

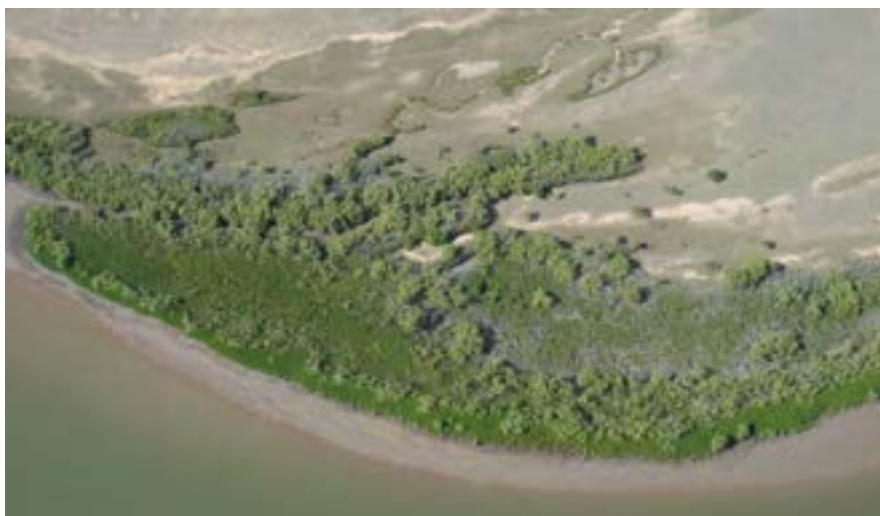
Both Diuron and Atrazine have been recorded at moderate levels within the estuary. These herbicides are known to impact mangroves and have likely contributed to reduced mangrove resilience to both flood and drought impacts.

**Figure 92: Dead (grey) *Avicennia* and *Aegiceras*. The cause of death is related to herbicide runoff.**

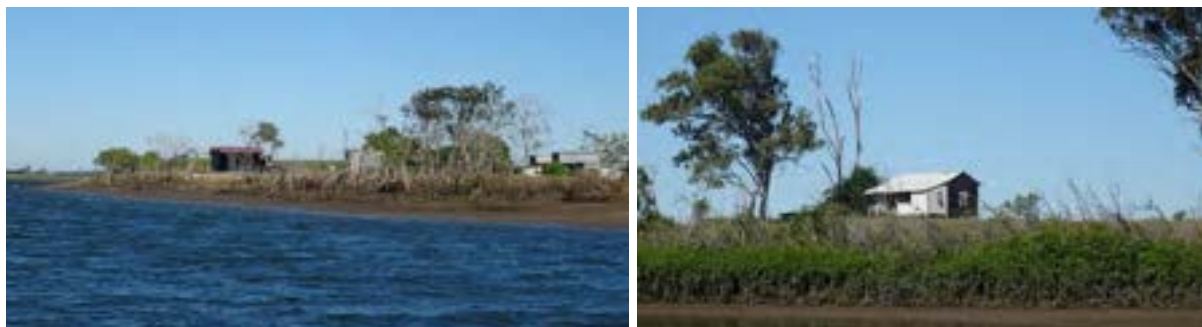
Mangrove recovery following severe flooding is evident in the lower and mid estuary. Newly deposited mudbanks are now colonised with mangrove seedlings. A new mangrove channel was created opposite Yandaran Creek. In some locations, flood recovery has been impeded by human mangrove removal, bank hardening and cattle grazing.

More frequent severe flood events in this estuary will likely see the loss of upstream mangrove habitats in the future as a result of bank erosion exacerbated by agricultural encroachment.

**Figure 93: Flood impacted mangroves showing recovery (left) and lack of recovery (right).**

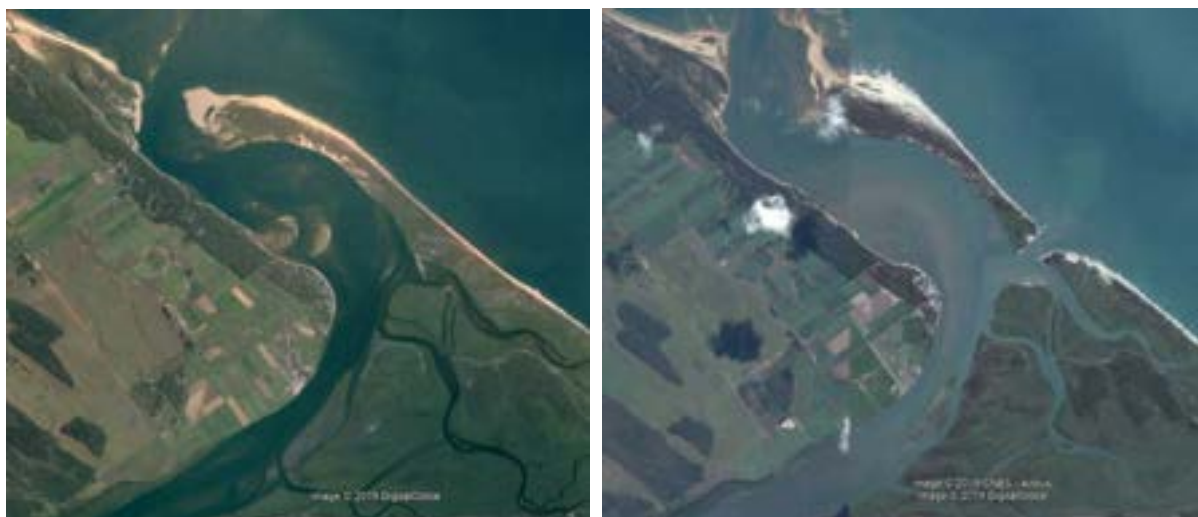
Recent severe weather events in the region resulted in the formation of new estuary entrance at the Kolan River mouth. This dramatic change to the estuary morphology has altered estuary hydrology and hydrodynamics increasing tidal flow and seawater exchange at the estuary mouth. Shoreline and tidal wetland habitats in this area are undergoing natural adjustment to these changes. Large-scale erosion of shoreline habitats is now occurring at the estuary mouth resulting in a loss of habitat. The changes currently being experienced in the Kolan estuary may be indicative of how estuaries will respond to future sea level.

**Figure 95: Kolan estuary mouth in 2005 (left) and 2018 (right) (*Images from Google Earth*).**

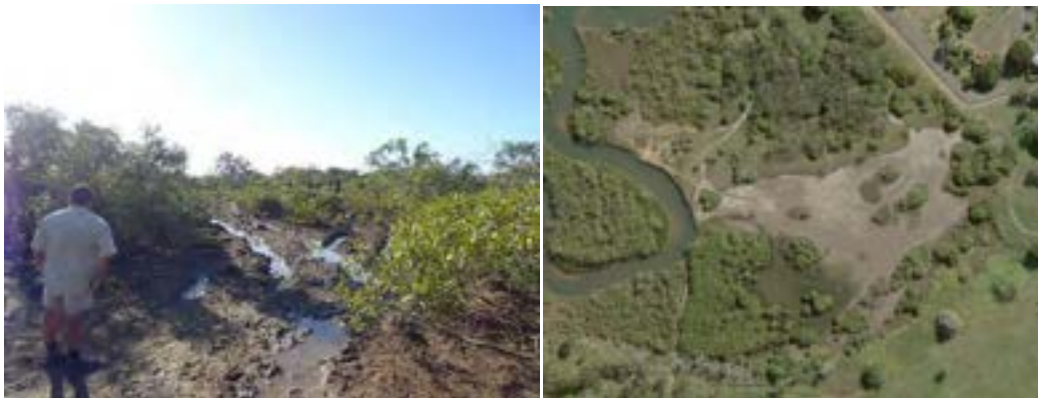
Figure 103: Vehicle damage to Walkers Creek tidal wetlands (*Aerial image: Qld Globe*).

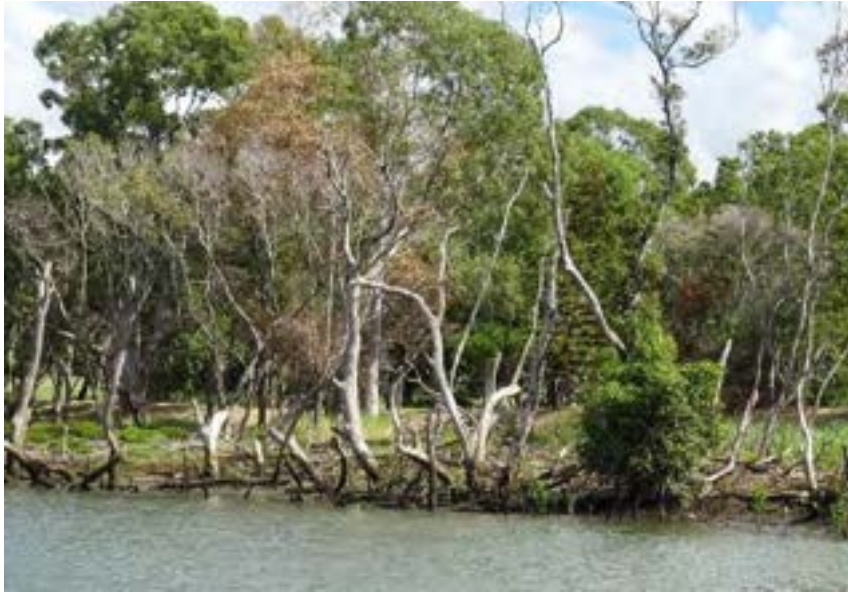
Following severe flooding there was a local management response to cut and remove dead mangroves from some areas of shoreline along the town reach.

**Figure 104: Poisoning of surviving mangroves and adjacent riparian buffer adjacent to urban land.**

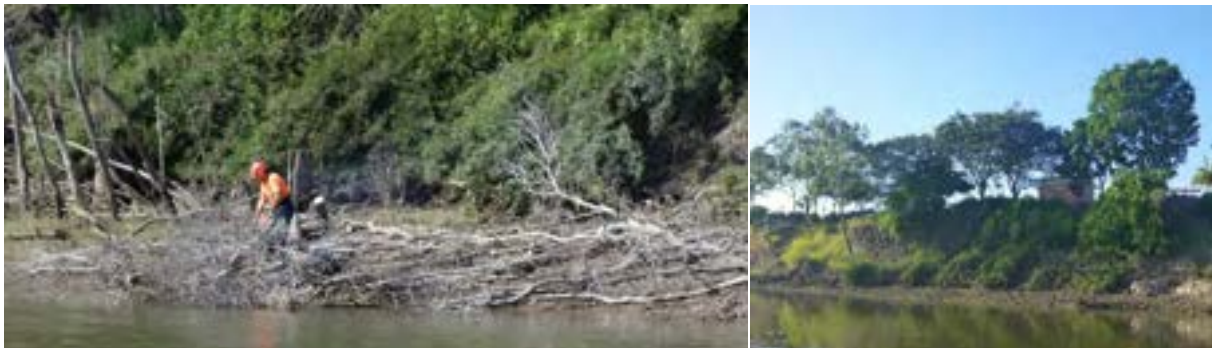
This approach was taken in the interests of public safety. Some of these areas have not since re-established with mangroves. Some shoreline residents took advantage of the damaged state of mangroves along shore frontage to remove mangroves and it is likely that active mangrove seedling removal to prevent mangrove re-establishment is occurring in some locations. Trimming and removal of mangroves continues along the estuary for view maintenance and access.

**Figure 105: Dead mangroves being cut following flooding in 2013 (left) and the same area showing little recovery in 2016 (right).**

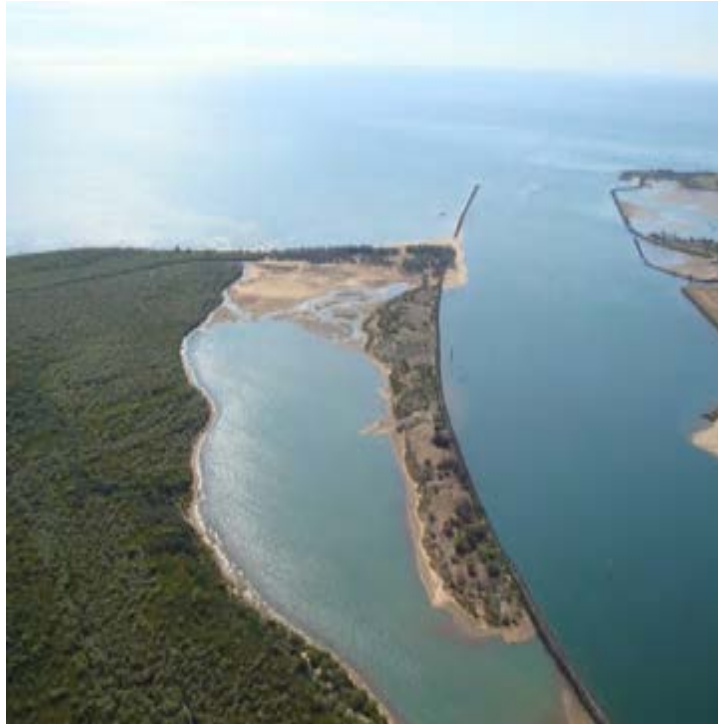
The primary driving factor affecting tidal wetlands within the Burnett River is altered hydrology. Barrage construction and alterations to the river mouth have dramatically altered flow regimes. This has consequently altered sediment deposition within the estuary and potentially increased erosion on some banks. The construction of the training wall separating Barrubra Island has dramatically altered the natural hydrological conditions within this large mangrove area. The reduced frequency of freshwater flows resulting from the presence of the Ben Anderson Barrage limits the flushing capacity of the estuary resulting in the accumulation of sediments, nutrients and pollutants within the estuary, all of which can influence tidal wetland ecology and ecological integrity.

The presence of the barrage within the estuary will restrict upstream mangrove estuarine shift as sea levels rise.

**Figure 107: The training wall at the mouth of the Burnett River severely impacts natural flow.**

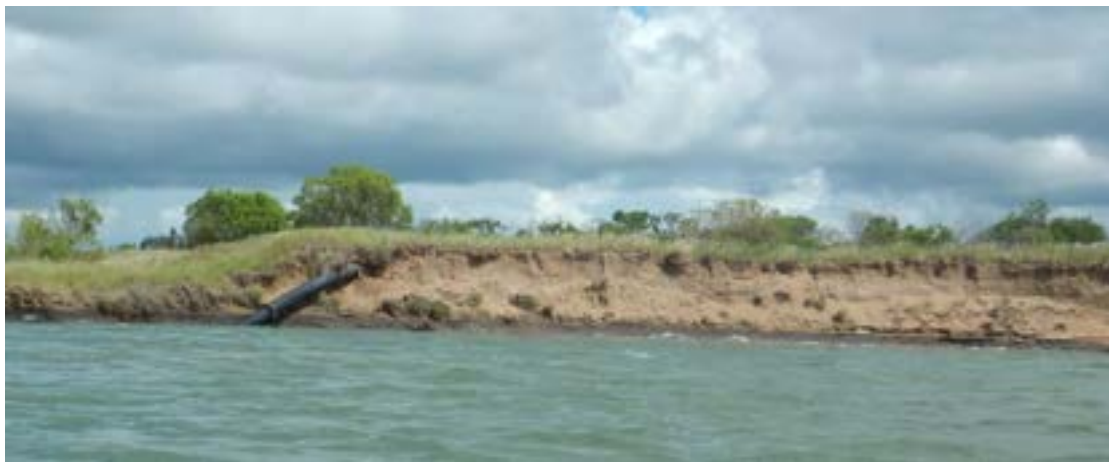
**Figure 109: Bank erosion associated with wave action undermining unconsolidated shorelines downstream in the Burnett estuary.**

Significant bank erosion occurred along the estuary following flooding. Erosion was likely exacerbated by estuary siltation, loss of riparian vegetation and low mangrove resilience related to high nutrient loads. Bank erosion threatens both agricultural and urban land, and tidal wetlands. Of particular concern is bank erosion that is impacting threatened sub-tropical saltmarsh on the northern bank at Fairymead. There is little remnant saltmarsh vegetation in the Burnett River system and efforts should be undertaken to protect remnant areas where possible. A shoreline protection strategy for this area has been developed and is awaiting funding for implementation by Gidarjil Development Corporation.

Erosion control using shoreline bank hardening (Fig. 110) is a common feature along the estuary. It is recommended that all future shoreline erosion management strategies include consideration of shoreline vegetation and promote natural engineering approaches.

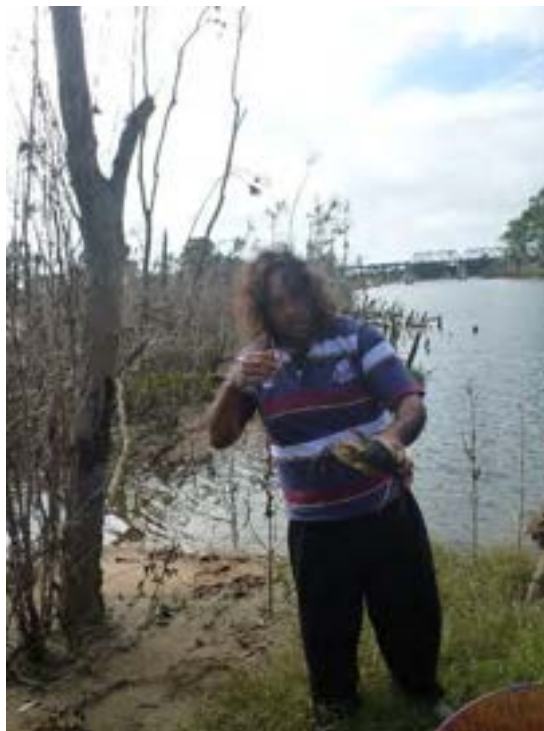
Herbicide and pesticide runoff from agricultural and urban land threatens both tidal wetland habitat and associated fisheries resources.

**Figure 111: Crustaceans like mud crabs are sensitive to pesticide pollution.**

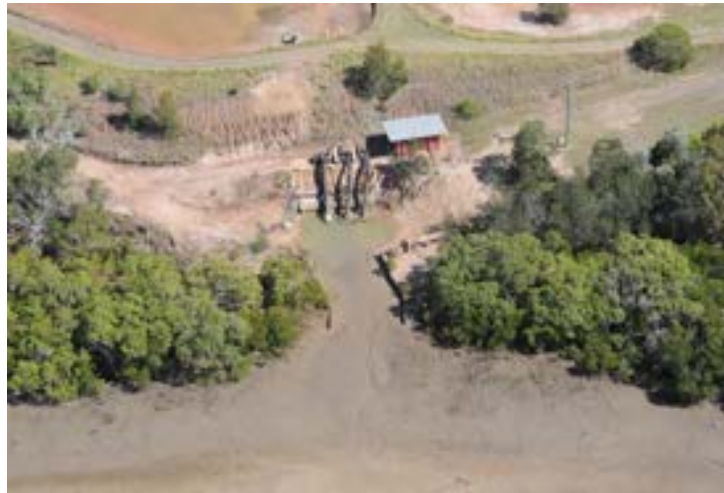
Fringing mangroves have been removed from a few isolated locations along the estuary margins. Mostly mangroves are removed to maintain access to boat ramps, jetties and fishing spots. The largest incident of mangrove removal is the construction and maintenance of intake/outtake pipe for the large aquaculture facility upstream of Riverview. Whilst, these incidents are isolated, continued and increased mangrove removal associated with intensified

development adjacent to the estuary will add up to have a significant ecological impact on the estuary.

**Figure 122: Mangrove removal for aquaculture intake/outlet pipes.**

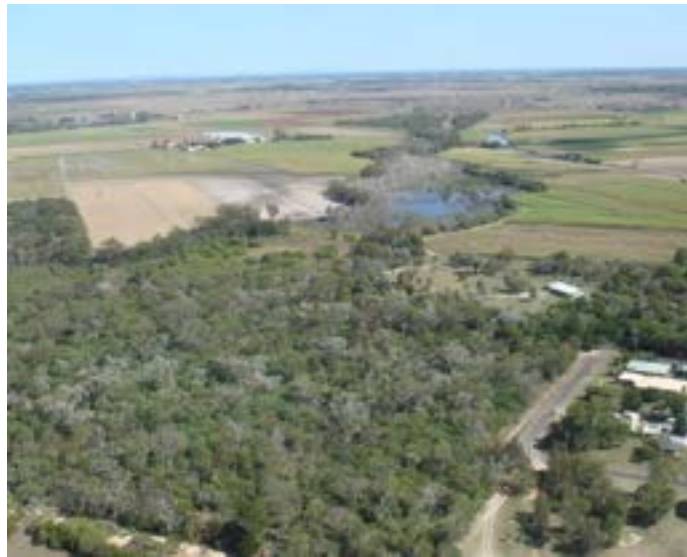
Intensive agriculture relying on irrigation is the dominant landuse surrounding the estuary. To provide consistent water for irrigation supplies, many creek headwaters have been impounded. The loss of terrestrial hydrological connectivity is impacting tidal wetlands and freshwater wetlands within the creeks and the Elliott River. During drought periods small freshwater flows are important for maintaining ecological function in wetland ecosystems. Impoundment has reduced freshwater flows and freshwater availability to downstream tidal wetlands. Consequently, the effects of drought have been exacerbated in these areas, with increased rates of mangrove retreat. The presence of terrestrial barriers to freshwater flow greatly reduces the resistance capacity of tidal wetlands to drought.

**Figure 124: Restricted flow in stream headwaters has increased drought effects in freshwater wetlands and reduced tidal wetland - terrestrial connectivity.**

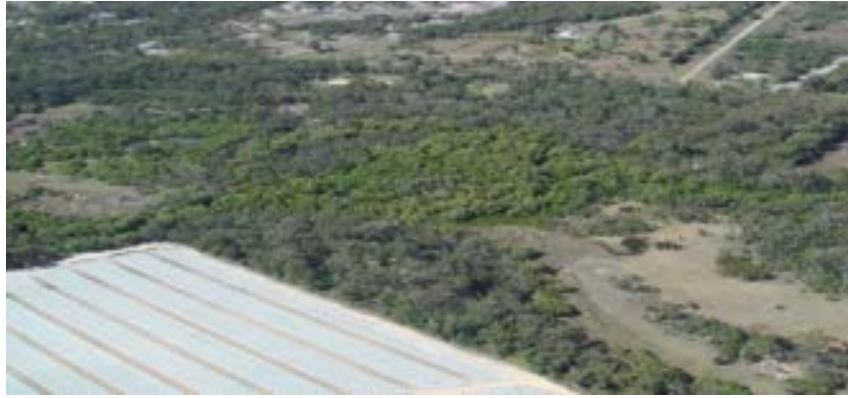
The effects of direct nutrient runoff to the estuary are visible in tidal wetlands adjacent to some areas of intensive agriculture and aquaculture. The estuary is susceptible to eutrophication through groundwater pollution. Additionally, large areas of agricultural land have minimal vegetation buffer zones between crops and tidal wetland areas.

**Figure 125: Direct connectivity between intensive agriculture and tidal wetlands without a significant tidal buffer increases risk of eutrophication.**

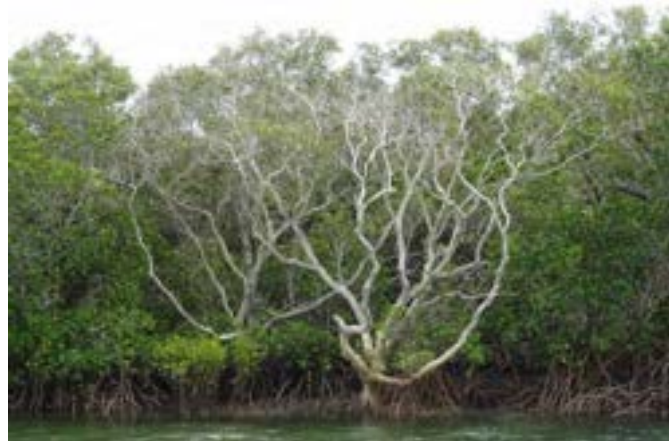
**Figure 126: Species-specific dieback of *Avicennia marina* was recorded in the Elliott estuary. This is indicative of herbicides in runoff waters from agricultural lands.**

Dieback of particularly sensitive mangrove trees of *Avicennia marina* is caused by herbicides in runoff from agricultural lands. These effects can be reduced with the greater use of buffering stands of vegetation between the fields and estuarine waters.

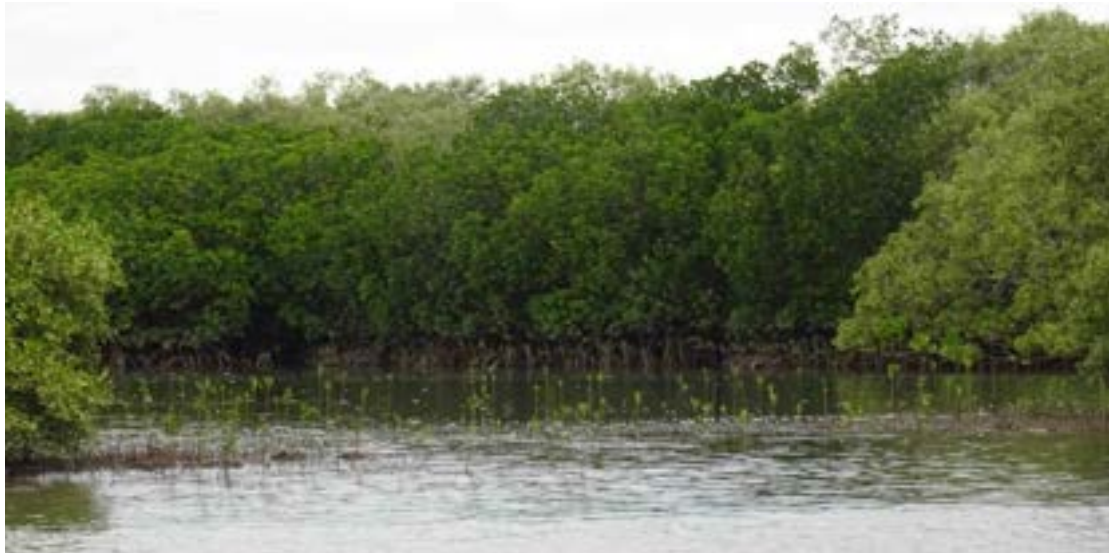
There were notable areas of expanding shoreline margins with fields of young seedlings taking advantage of sediment deposits reaching mean sea levels. These sediments are the result of a combination of clearing of ground cover in the catchment, tillage agriculture and soil disturbances, and the installation of dams and weirs blocking normal flushing flows.

Figure 127: Lots of seedlings growing in front of established shoreline trees is indicative of depositional gain.

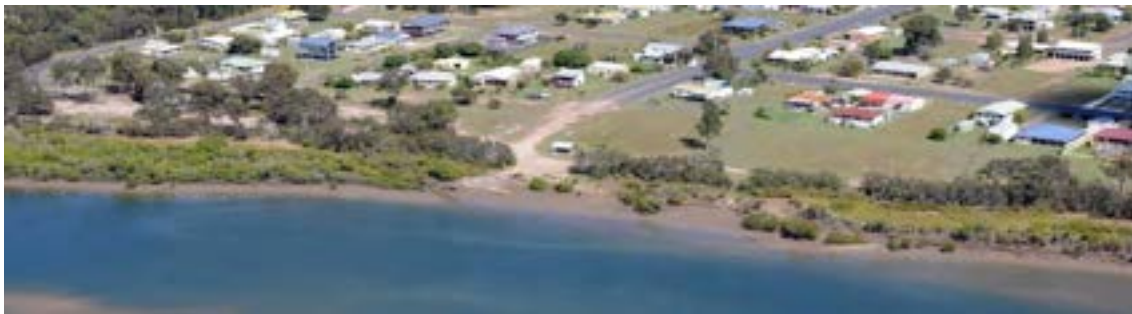
Mangrove damage and impacts to mangroves related to altered hydrology is present near the Burrum Heads township. Population growth and urban expansion will see direct and indirect impacts to mangroves increase with appropriate management (Fig. 138). There are a number of abandoned vessels present in the estuary that are impacting mangrove habitat. Litter and rubbish was frequently observed in mangrove habitat along the estuary. Although this does not directly impact mangrove habitats, it is an issue of concern for other marine wildlife, particularly sea turtles which are known to utilise mangroves within the Burrum estuary.

**Figure 138: Mangrove removal is common along the Burrum estuary.**

| <b>Burrum River estuary – chief drivers, condition &amp; threats – a summary</b> | | | |
|---|---|---|---|
| Direct Damage - Cutting/ Removal | 4 | 2 | 8 |

- Increase environmental freshwater flows to the estuary
- Reduce sediment inflows to the upper estuary
- Increase public awareness regarding the importance of mangroves and riparian vegetation to reduce cutting and clearing.
- Develop and implement a shoreline erosion management plan that incorporates natural and hard engineering approaches (Fig. 139).
- Remove abandoned vessels impacting mangroves.

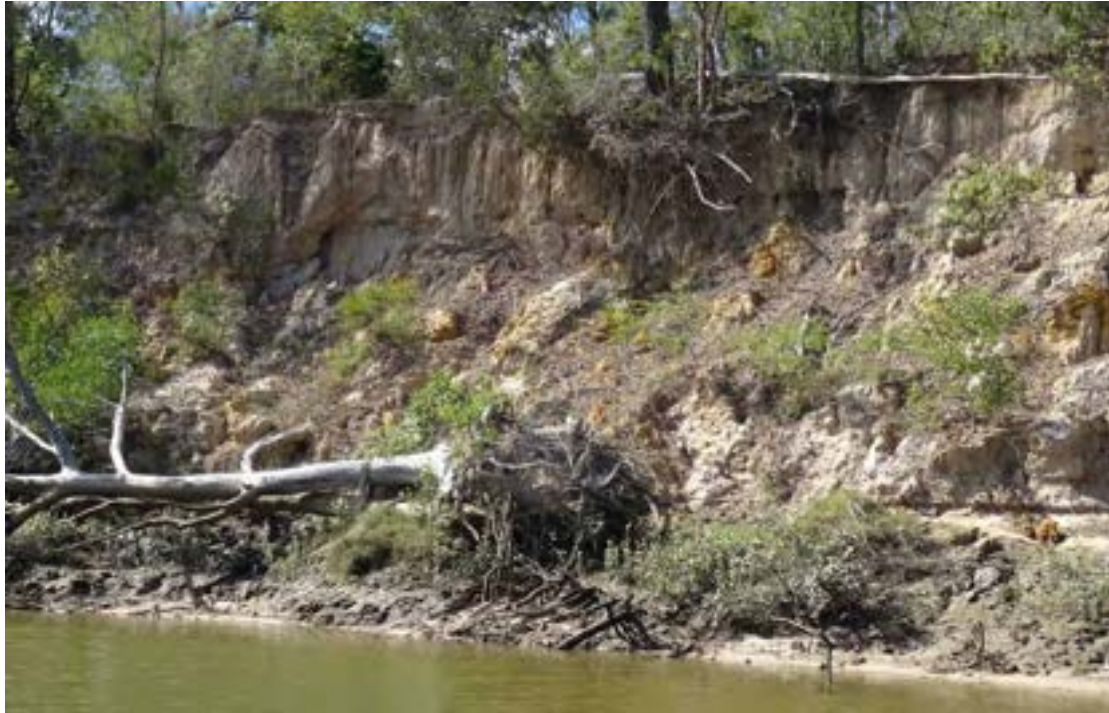
Figure 139: Large-scale bank erosion in the mid-section of the Burrum River estuary.

been recorded to be approximately one meter per year (C. Bussey pers comm.). In the mid-estuary mud and sediment deposition and accumulation from reduced flushing, may cause a shallowing of the estuary and a localised sea-level rise effect. Banks in this area of the estuary are susceptible to erosion, having sheer or steep profiles with loosely compacted sedimentary rock substrate.

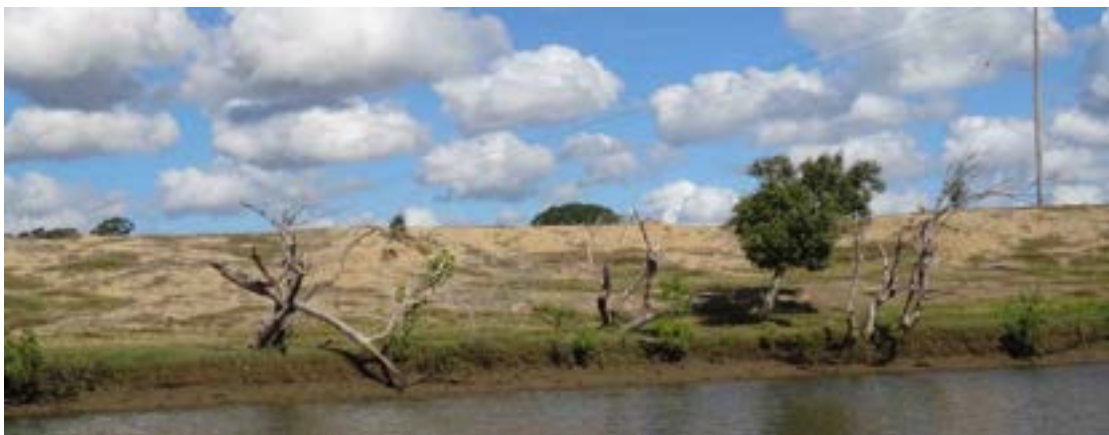
Low levels of environmental impact from cattle grazing were observed in a small saltmarsh area upstream of the Isis River entrance. The stock density in the tidal wetland area appeared to be low. Given the small area of saltmarsh/saltpan complex within the Burrum River, these areas should be provided with greater protection through fencing to reduce the risk of damage from increased stock access. Stock access to shoreline habitats is limiting natural habitat recovery following flooding.

Recreational 4WD/ motorbike activity was observed during aerial surveys to be damaging a small area of saltmarsh upstream from the Burrum Heads township, adjacent to private property. The small area of this saltmarsh area limits the extent of the damage and limits usage. However, given the small area, it is highly susceptible to damage. The Burrum River has a low saltmarsh and saltpan area and existent areas should be protected from damage resulting from vehicle use.

**Figure 141: Grazing by stock plus access and vehicle use has contributed to tree death and loss of saltmarsh vegetation in the Burrum mid estuary.**

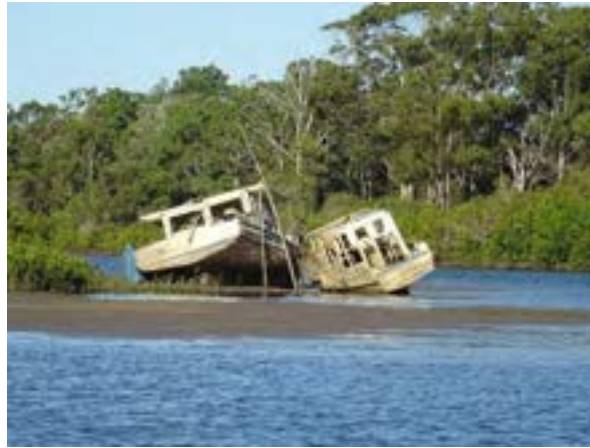
A number of abandoned vessels are present in the lower estuary near Burrum Heads. Although these vessels have a limited impact area, they represent a lack of management oversight in the estuary as they are relatively easy issue to rectify. It is recommended that abandoned vessels are removed as soon as practical.

Figure 142: Abandoned vessels impacting mangroves near Burrum Heads.

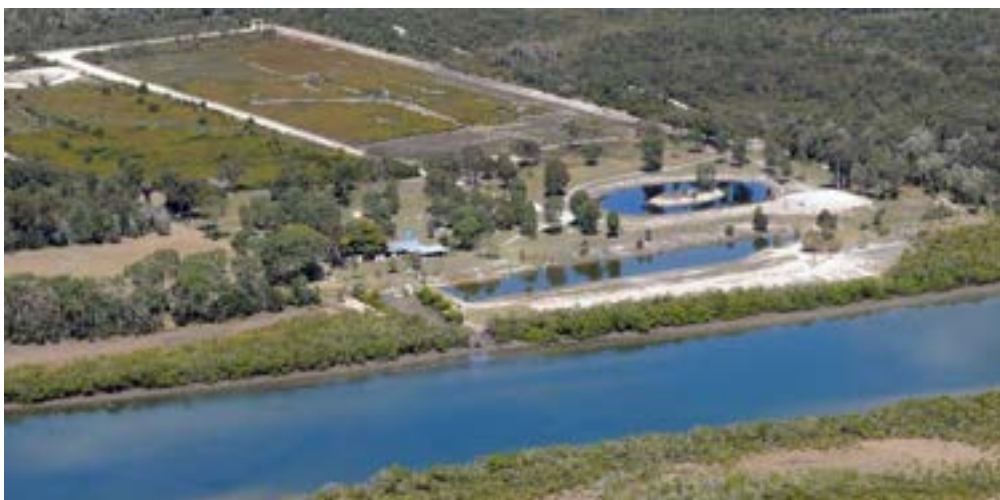
A small dam constructed in upper-intertidal tidal wetland on the southern bank upstream of Burrum Heads has reduced terrestrial connectivity and freshwater supply. The dam appears to be associated with a bund wall that restricts cross-flow tidal influence. It appears that the dam was initially constructed on saltmarsh/saltpan habitat causing a loss of tidal wetland area. The alteration to hydrology in this area appears to have caused reduced vegetation cover, with loss of mangroves and an expansion of saltpan relative to the adjacent unaffected tidal wetland areas. The severe ecological impact of this construction highlights the sensitivity of tidal wetland areas to hydrological change from terrestrial barriers to flow.

Figure 143: Altered hydrology caused by restricting freshwater flow and influencing tidal flow impacts tidal wetland areas.

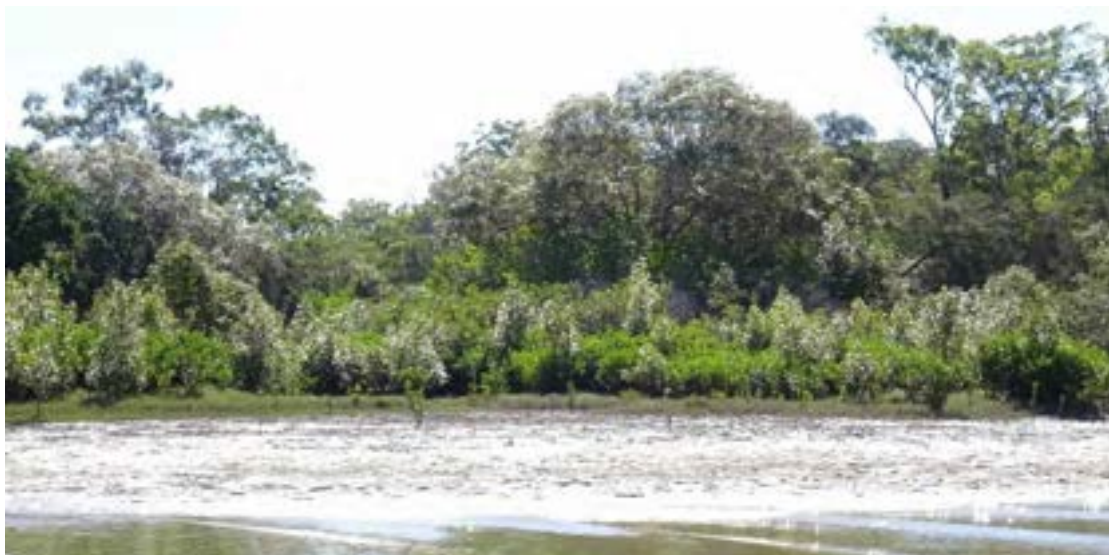
Lenthalls Dam, Burrum Weir #1 and the Isis and Gregory weirs reduce freshwater flow volume and frequency to the lower estuary. These waterway barriers caused large-scale ecological change when they were constructed and continue to effect downstream estuarine environments. Increased sediment deposition in the upper estuary from reduced flows has enabled increased mangrove colonisation, whereas reduced riverine influence downstream, in combination with reduced sediment supply has caused increased erosion and loss of fringing tidal wetlands. Erosion also restricts mangrove colonisation and establishment on fringing banks, especially where vegetation has been removed. Reduced flows and sedimentation reduce the capacity of tidal wetlands to resist drought and exacerbate drought effects. Small to moderate freshwater flows are important during droughts, as these flows limit salinity. Weirs and dams restrict low flow events, and consequently salinity increases upstream. Increased salinity reduces plant productivity and can cause increased mangrove mortality. Mangroves that establish on high nutrient anthropogenically sourced sediment deposits are more susceptible to drought and water stress (Fig. 144), leading to an increase in mortality and loss in productivity during low rainfall periods (Lovelock *et al.* 2009). It is recommended that improving environmental flows during drought be considered when assessing future water usage and storage in the catchment.

Figure 144: Depositional gain is common along banks showing that sediments have accumulated and been colonised by mangroves.

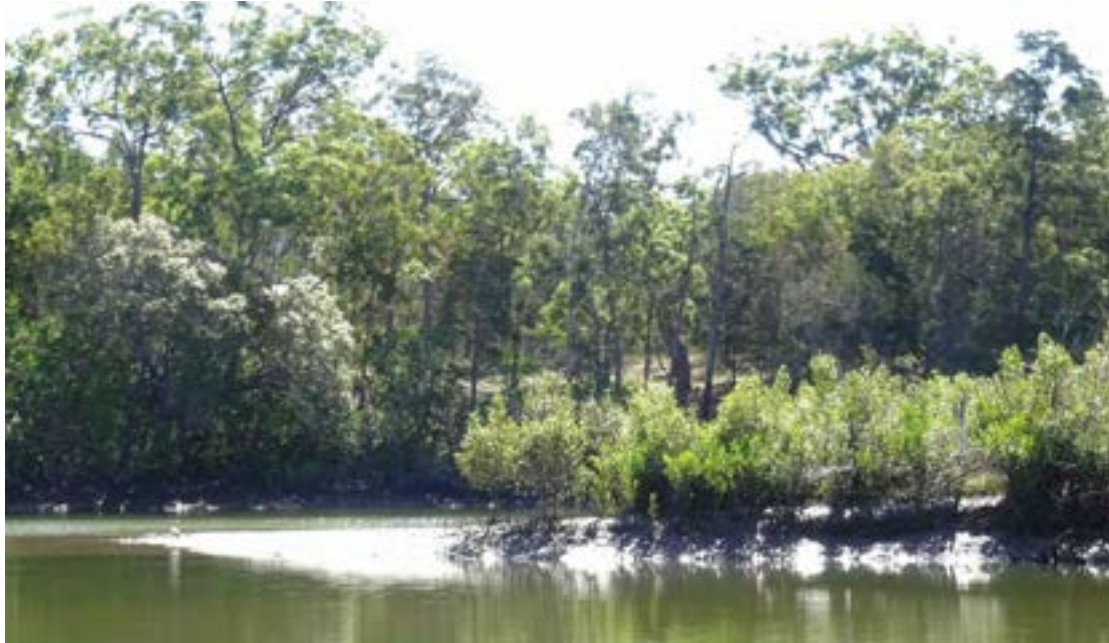
The construction of a high density residential housing area in Burrum Heads has increased freshwater and possibly nutrient runoff to a small creek flowing into the Burrum estuary upstream of Burrum Heads. Mangroves have now extensively colonised this area (Fig. 145). The area is protected from erosion by a small sand ridge running parallel to the shore. Whilst increasing mangrove area in the river may have some positive ecological effects, their presence is decreasing the visual amenity and recreational values of the area. The mangroves however should remain as they are required to buffer pollutants possibly entering the Burrum estuary from the residential area. Due to the rapid colonisation of mangroves, it is highly likely the water from the creek has a high nutrient load. The water quality in this stream should be investigated further.

Figure 145: New sapling growth sites mark locations of depositional gain.

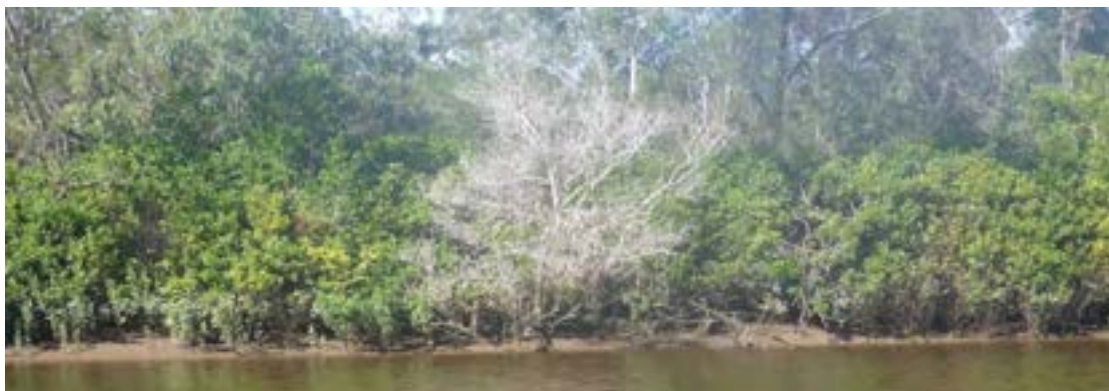
*Avicennia* throughout the Gregory River estuary appear to be experiencing greater levels of dieback compared to the nearby Isis river system. From aerial surveys this effect appeared similar to that previously observed in the Pioneer River system near Mackay which was shown to be the result of herbicide contamination in mangrove sediments (Duke *et al.* 2005). High levels of Diuron, Ametryn and Simazine, all agricultural herbicides, have previously been reported in surface waters of the Gregory River (McMahon *et al.* 2005). Herbicide pollution has the potential to severely reduce mangrove ecosystem productivity (Duke *et al.* 2005) and increase susceptibility to drought. Flows from the Gregory River with high herbicide concentration is also likely to impact upon adjacent seagrass beds in the Burrum River and Hervey Bay (McMahon *et al.* 2005). Flow based sampling of water entering the Gregory River over the weir should specifically test for herbicide contamination. There is increasing pressure within the Gregory catchment to intensify agricultural production in response to conversion of fertile lands surrounding Bundaberg to housing. This will increase the risk of herbicide contamination. Strategies to reduce herbicide application and farm runoff should be implemented within the Gregory catchment to protect estuarine tidal wetland and seagrass habitat.

Figure 146: Species specific dieback of *Avicennia marina* whilst other species appear healthy.

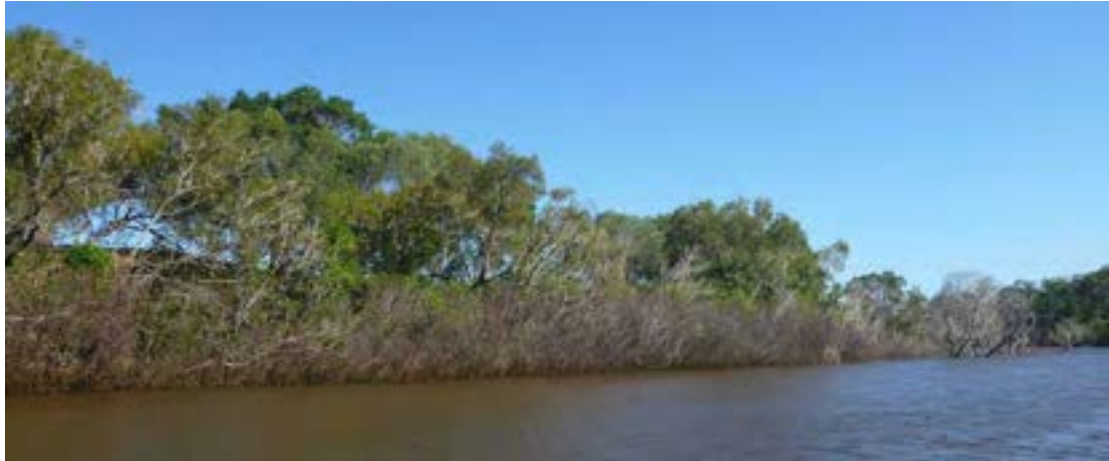
| <b>Burrum River estuary – chief drivers, condition &amp; threats – a summary</b> | | | |
|---|---|---|---|
| Flood Damage | 4 | 3 | 12 |

Recent flooding has caused notable damage to shoreline vegetation. This is often dead and layered in sediment.

Figure 147: Damage from recent flooding shows dieback of lower elevation vegetation, and the leaning dead stems are largely unidirectional.

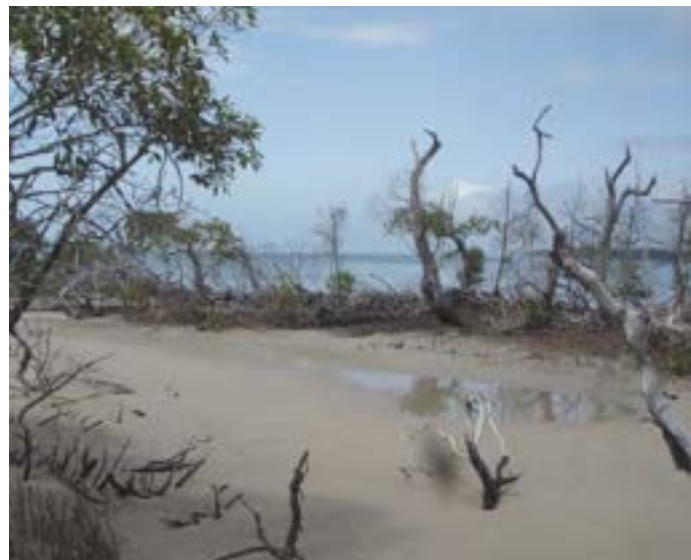
| <b>Burrum River estuary – chief drivers, condition &amp; threats – a summary</b> | | | |
|---|---|---|---|
| Root Burial – Storm Damage | 2 | 1 | 2 |

An area of mangroves on the northern bank in Burrum Coast NP appears to have experienced significant sand deposition in the past. It's likely this occurred resulting from a climatic event such as a cyclone or large flood. The event is likely to have taken place more than 50 years ago. Mangroves in this area are now recovering with colonisation and expansion of *Osbornia* and *Aegialitis* occurring. The volume of sand deposited in the area shows the extent to which natural events can dramatically alter ecological systems and the risk these events pose to coastal urban areas.

Figure 149: Sand deposition and root burial within the highly dynamic lower estuary.

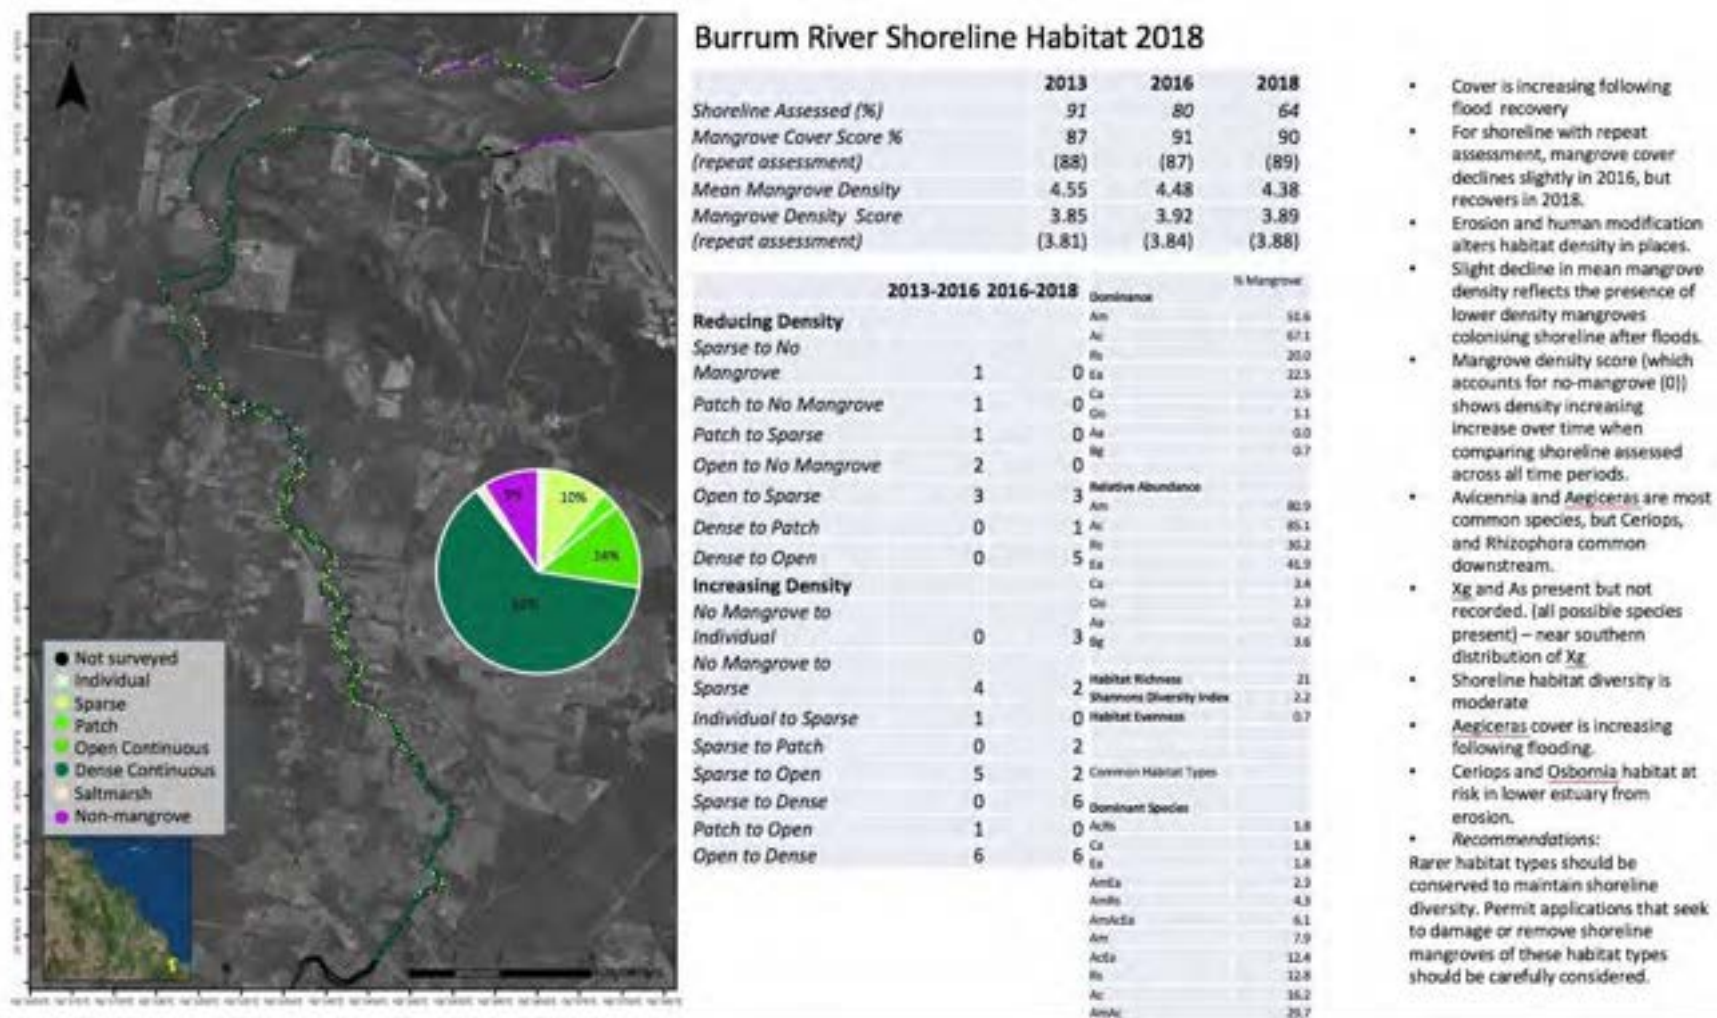
Figure 150: Mangrove condition scores derived from the detailed field data of the Burrum River estuary.

- 1) Mangrove stands were sparse and patchy along the lower estuary, while they were denser upstream;
- 2) Mangrove presence during two time periods (2013-2016 & 2016-2018) showed limited recovery after flood damage, and human modifications affected density; and
- 3) Mangrove species diversity was dominated by *Avicennia marina* (Am = grey mangrove) and *Aegiceras corniculatum* (Ac = river mangrove).
